Beinn Ghlas Outline Biodiversity Enhancement and Habitat Management Plan Walkover Survey Report - November 2023

November 2023

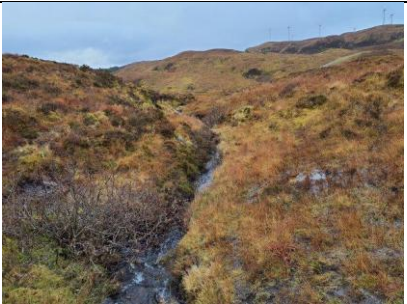
No.	Grid ref	Note	Illustrative photo
1	NM 98882 26251	Riparian planting suitable along this watercourse. There were occasional eared willow present, which demonstrates suitability.

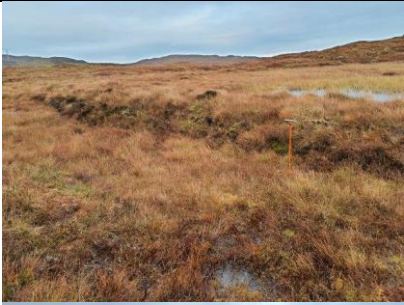
5	NM 99178 26138	A clear linear feature which may have been an old peat cutting. It is connected to the drains further downslope. Dams could be used here to prevent drainage from the surrounding bog habitat.

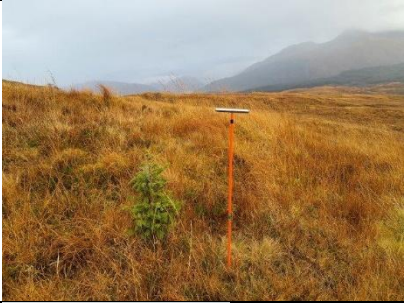
11	NM 00084 26080	Several regenerating Sitka spruce noted in the wet heath. They were between c. 0.5m and 1.5m in height. These non-native trees should be removed.

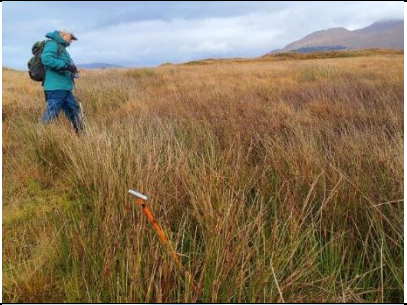
24	NM 00510 26953	Several historic drainage ditches in this area. The drains have rushes within them, and water was flowing in some of them. Dams could be placed within the ditches at regular intervals to slow/reduce flow.

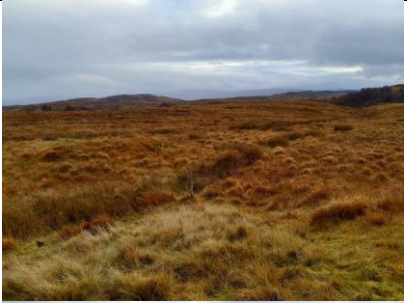
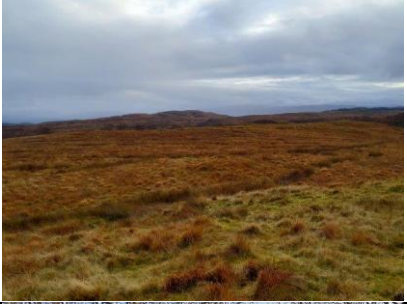
25	NM 00498 27016	View of drained purple moor-grass dominated (M25a) wet modified bog.

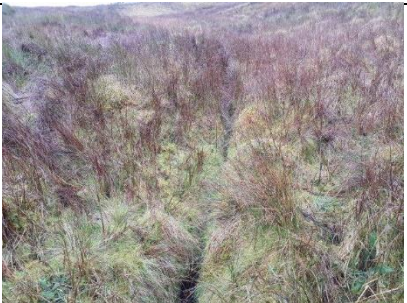
44	NM 97438 27033	Fast flowing, functional drainage ditch, c. 0.3m wide and 0.5m deep. Vegetation was largely sharp flowered rush and soft rush dominated rush pasture (MG10). Not blanket bog habitat.

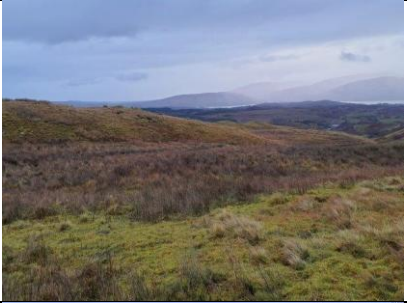
47	NM 97410 27461	Series of drainage ditches in rush pasture (MG10), not bog habitat. Drained for sheep grazing.

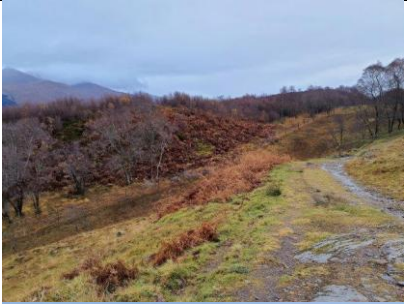
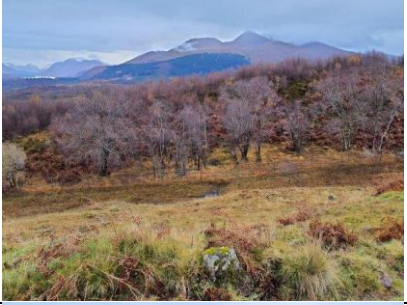
58	NM 99465 28464	Open woodland and scrub with grassland on to upland moor is ideal black grouse habitat. Unmarked deer fence through the middle of it – fence should be marked to reduce preventable black grouse mortality via fence strikes . Can see birch regen coming through beyond deer fence indicating high grazing pressure on one side of it.

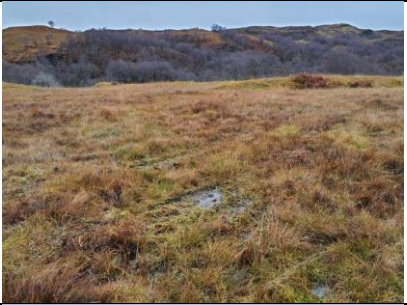
61	NM 00428 27592	Historic drainage ditch, c. 1.5m wide, 0.4m deep, generally well vegetated. Suitable for blocking by e.g. plastic dam.

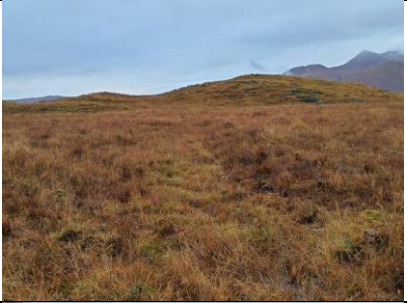
62	NM 00476 27479	M17 blanket bog with signs of modification including fresh signs of grazing and bare patches. Historic drainage ditches well vegetated but could have plastic dams to reduce under surface drainage.

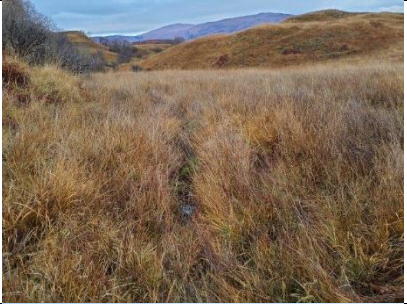
63	NM 00681 27266	Historic drainage ditch. In M15b/M25a wet modified bog (over deep peat), with purple moor-grass and bog myrtle. Sharp flowered rush was noted in some places but did not dominate.

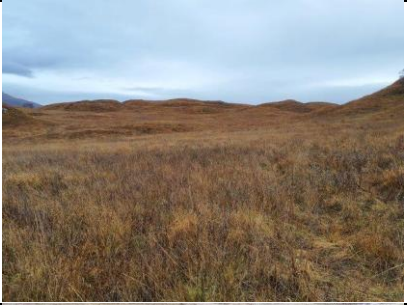
64	NM 00744 27248	Wet modified bog (M15b/M25a) in a Modified and Drained condition.

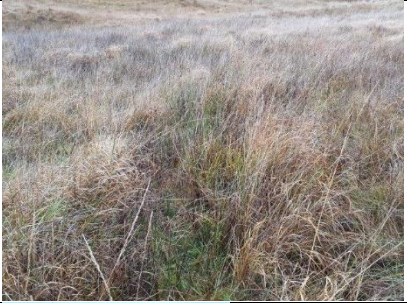
65	NM 00757 27261	Drainage ditch, marked with rushes. It was well vegetated, but some ongoing drainage is likely to be adversely affecting surrounding habitat.

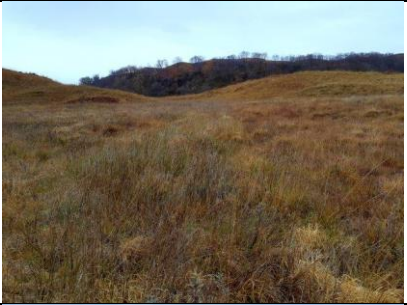
67	NM 00752 27248	Historic drainage ditch. Generally well vegetated but could hear under surface water movement so clearly some drainage and drying out of surrounding habitat occurring.

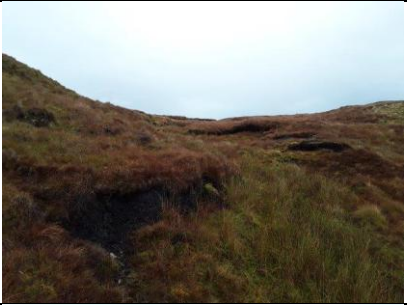
There was a very small amount of Actively Eroding blanket bog, with erosion features c. 50-100m long and c. 1m deep (e.g. Target Note 79 and 80).

79	NM 99428 27035	Eroded peat suitable for restoration. C. 100m long erosion feature, c. 1m deep.

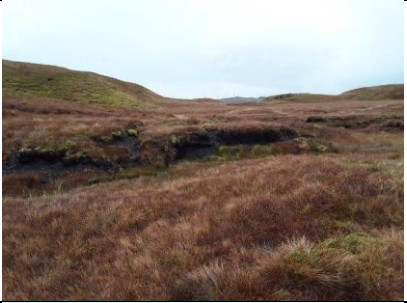
80	NM 99383 27026	Same erosion feature as above, c. 1.2m deep.

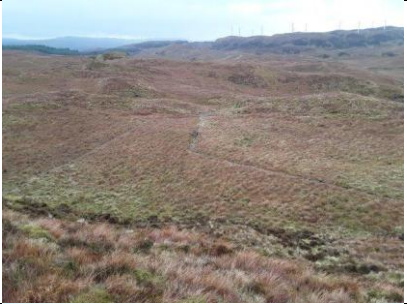
81	NM 99110 26851	Drainage ditches in bog. Suitable for restoration.

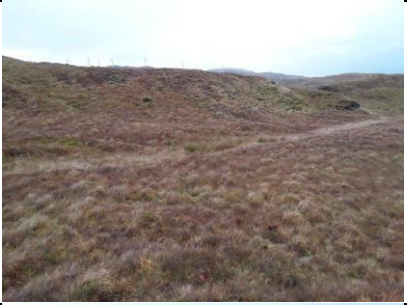
82	NM 99017 26736	Old ditch. Vegetated over.

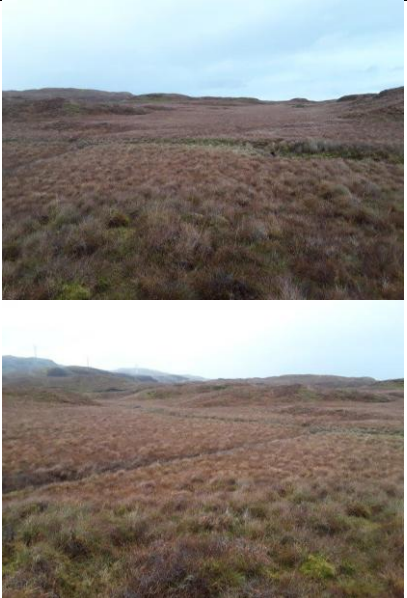
83	NM 98820 26668	Ditches draining bog into burn. Highly suitable for blocking and restoration. (already noted in original PCA).
