Beinn Ghlas Repowering Peatland Condition Assessment Survey Report

Alba Ecology Ltd.

November 2022

This document reports the findings of the PCA undertaken by Alba Ecology Ltd. in April 2022.

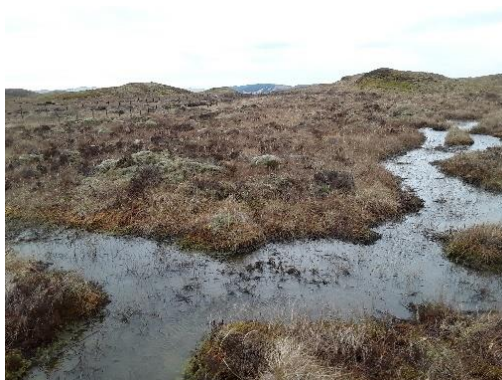
The blanket bog which was considered to be in or approaching a 'Near-Natural' condition contained complexes of bog pools, bog-mosses hummocks and a relatively intact bog-moss layer which was generally thick and included several species (Photo 1). There were limited signs of grazing impacts or artificial drainage. The Near-Natural blanket bog was more frequently recorded in the western part of the Study Area.

Photo 1: Example of Near-Natural peatland with bog pools with open vegetation and hummocks of bog-mosses.

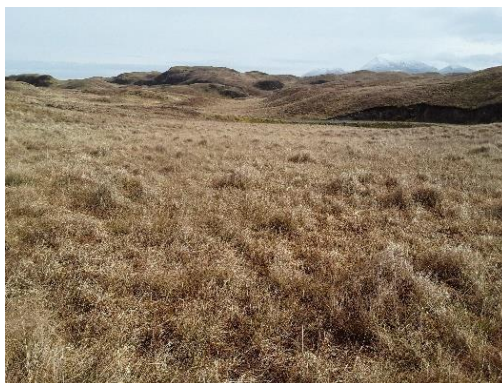
The areas termed 'Lightly Modified' denotes blanket bog habitat which was damp with bog-mosses frequent to abundant but had clearly experienced modifying influence (Photo 2). In these areas signs of grazing pressure were usually obvious. To distinguish these areas from the more Modified vegetation (described in the 'Modified' section) these areas were termed 'Lightly Modified'. Most of the Lightly Modified bog was in the west of the Study Area.

Photo 2: An example of blanket bog vegetation classified as Lightly Modified bog.

The Lightly Modified bog was generally drier with a more impoverished bog-moss layer than in a Near-Natural setting. Bog-mosses were usually limited to red bog-moss and papillose bog-moss, although these could be thick and abundant in places. The vegetation included hare's-tail cottongrass, and purple moor-grass which were often, but not always as tussocks, common cottongrass, cross-leaved heath and heather. There were occasional pools and hummocks of moss, but these were not characteristic of the Lightly Modified bog and not as extensive as found in the Near-Natural bog.

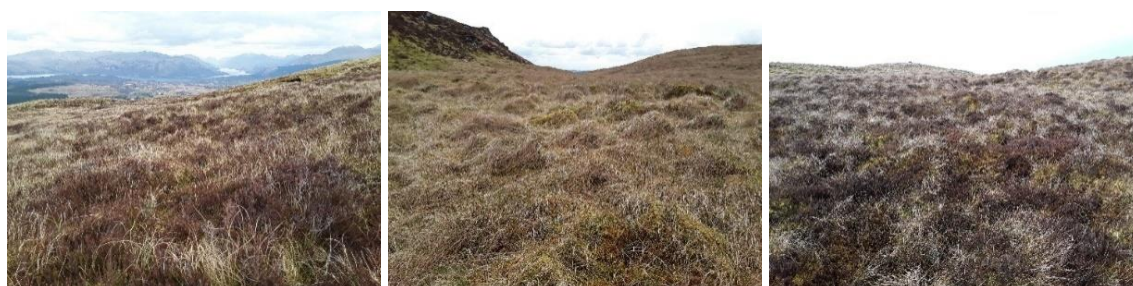
- Wet heath vegetation (e.g. NVC community M15), potentially on deep peat in places (Photo 3a),
- Tussocky vegetation of hare's-tail cottongrass (e.g. NVC community M20) or purple moor-grass (e.g. NVC community M25) (Photo 3b), and
- Tussocky vegetation with heather (e.g. NVC community M19) (Photo 3c).

Photos 3a-c: Examples of blanket bog vegetation classified as Modified with wet heath vegetation (M15) over deep peat, tussocky hare's-tail cottongrass (M20) vegetation and tussocky heather and hare's-tail cottongrass vegetation (M19).

Blanket bog in a Modified condition characterised by wet heath (M15) vegetation was generally located on hill slopes. Heather was usually abundant to dominant and often tall and tussocky. There was usually a mix of common cottongrass and occasional hare's tail cottongrass with mosses such as glittering wood-moss and red-stemmed feathermoss. There was little bog-moss present which was generally restricted to red bog-moss. Much of this was not mapped separately as part of the PCA survey unless it was clearly on deep peat. The PCA mapping generally relied on the NVC mapping completed by Avian Ecology (e.g. where mapped as the M15/M17 mosaics or similar and is shown as a slightly lighter green colour in **Figure 5**). There is likely to be a frequent transition between shallow and deep peat and/or peat regularly being at the boundary of 'peaty soils (<0.5 m) and deep peat (>0.5 m) with wet heath vegetation.

The tussocky vegetation with either hare's-tail cottongrass (M20) or purple-moor grass (M25) dominant was likewise depleted in bog mosses. There were some hillsides and valleys to the west of the Study Area which were covered in these tussocky graminoids. Glittering wood-moss was common beneath. The presence of tussocks of hare's-tail cottongrasses and/or purple moor-grass provides evidence of sustained grazing pressure to the blanket bog resource. These tussocks can give a bumpy surface pattern to the bog making walking across it a chore and demonstrates a prolonged degradation of the habitat.

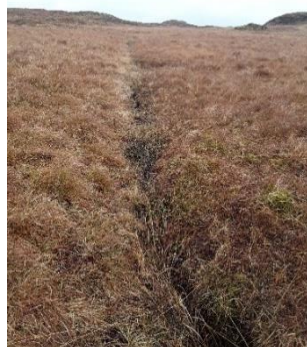
There was ca. 720 m of historic drainage ditches mapped in the west of the Study Area. These were generally straight ditches, and between ca. 0.4 m-0.7 m wide and deep (Photo 4). These were often infilled with bog-mosses or other vegetation such as common cottongrass and there was limited evidence of vegetation change due to drainage either side of the ditches (e.g. heather wasn't lining the drains). Despite this, well vegetated drains can still drain water under certain flow conditions and drainage channels may still be functional below vegetation. Therefore, it would likely be beneficial to the blanket bog to block the drainage ditches. An estimated 30m 'Drained' buffer can be applied to drainage ditches.

Photo 4: Example of an historic drainage ditch in blanket bog vegetation.

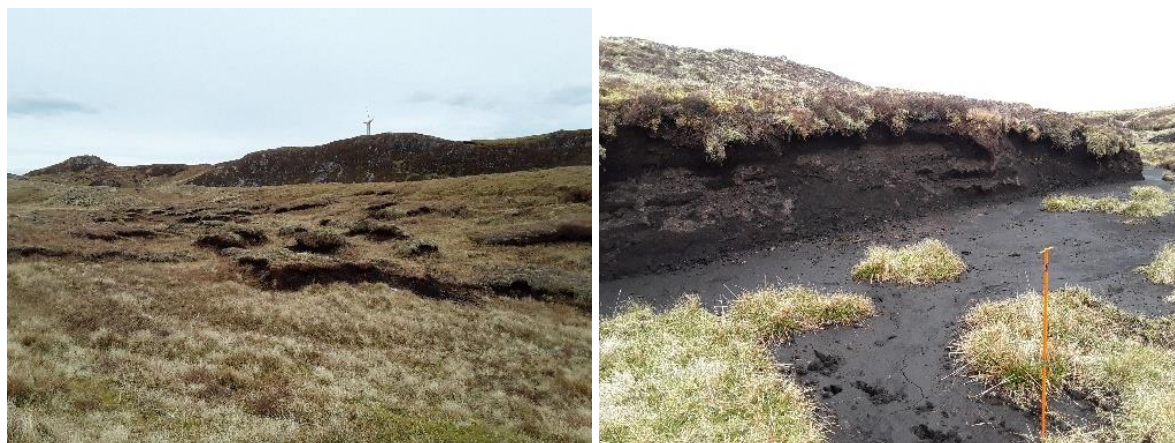
The areas termed 'Actively Eroding' denotes blanket bog habitats that had extensive bare peat surfaces. There were many small and large areas of peatland habitat which was likely to be Actively Eroding. These areas were considered to be Modified, Drained and Actively Eroding (Photos 5a-b).

Photos 5a-b: Examples of blanket bog habitat classified as Actively Eroding.

These areas were generally characterised by bare peat, sometimes with blocks of peat recently broken. The vegetation at the top of the erosion features was characterised by heather and woolly fringe moss with common cottongrass and lichens. There was also cross-leaved heath present. Bog-mosses were depleted with only red bog-moss having any presence.

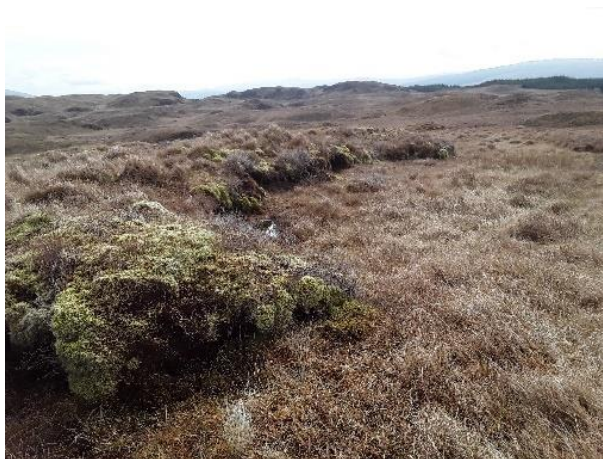
Photo 6: Example of blanket bog habitat classified as Recovering Erosion.

The areas termed 'Recovering Erosion' denotes blanket bog habitats that were characterised by old erosion features which had less exposed peat than those classed as Actively Eroding features with vegetated tops often folded over coving the once bare peat surface (Photo 6). In some places there was very wet habitat at the base of erosion features with pools and bog-mosses common. The pools may have been permanent or semi-permanent. It was considered likely that these areas were once bog pool rich which at some point dried out/de-watered from the original bog surface, leaving the original surface dry and with areas of active erosion. However, given the topography and the wet climate the lower surface is now characterised by bog pools and bog-mosses showing affinity to Near-Natural conditions.

These areas were generally considered to have some restoration potential. Although these areas have restored naturally, some effort to revegetate remaining bare peat surface and wet the original bog surface would be beneficial.

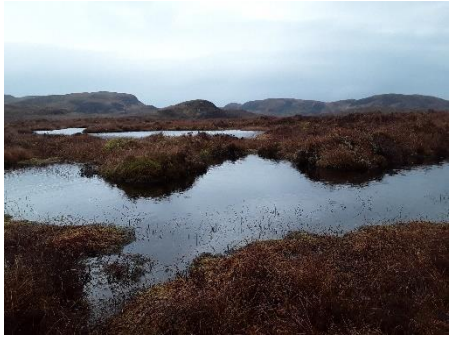
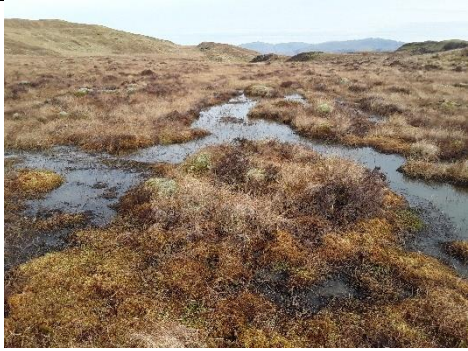
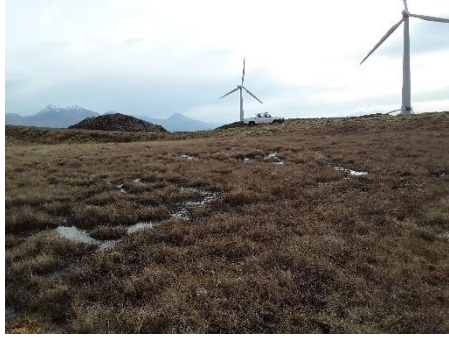
PCA Category	Peatland Condition Category Descriptions	Comment	Example Photos		
Near-Natural	Peat forming bog-mosses dominant, with no recent fires, little or no grazing pressure and little or no bare peat, heather is not dominant.	Habitat approaching Near-Natural conditions within the Study Area had bog pool complexes, hummocks of bog-mosses and a good bog-moss layer. There were no clear signs of fires or drainage. Grazing pressure was present but not extensive. Heather was not dominant.

Bog pool systems.	Bog-mosses were abundant, sometimes forming hummocks and the vegetation was open.	Bog pool system beside wind farm infrastructure.
Lightly Modified	Part of the Modified PCA description - Bare peat is in small patches, fires may be recent, grazing impacts are evident, bog-mosses are absent or rare, extensive cover of heather or purple moor-grass.	Fires were not a recent feature of the Study Area, but historic burning is known to have occurred. Small patches of bare peat were sometimes present. Bog-moss cover was depleted compared to areas classed as 'Near-Natural' but not usually absent and sometimes frequent to abundant. Heather wasn't dominant, but graminoids were. The tussocky structure of the vegetation demonstrated modification through grazing. Little to no surface water present. Sheep/deer grazing pressure was obvious.

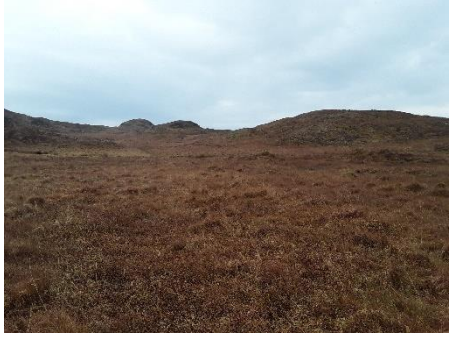
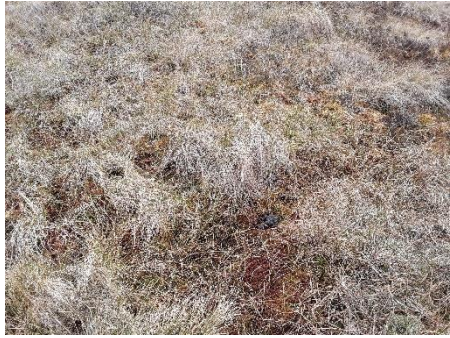
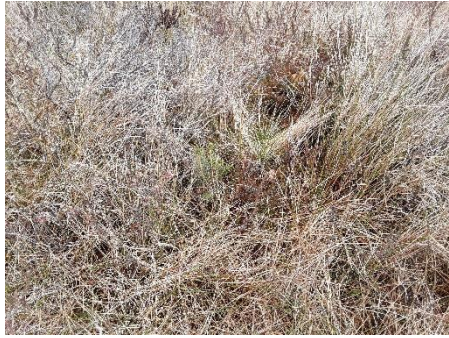
Frequent to abundant bog-moss and occasional pools, but tussocky vegetation and the moss layer was more depleted than the example of Near-Natural bog.	Signs of sheep were common as tracks, hoof marks and dung piles.	Sitka spruce seedling emerging in Lightly Modified blanket bog.
Modified	Bare peat is in small patches, fires may be recent, grazing impacts are evident, bog-mosses are absent or rare, extensive cover of heather or purple moor-grass.	Fires were not a recent feature of the Study Area, but historic burning (until about 10 year ago) is known to have occurred. Bare peat patches were evident across some of the peatland habitat. Bog-moss cover was generally depleted, but not usually absent. The structure of the vegetation demonstrated modification through grazing. For example, there were extensive areas dominated by purple moor-grass and hare's-tail cottongrass.

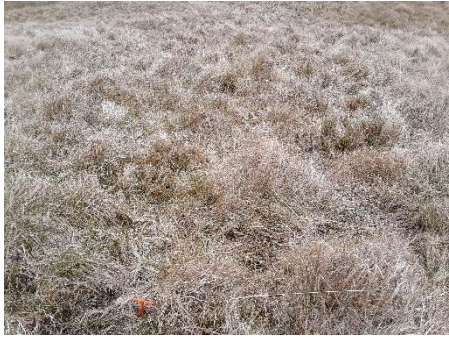
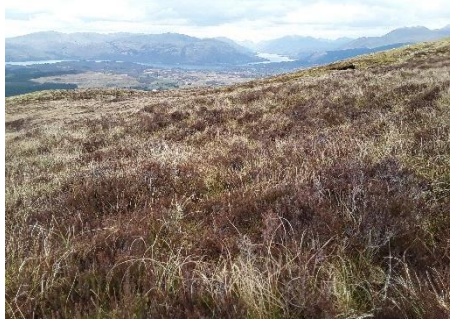
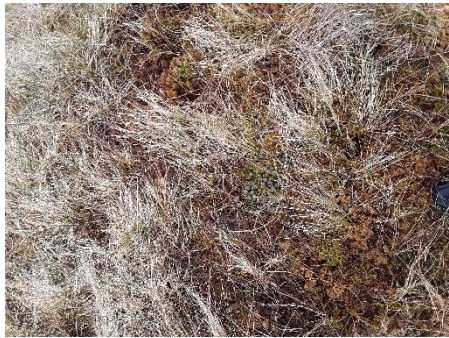
Deep peat with tussocky vegetation. Lots of signs of deer/sheep including dung, tracks and prints.	Deep peat with tall tussocky heather common cottongrass and occasional hare's tail cottongrass. Lots of pleurocarps e.g. glittering wood-moss. Little bog-moss present.	Deer and sheep hoof marks and dung in this Modified bog.

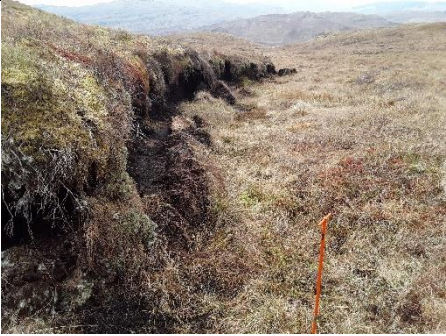
<p>Actively Eroding feature. It was ca. 1.5m high and ca. 70m long. Blocks of peat were recently broken off.</p>

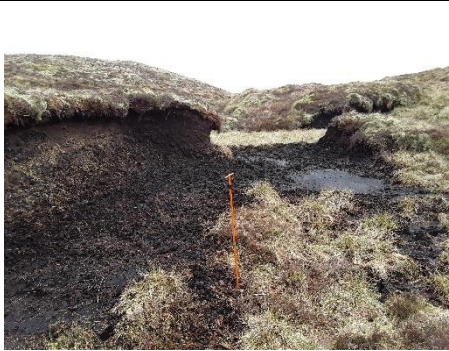
<p>Feature was ca. 1.5m high with 2m of bare peat at base.</p>

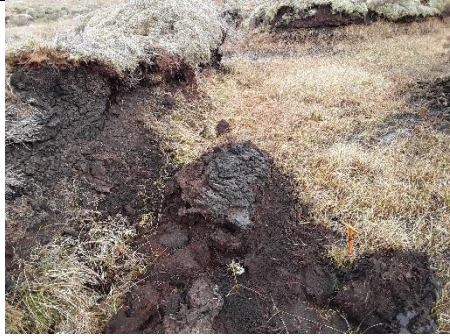
<p>Clear evidence of active erosion. A peat block ca. 1m x 0.5m had broken off the side of an erosion feature.</p>
Recovering Erosion	No specific PCA description, but part of the Modified bog with small areas Actively Eroding and some Near-Natural features present. Bare peat is in small patches, fires may be recent, grazing impacts are evident, bog-mosses are absent or rare, extensive cover of heather or purple moor-grass.	Bare peat was evident, sometimes with small areas clearly Actively Eroding. Fires were not recent but known to have occurred in the past. Bog mosses were only present on the lower (eroded) surface of bog, not on the original bog surface. Woolly fringe moss was a common feature, along with heather and purple moor-grass on the original bog surface.

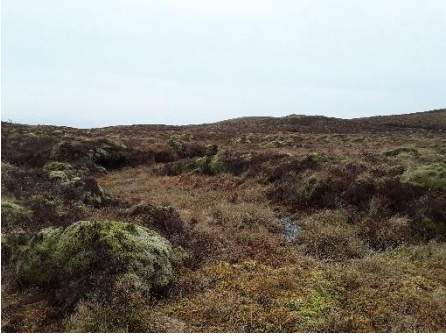
<p>Recovering Erosion. Eroded, but recovering with woolly fringe moss folder over many old erosion features. Bog-mosses were well established between erosion features.</p>

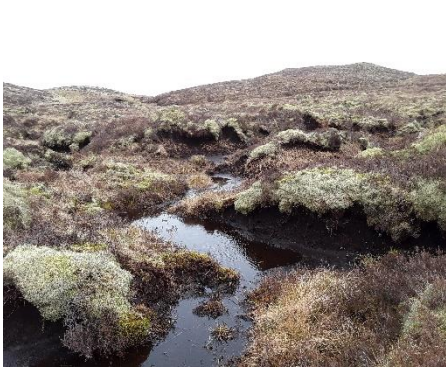
<p>Some little patches of active erosion present in the Recovering Erosion area. This small erosion feature was ca. 0.7m high.</p>

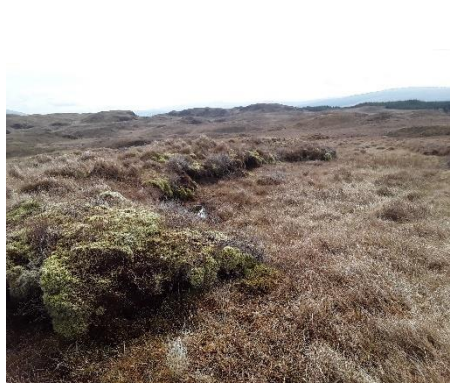
<p>Some old erosion features. Little bare peat remaining. Some pools at base.</p>

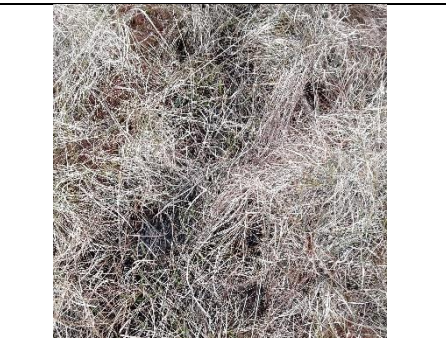
<p>Patches of bare peat with hoof marks were common in the Modified bog = 'Intermediate' condition.</p>	  <p>Bare peat formed ca. 10-30% of the areas considered to be Actively Eroding = 'Bad' condition.</p>	  <p>Areas of bare peat that was Actively Eroding was common = 'Bad' condition.</p>

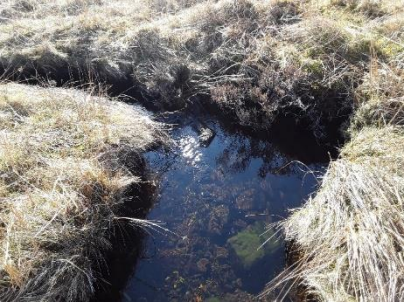
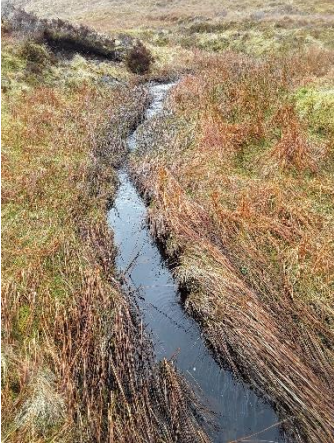
</div> <p>Water coming from the Study Area and in the Lochs and Lochans was clear to peat stained. 'good' to Intermediate' condition.</p>				
Resultant 'activity' level		Likely active.	Likely inactive (but may have some limited activity where bog pools present).	Likely inactive.	Likely inactive.	Likely inactive (but may have some limited activity where bog pools present).

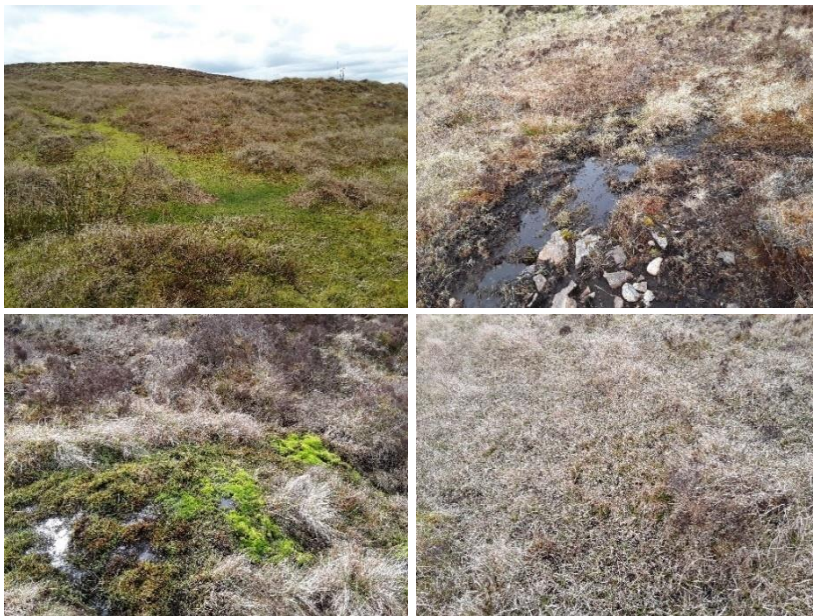
Photos 7a-d: Examples acid/neutral flush (M6), a base-rich flush (M11) a spring head (M37) and a sedge rich area of wet heath (M15a).

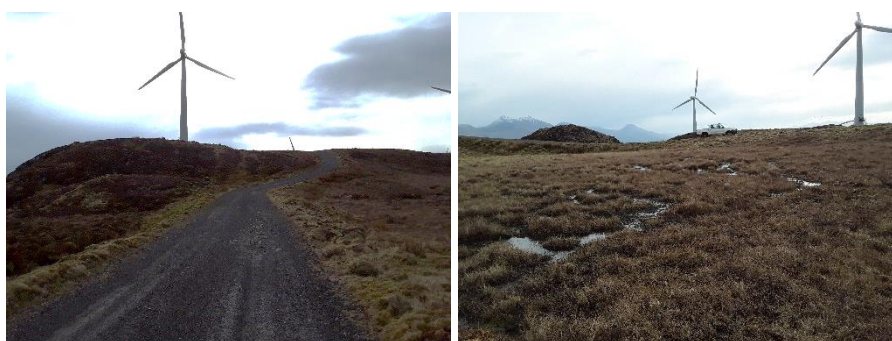
Photos 8a-b: Examples of the co-existence of wind farm infrastructure and blanket bog in a Near-Natural condition.

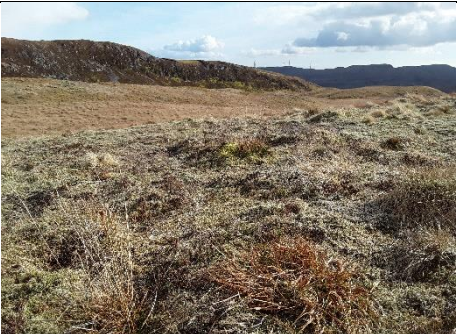
TG	Grid	Note	Photos
1	NM 97139 25948	Small patch (ca. 10 m x 10 m) of montane heath. Dominated by woolly fringe moss (90 %) with mat grass, heath rush and stiff sedge. Heather in small sprigs and rocks showing through.

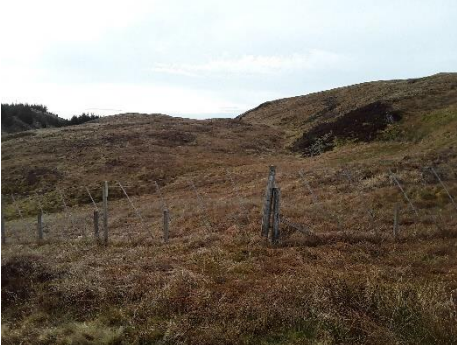
2	NM 98649 26033	Fence line marked to reduce bird strikes. Fence is protecting recently planted trees from grazing pressure.

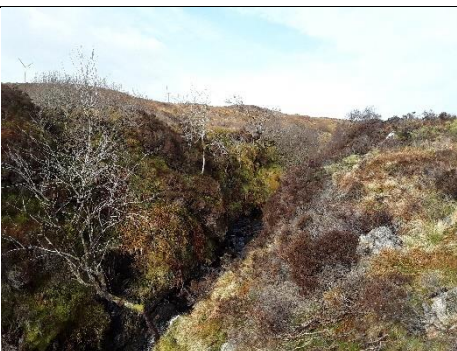
3	NM 98632 26076	Trees and thick heather restricted to steep inaccessible valleys and slopes due to grazing pressure.

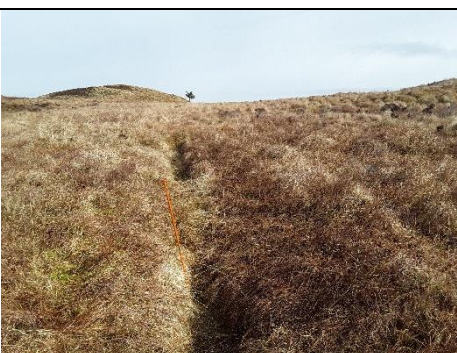
4	NM 98527 26206	Historic drainage ditch. It was ca. 50cm wide. Generally vegetated including some bog-mosses, but likely to have some limited drainage effect on surrounding bog.

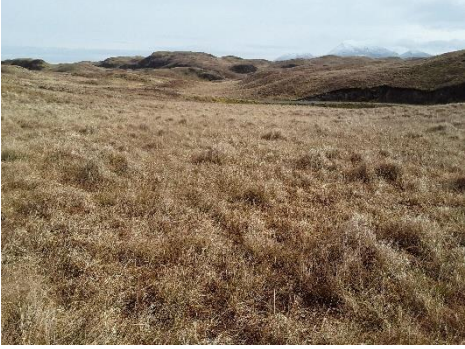
7	NM 98488 26372	Lightly Modified. It was much less bog-moss rich than the Near-Natural bog. Tussocks of hare's-tail cottongrass. Likely preferable to grazing animals as on slope and not as wet. Purple moor-grass common, common cottongrass absent but cross-leaved heath common. Red bog-moss, papillose bog-moss frequent.

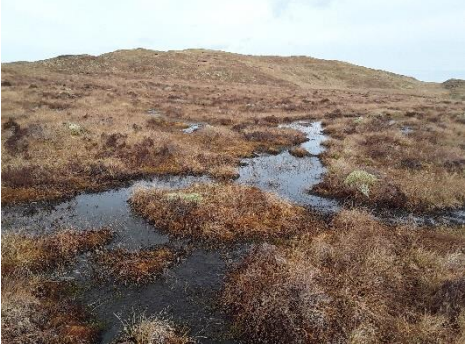
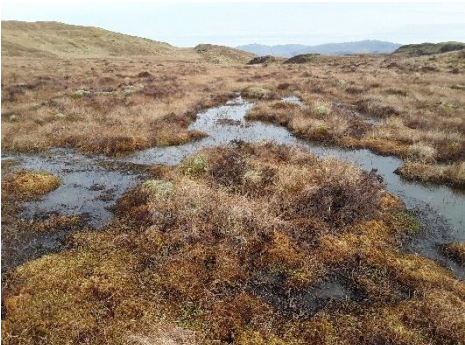
TG	Grid	Note	Photos
8	NM 98369 26494	Near-Natural blanket bog. High quality, wet bog set within a topographic basin. Bog-mosses dominant with pools, hummocks and hollows. Mixture of bog-moss species present including papillose, red, magellanicum, lustrous and soft. There were also hummocks of woolly fringe moss and some pleurocarp mosses.

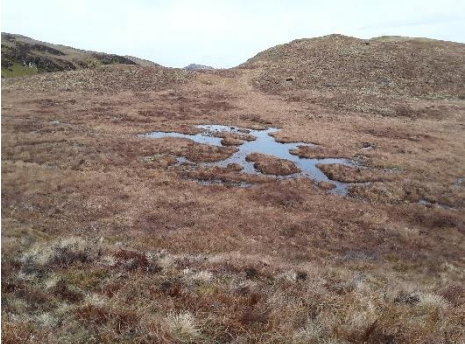
9	NM 98260 26564	Near-Natural blanket bog developed between two hills of wet heath. Pools and bog-mosses very common.

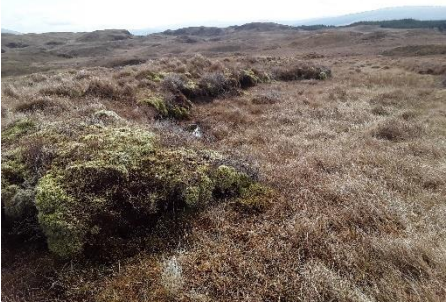
10	NM 98176 26740	Recovering Erosion. Some old erosion features. Little bare peat remaining. Some pools at base. Features likely having little impact, other than some drying effect locally with woolly fringe moss on edge of features. Features ca. 75cm high. No restoration required.

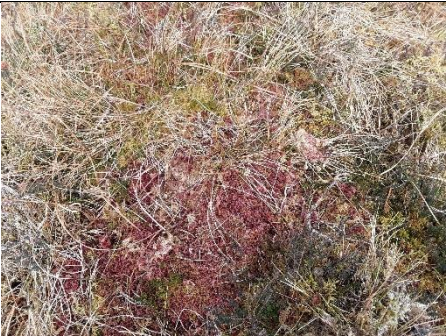
11	NM 98167 26756	Signs of modification. Pulled bog-mosses. Lagomorph droppings. Deer and sheep droppings were frequent.

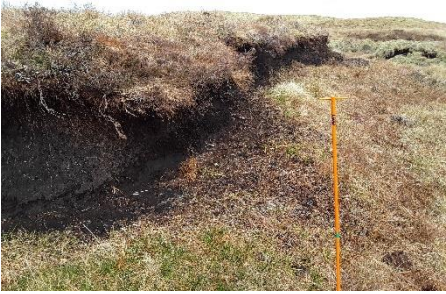
12	NM 98146 26780	Actively Eroding feature ca. 1.2 m high. Bare peat face and base for ca. 0.5 m and ca. 15 m long. Heather overhanging.

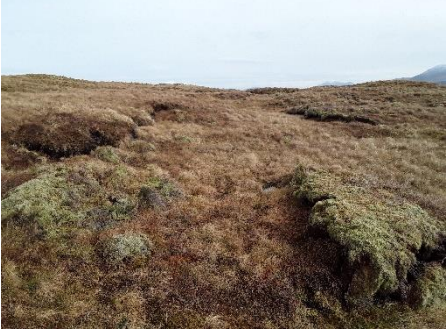
13	NM 98144 26791	Some Actively Eroding blanket bog in this area. but much is revegetated. Wet at base. Little restoration action needed.

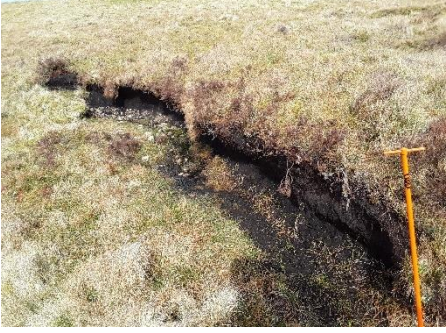
14	NM 98110 26827	Actively Eroding feature ca. 0.75 m high and 10 m long.

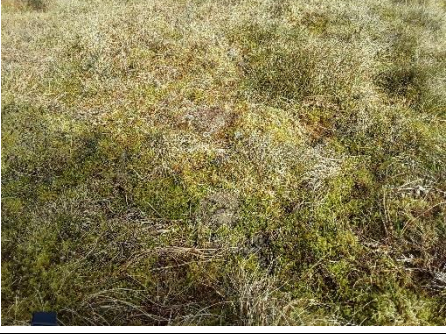
15	NM 98155 26928	Multiple of signs of grazing on this tussocky Lightly Modified bog. Transition between acid grassland and blanket bog often goes through tussocky M19 for ca. 5 m.

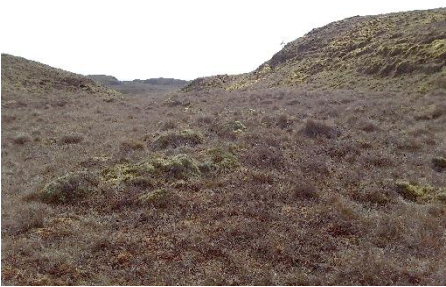
TG	Grid	Note	Photos
16	NM 98196 26990	Valleys of blanket bog vegetation between hills of wet heath and acid grassland. Can be quite wet underfoot, with occasional bog-moss hummocks, but generally no bog pools. Signs of grazing animals common. Lightly Modified.

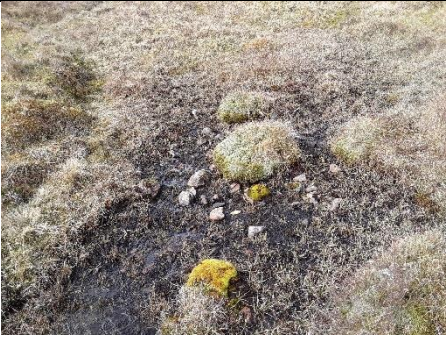
17	NM 98296 26864	M11 Potential GWDTE. Ca. 5 m x 5 m in size, followed by a small line of M11 ca. 20 m long. Common yellow sedge, brown mosses frequent over bare stones. Break in hill slope.

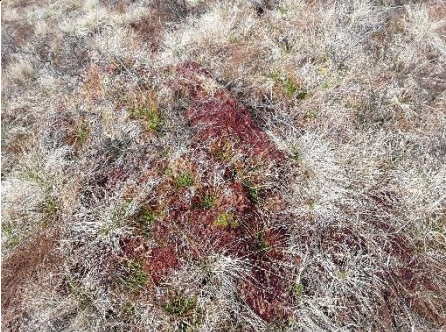
18	NM 98336 26697	Hummocks of the compact form of red bog-moss were quite common in the wet heath vegetation. There was a small wet heath rise within a large area of M17a. Lightly Modified.

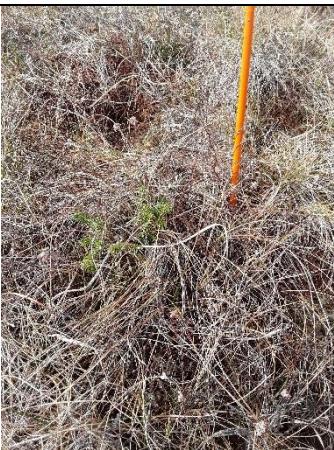
19	NM 98461 26218	Example of sitka spruce growing within the blanket bog. It was ca. 15 cm tall.

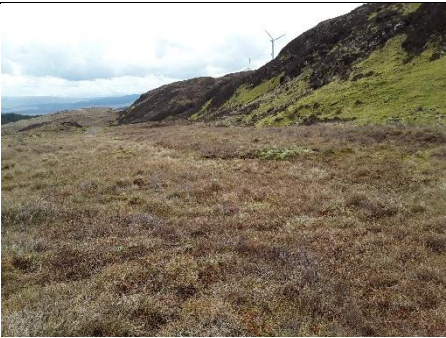
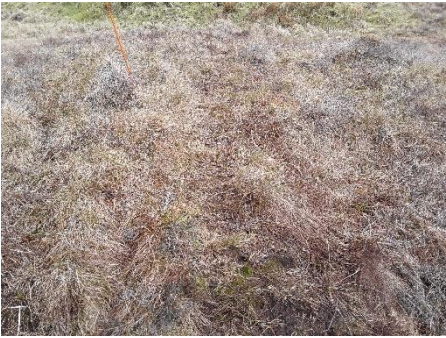
TG	Grid	Note	Photos
20	NM 97835 26228	Line of blanket bog vegetation beside track. Grazed by sheep. Occasional pools and hummocks present but Lightly Modified as much drier and more impoverished bog-moss layer than in a Near-Natural setting and signs of sheep common such as tracks and dung piles.

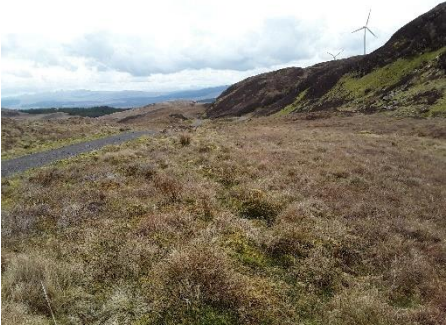
21	NM 97841 26240	Impact of wind farm track on the species composition was ca. 5-7 m wide. In this area acid grassland vegetation of mat grass, heather, soft rush, shaggy moss and common haircap were predominant as it transitioned to the M17a blanket bog habitat.

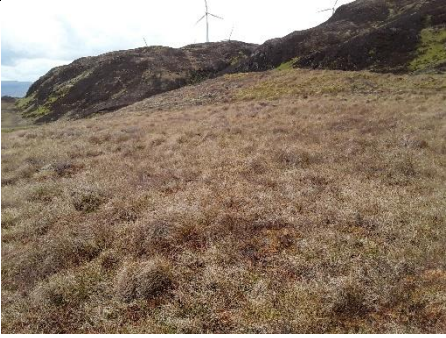
22	NM 97972 26191	Lightly Modified area of blanket bog. Hare's-tail cottongrass was tussocky, but a thick near complete bog-moss layer between tussocks. No surface water and signs of grazing present.

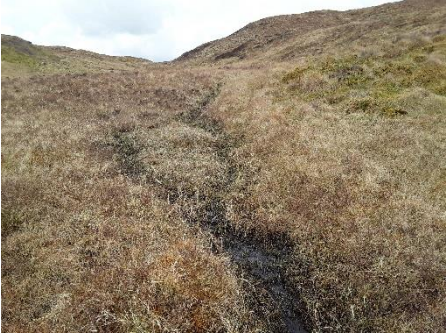
23	NM 98060 26252	Occasional small drainage features within the blanket bog habitat. They were thin and dark coloured. This example had a thin line of sedges and bog pondweed.

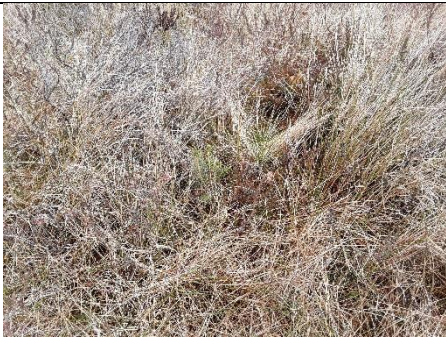
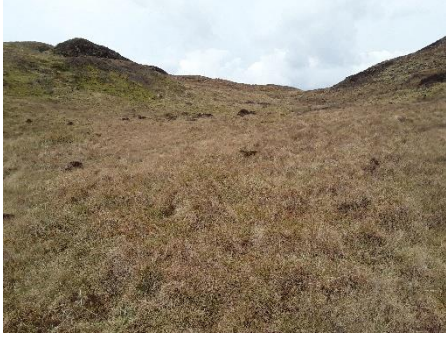
TG	Grid	Note	Photos
24	NM 98036 26275	Sitka spruce seedling emerging in this generally Lightly Modified blanket bog. Slightly tussocky in nature with no bog pools.

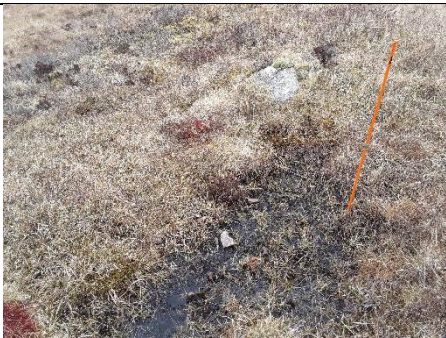
25	NM 98123 26324	M11, likely a highly GWDTE. It was ca. 1 m x 2 m, going to a 20 cm wide watercourse.

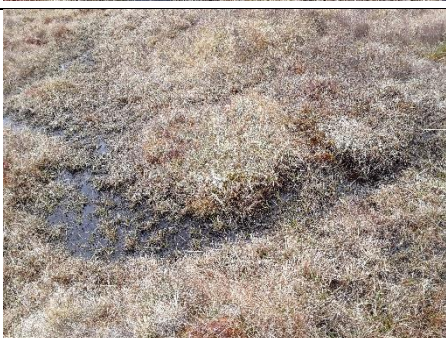
26	NM 98107 26309	M11, likely a highly GWDTE. Very small (ca. 50 cm x 50 cm) going to a 20 cm wide watercourse.

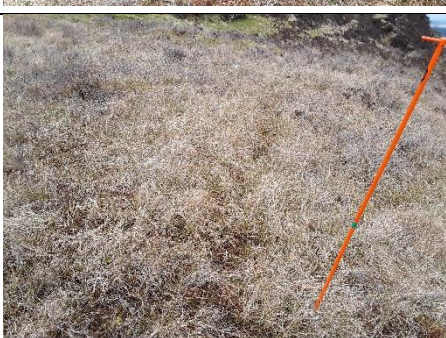
27	NM 98081 26460	Sheep tracks and dung were evident in this Lightly Modified bog.

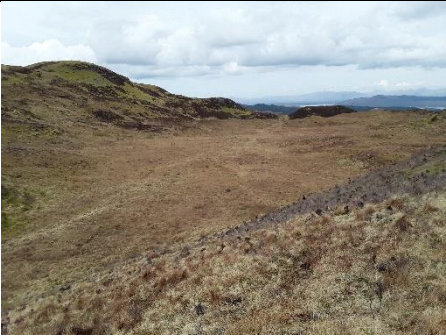
TG	Grid	Note	Photos
28	NM 97980 26461	View of a blanket bog filled basin. There were vehicle tracks across it. The basin was set between steep slopes of heath and acid grassland. The blanket bog was on the lower shallow slopes and in the basin.

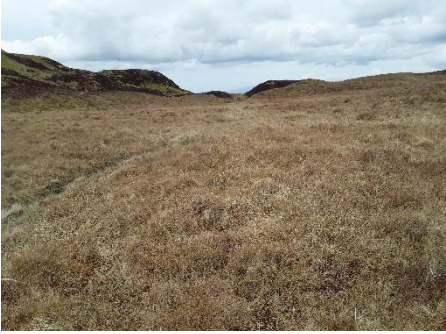
29	NM 97915 26522	Sign of modification were evident. There were no bog pools but there was a watercourse with bottle sedge along it. There was a good carpet of papillose and red bog-moss. Vegetation was tussocky.

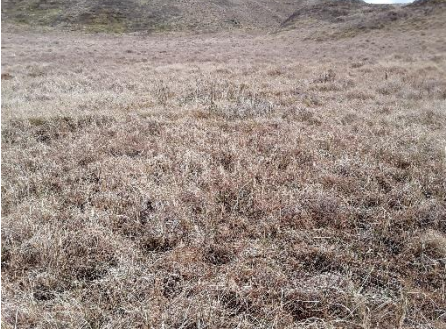
30	NM 97868 26522	Small patch (ca. 10 m x 10 m) with abundant bottle sedge.

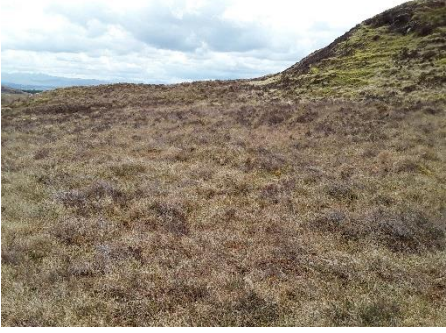
31	NM 97765 26447	Very small patch (ca. 10 m x 30 m) of Lightly Modified blanket bog on a plateau on a steep hill slope.

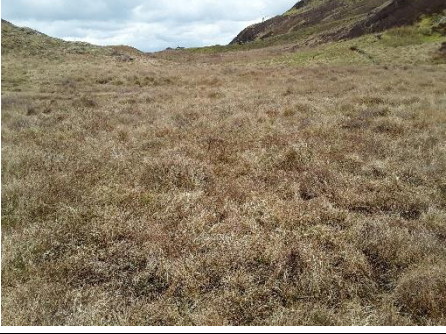
32	NM 97647 26432	Valley/basin without pools. Quite dry, bog-mosses present, but not forming a complete carpet. Modified to Lightly Modified. Tussocky. Heath rush was common in this area.

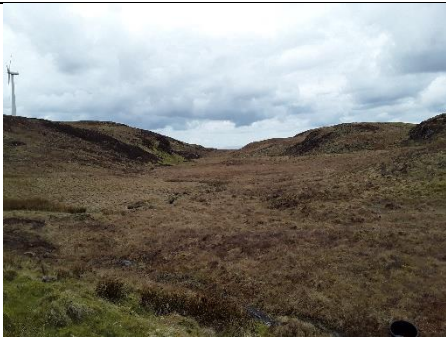
TG	Grid	Note	Photos
33	NM 97794 26287	View of valley from the track. Blanket bog and deep peat between ridges of shallow soil with wet/dry heath and acid grassland. Bottle sedge occasionally present.

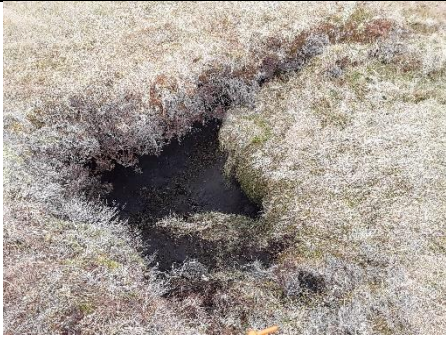
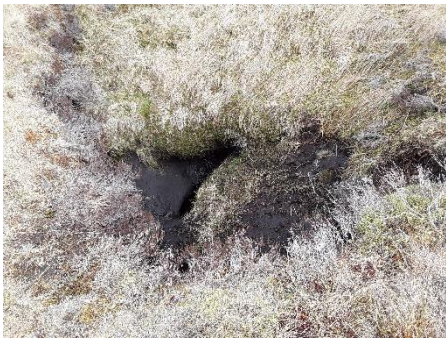
34	NM 97532 25961	Evidence of an underground peat pipe collapse.

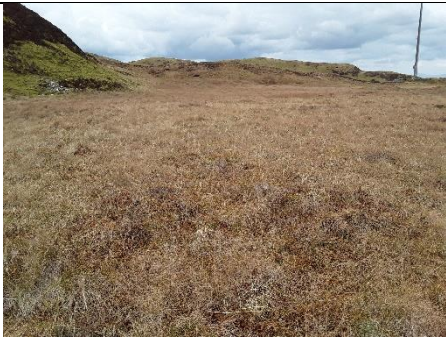
35	NM 97488 25994	Generally, bog-moss rich and damp underfoot. However, there were no bog pools, it was tussocky and there were signs of grazing pressure. Bottle sedge was common.

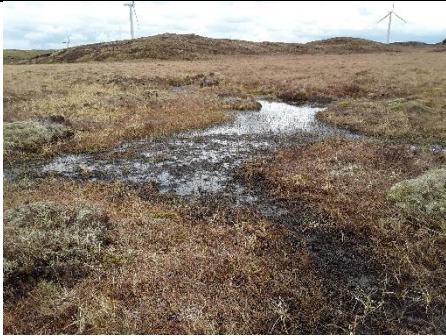
36	NM 97474 26041	Bog pools system. Bare peat frequent. Bog-mosses common with occasional bottle sedge.

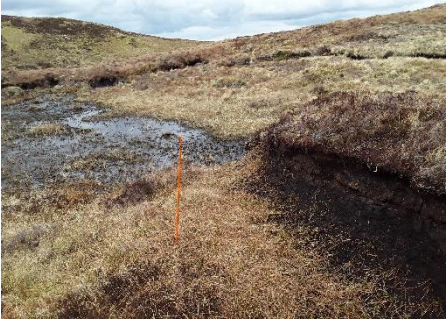
TG	Grid	Note	Photos
37	NM 97387 26244	Actively Eroding. M3 pool and erosion features. The erosion features were ca. 75 cm tall with some bare peat exposed on the erosion face. The expanse of bare peat at the base had water sitting on it at the time of the survey, but it is likely that it dries out in the summer months and experiences erosion.

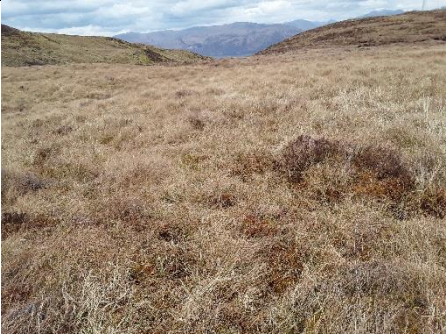
38	NM 97301 26210	Lightly Modified. Deer/sheep tracks and tussocky nature despite a good bog-moss layer.

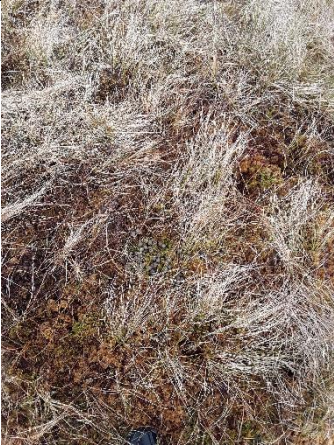
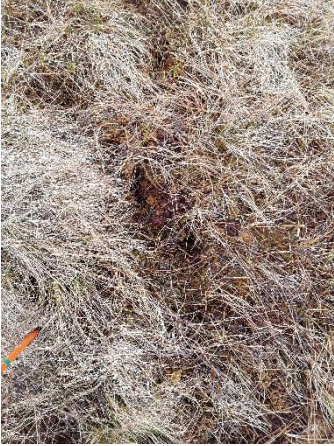
39	NM 97279 26028	Deer/sheep hoof marks and dung in this Modified bog.

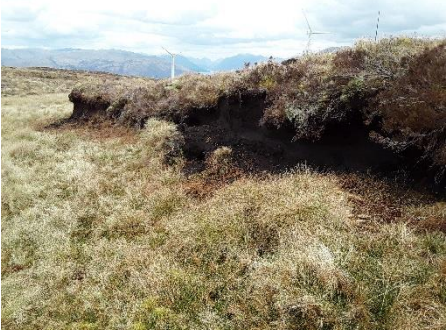
TG	Grid	Note	Photos
40	NM 97242 25982	Erosion feature ca. 1.2 m high and 50 m long. Actively eroding on face and along base in some places.

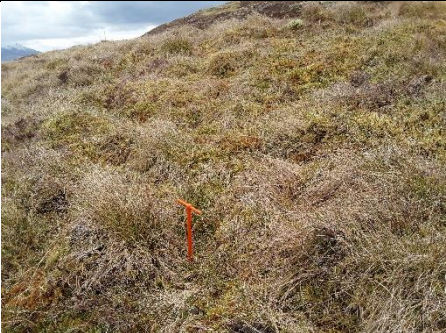
41	NM 97241 25980	There appeared to be some areas of deep peat (ca. 80 cm). Corresponds to wet heath/blanket bog in NVC mapping. Little remaining evidence of bog habitat. Modified to the point that it is indistinguishable from wet heath habitat. There were occasional tussocks of hare's-tail cottongrass, common haircap, glittering wood-moss with patches of heather. There was little to no bog-moss present. Modified.

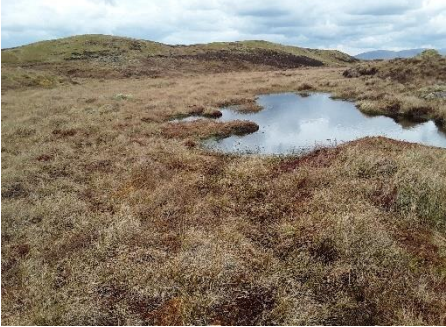
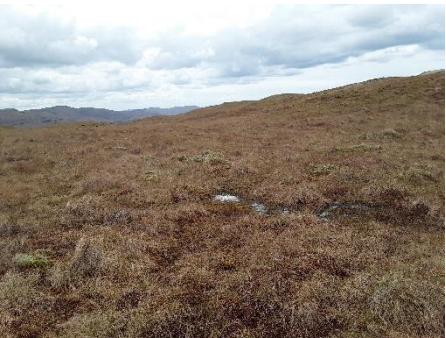
42	NM 97197 25957	Near-Natural. Bog pool with extensive bog-moss layer. Hummocks and hollows evident.

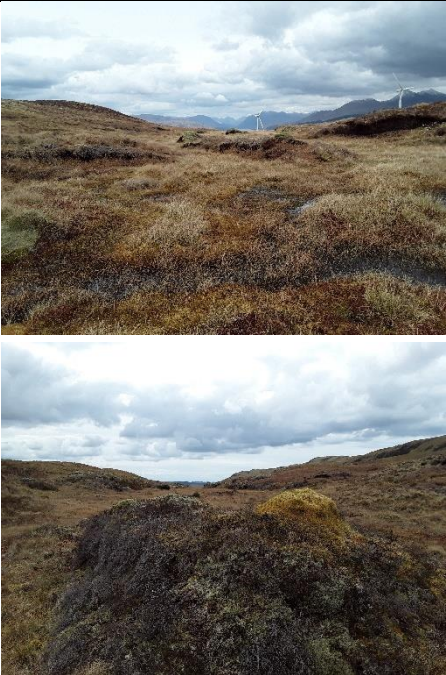
TG	Grid	Note	Photos
43	NM 97147 25990	Actively Eroding. Erosion features set between much less modified blanket bog. Most erosion features were somewhat overgrown with gully infilled. But some erosion features had ca. 1m of exposed bare peat.

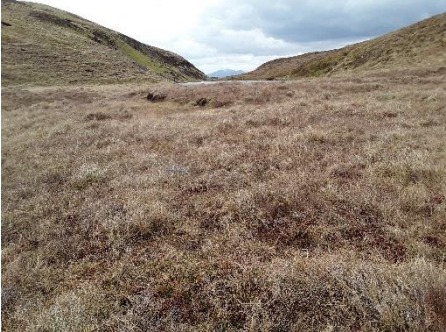
44	NM 96984 26002	Lightly Modified bog at edge of unnamed lochan.

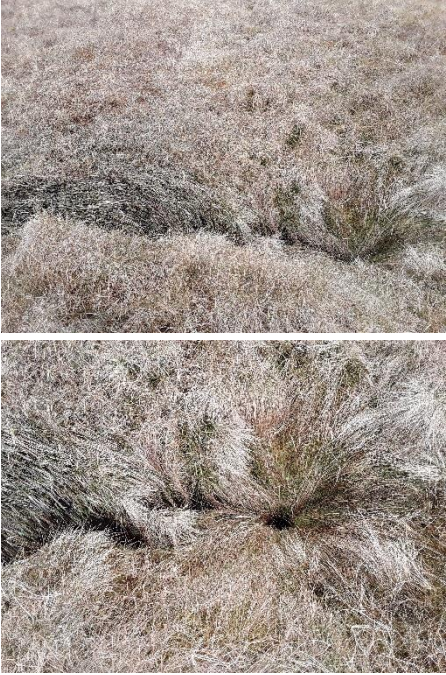
45	NM 96866 26131	Evidence of underground peat pipes. Water trickling overground then disappearing into what looked like a 'plug hole' or sump.

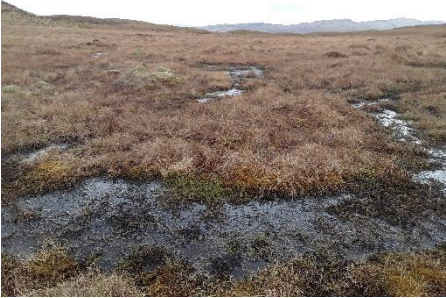
TG	Grid	Note	Photos
46	NM 96897 26203	Near-Natural. Bog pools persist in the centre of this wider area of blanket bog. Bog-mosses were extensive with some hummocks evident.

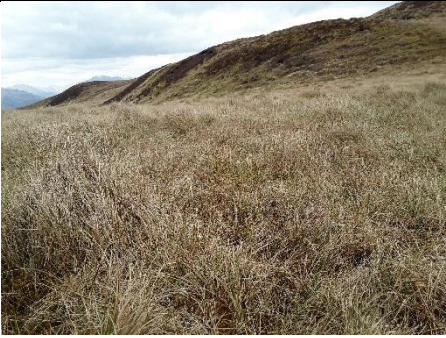
47	NM 96893 26260	The blanket bog was generally tussocky with hare's-tail cottongrass. Bog-mosses abundant including papillose bog-moss. There was also some common haircap. Only a little deergrass or heather, blaeberry or cross-leaved heath.

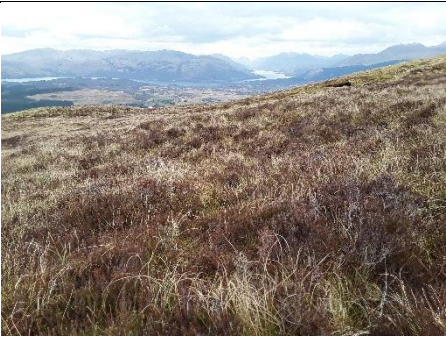
49	NM 96912 26604	Deep peat with heather common cottongrass and occasional hare's tail cottongrass. Abundant glittering wood-moss. Little bog-moss present. Modified. Heather tall and tussocky. M15.

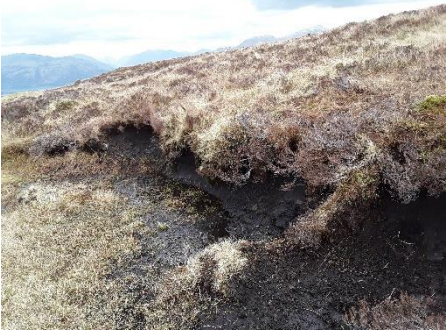
TG	Grid	Note	Photos
50	NM 96872 26636	Erosion feature ca. 1.2 m high and 10 m long. Actively Eroding.

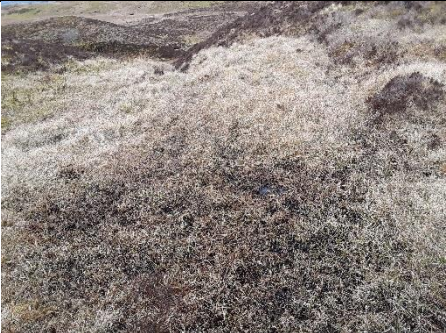
51	NM 96874 26671	M11. Potential GWDTE. Ca. 3 m x 5 m at head then line of M11 (ca. 0.2 m wide). Common yellow sedge and brown mosses.

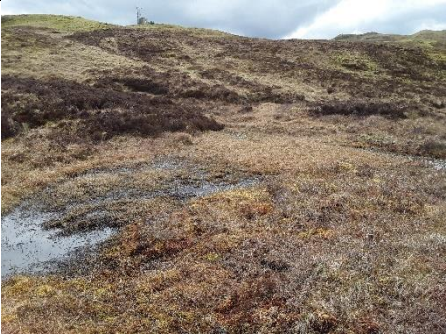
52	NM 96956 26731	Near-Natural. Small patch (e.g. 20 m x 50 m) with bog pools and bog-moss lawns.

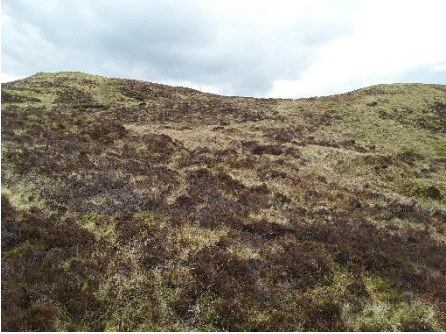
53	NM 97063 26832	Large area of possibly deep peat characterised by tussocky M15 with heather and little or no bog-moss. Modified.

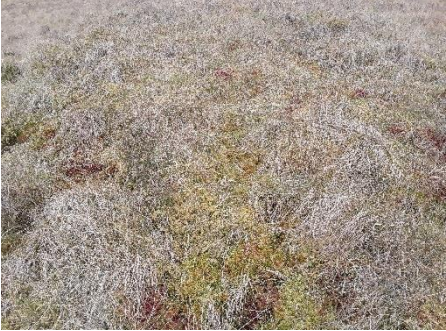
54	NM 97202 26740	Modified. Very tussocky hare's tail-cottongrass with little heather but cross-leaved heath present. Lots of glittering wood-moss. Patches of bog-moss. M20.

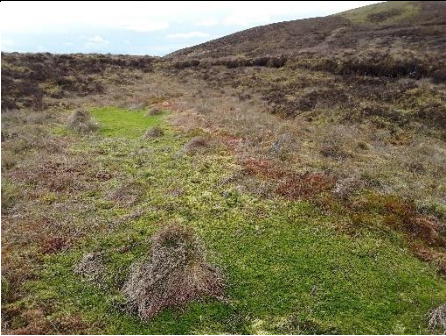
TG	Grid	Note	Photos
55	NM 96774 26327	Flat-topped bog-moss dominated pool (2 m wide, 8 m long). Beside old, folded over erosion feature.

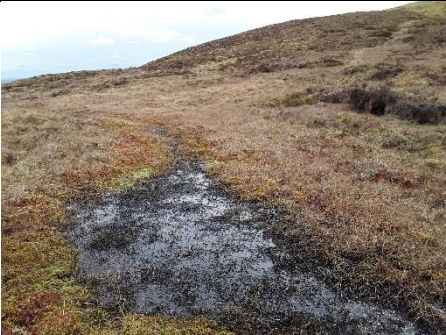
56	NM 96761 26286	Near-Natural. Very small patch (ca. 20 m x 50 m). Bog pools present, bog-moss dominated. Old erosion features present but well vegetated not likely to be Actively Eroding.

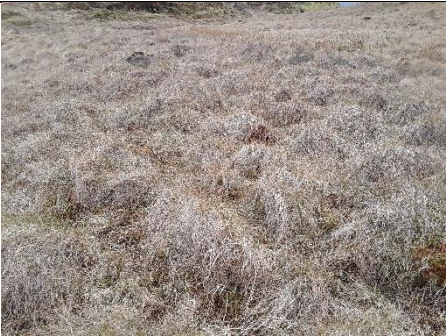
57	NM 96776 25882	Modified. Tussocks of hare's tail-cottongrass, patches of red bog-moss as part of tussocks. Dry underfoot.

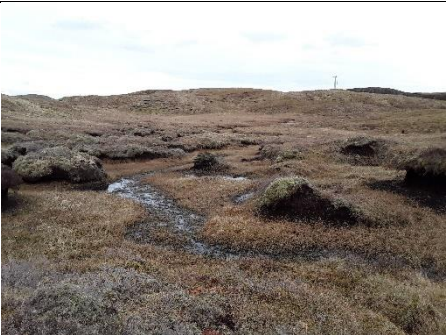
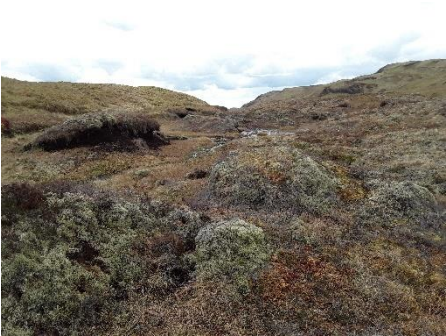
58	NM 96778 25796	Extensive area of Actively Eroding bog. Dry remains on top of peat islands. Wet bog at base. Often bare peat faces ca. 1 m high with ca. 1 m bare peat at base.

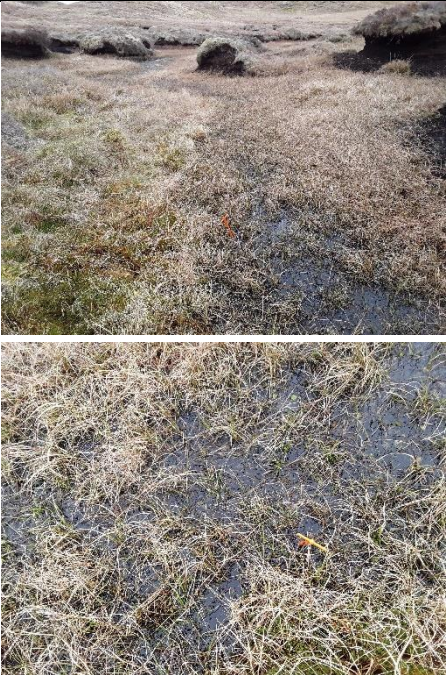
60	NM 96780 25787	Example erosion feature. It was ca.1.5 m tall with ca. 1 m bare peat at base. Actively Eroding.

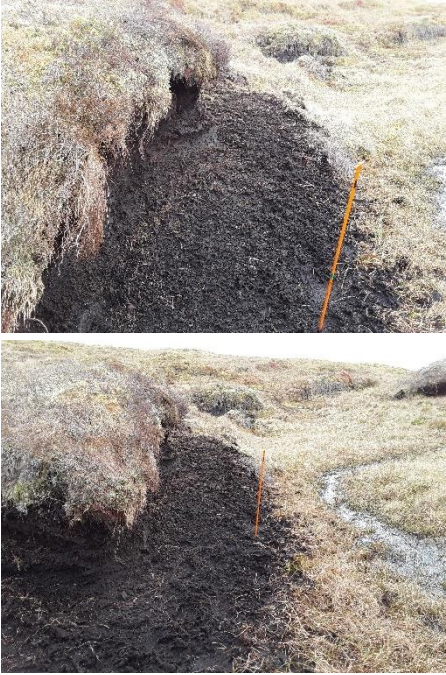
TG	Grid	Note	Photos
61	NM 96788 25805	Clear evidence of active erosion. A peat block ca. 1 m x 0.5 m had broken off the side of an erosion feature. The vegetation at the top of the feature was dominated by woolly fringe moss with common cottongrass and lichens. There was also cross-leaved heath present.

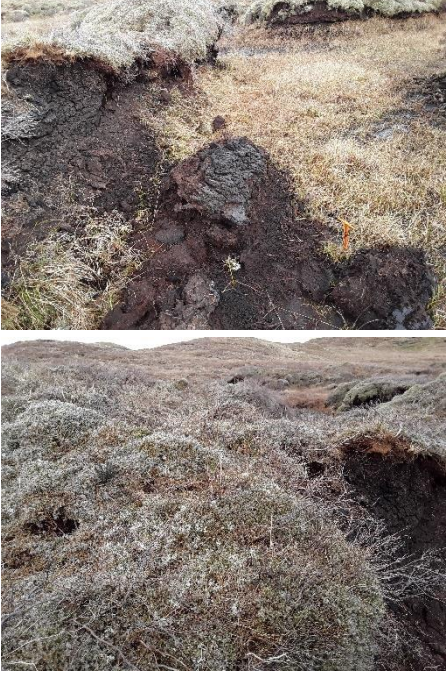
62	NM 96891 25766	Recovering Erosion. Area of old erosion features. They had less exposed peat with the tops often folded over. Very wet base of erosion features with pools common. The pools may have been permanent or semi-permanent. Likely these areas were once bog pool rich and have de-watered from the original bog surface but have remaining wet bog at the bases.

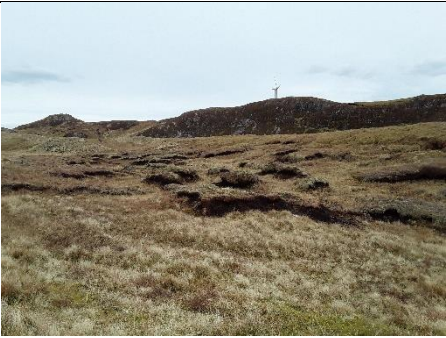
63	NM 96974 25677	Actively Eroding. Another area where erosion features were ca. 1 m to 1.5 m tall with dry vegetation on tops. Some erosion islands present. Wet vegetation at base in some places.

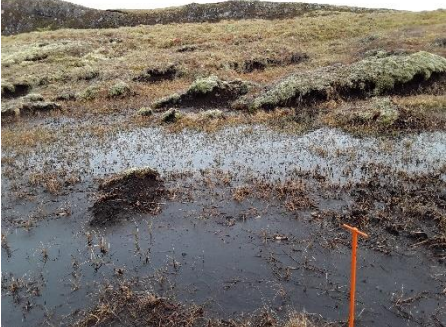
64	NM 97021 25710	At the base of the erosion gully is bare peat with scattered shoots of common cottongrass. It was wet at the time of survey but likely to dry out in summer months. Actively Eroding.

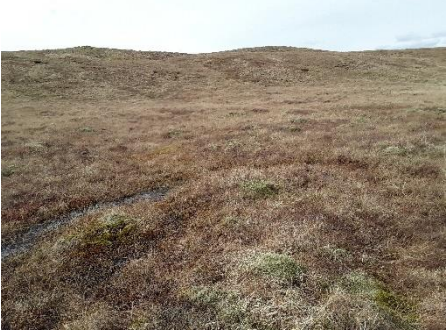
TG	Grid	Note	Photos
65	NM 97064 25744	Near-Natural. Hummocks and hollows evident with bog pools and an abundance of bog-mosses.

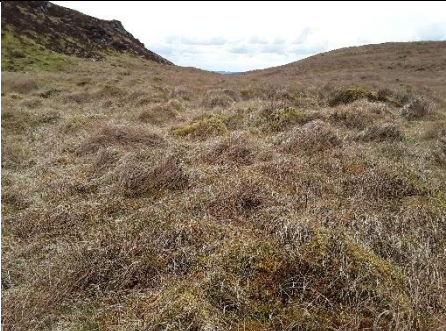
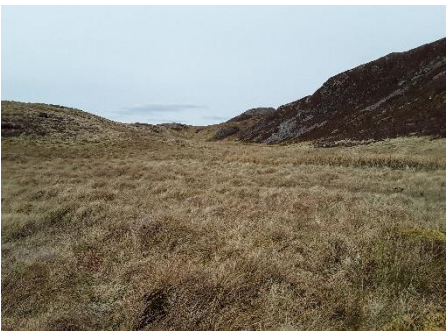
66	NM 97139 25657	Valley filled with deep peat and bog vegetation and a stream with soft rush. The blanket bog was Modified with large tussocks of hare's tail-cottongrass and abundant glittering wood-moss.
