Beinn Ghlas Repowering Peatland Condition Assessment Survey Report

Alba Ecology Ltd.

November 2022

This document reports the findings of the PCA undertaken by Alba Ecology Ltd. in April 2022.

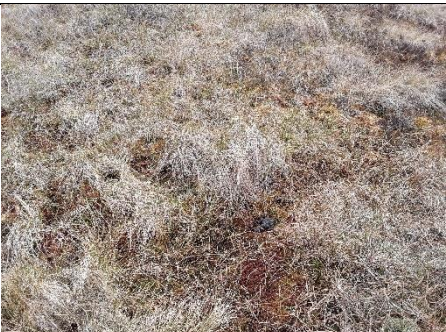
67	NM 97234 25939	Evidence of deer in this small patch of Lightly Modified bog.

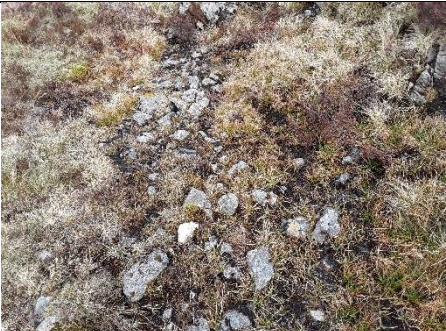
68	NM 97327 26045	M11. Potential GWDTE. It was ca. 2 m x 5 m in size with common yellow sedge, brown moss and rocks.

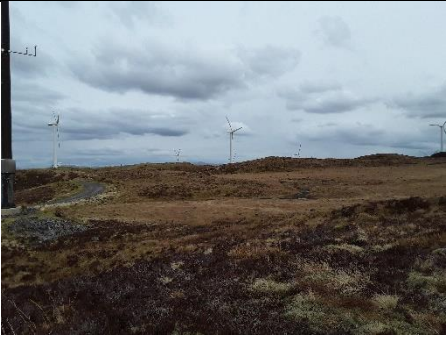
TG	Grid	Note	Photos
69	NM 97411 26089	View demonstrating the co-existence of wet blanket bog in generally good condition with the wind farm infrastructure beside it.

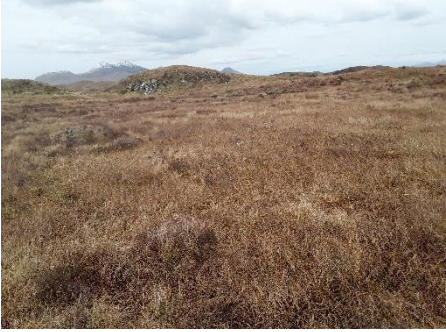
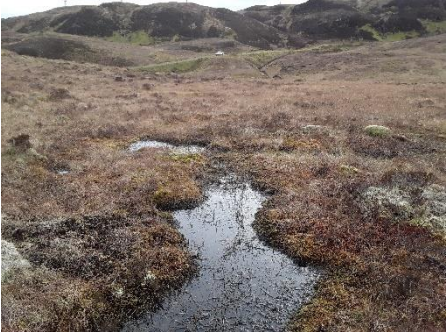
70	NM 98268 26213	Near-Natural. Wet underfoot, with an abundance of bog-moss. There were some bog pools and hummocks present. Woolly fringe moss present near small bare peat features.

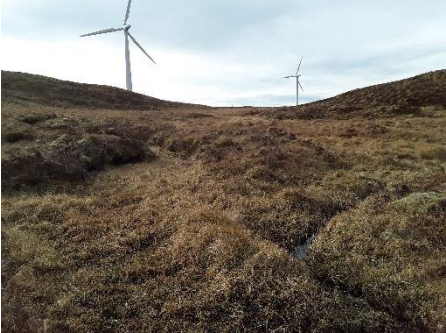
71	NM 97603 26091	Lightly Modified. Some old erosion features present. Small natural drainage channel. But generally wet and bog-moss rich.

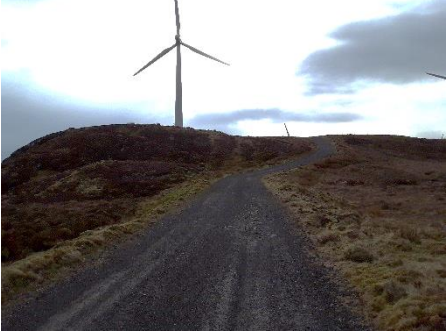
72	NM 97616 26088	Turbines here were located on rocky outcrops not on blanket bog.

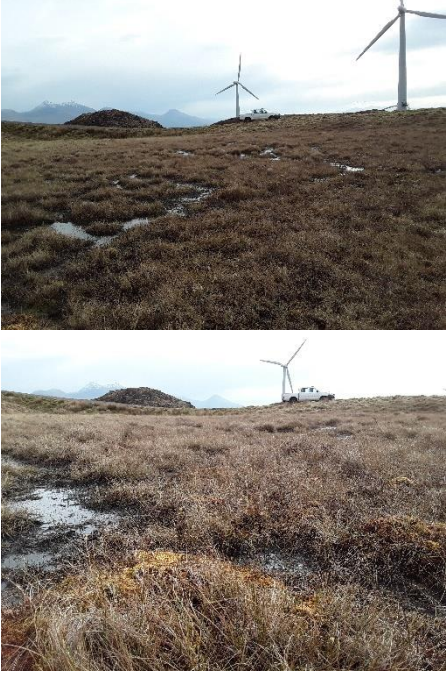
TG	Grid	Note	Photos
73	NM 97812 25758	Near-Natural bog was located in a basin right next to some wind farm infrastructure. Bog pools were wet with feathery bog-moss. There were hummocks and lawns of several bog-moss species including red bog-moss and papillose bog-moss. The vegetation surrounding the pools was very wet underfoot. This demonstrates the co-existence of good quality blanket bog and wind farms with a careful design layout.

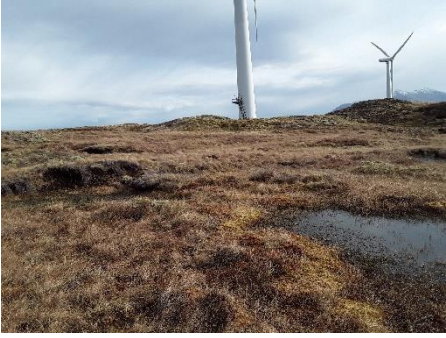
74	NM 97902 25658	The area around this turbine was a mixture of old erosion features and bog pools with lawns and hummocks of bog-mosses. There were some erosion features with bare peat present. Mapped as Actively Eroding, but there were areas of wet bog at the base and in hollows. Good restoration potential.

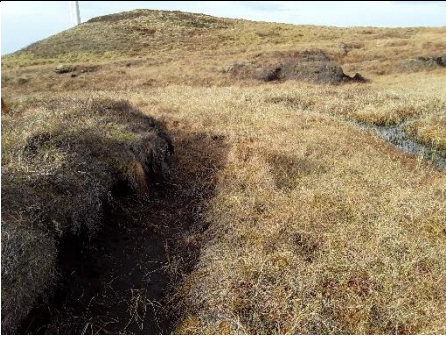
75	NM 97891 25665	Example erosion feature. It was ca. 0.5 m high and 0.5 m wide. Sparse common cottongrass on the bare peat. The vegetation on top of the feature was dry heather and woolly fringe moss.

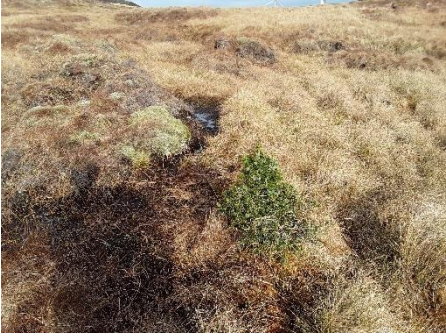
76	NM 97889 25673	Sitka spruce ca. 70 cm tall.

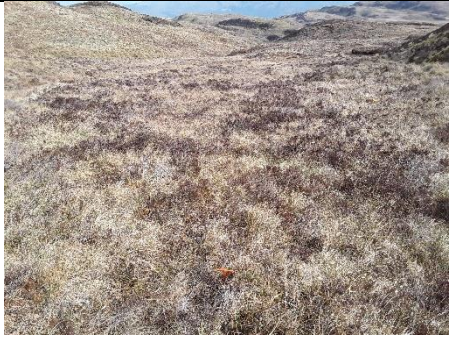
TG	Grid	Note	Photos
77	NM 97967 25748	Modified. Area of deep peat with wet heath vegetation (M15). It was tussocky heather with a depleted bog-moss layer.

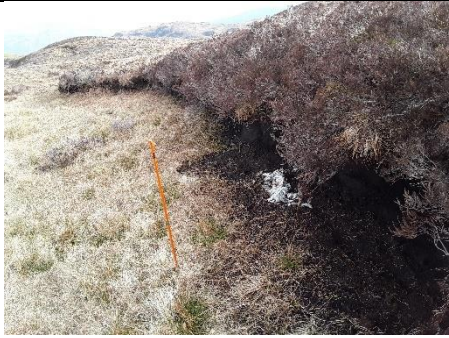
78	NM 97992 25790	Erosion feature. It was ca. 1.5 m high and 30 m long with ca. 0.5 m bare peat at base. Actively Eroding feature within a wider area of Modified blanket bog.

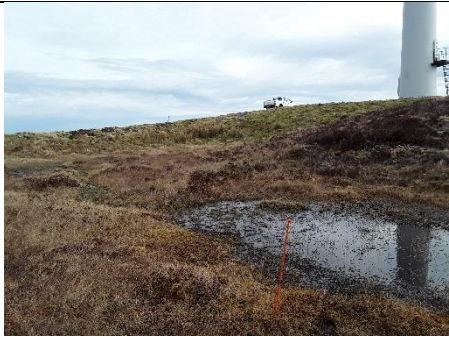
79	NM 98053 25750	Bog pools within ca. 30 m of wind farm infrastructure, in a small basin. The peat depth was perhaps ca. 80 cm. There was a bog-moss carpets of red bog-moss and papillose bog-moss.

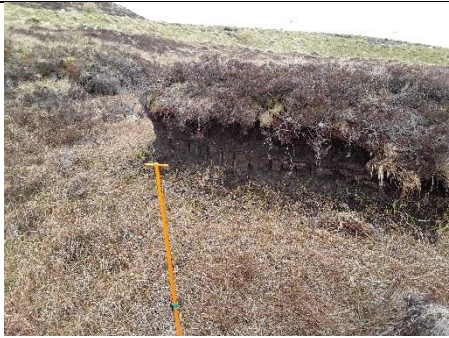
80	NM 98040 25706	Erosion feature. It was ca. 1 m high and straight so possibly an old peat cutting. It was well vegetated at the base.

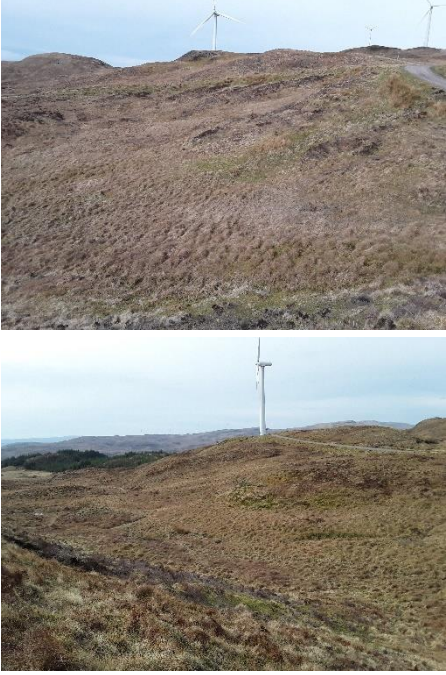
TG	Grid	Note	Photos
81	NM 98071 25577	View. Looking west toward main site. Valley with tussocky hare's tail-cottongrass on slopes (Modified). Wetter area was Lightly Modified.

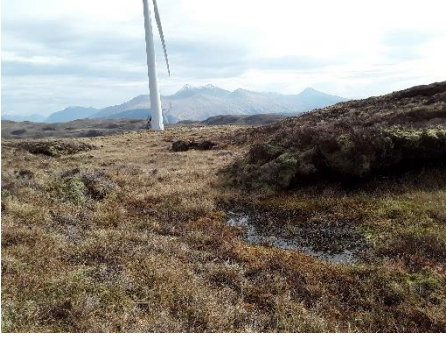
82	NM 98152 25542	Recovering Erosion. Group of old erosion features. Some erosion still evident, but largely revegetated edges with well-developed pools at base. Area recovering.

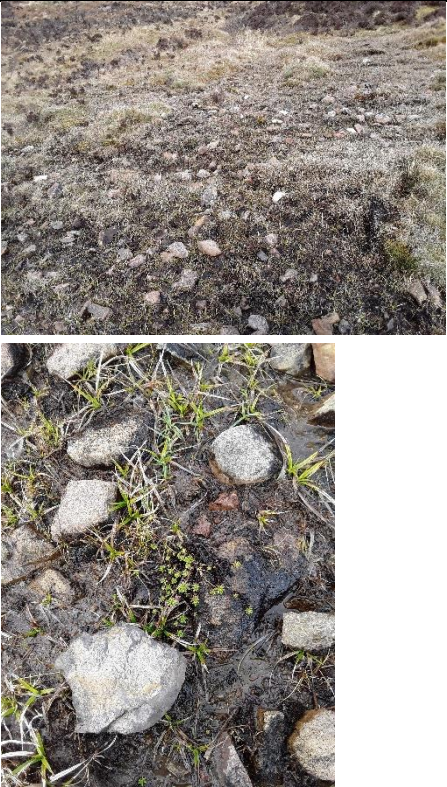
85	NM 98152 25270	Actively Eroding features. Some active erosion and some revegetation and generally wet at base. It was ca. 1.5 m high.

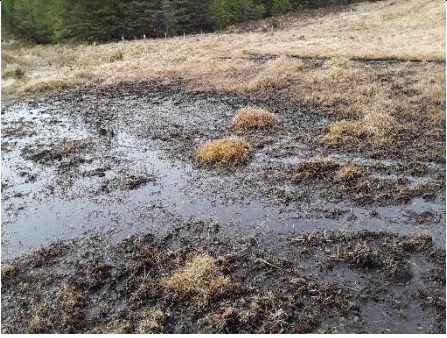
86	NM 98067 25186	Fen. Potential GWDTE. There was a ca. 20 m x 20 m patch of bare peat with bog pondweed, common yellow sedge and bottle sedge. It was very wet. In the wider area there was soft rush and small streams with bog pondweed, set within M17a blanket bog.

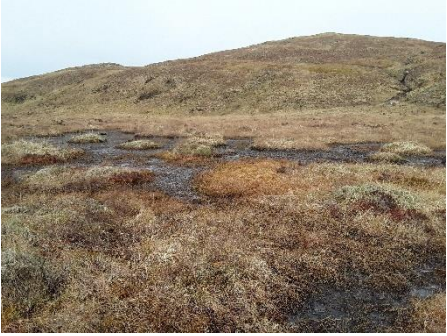
87	NM 97980 25184	Near-Natural bog.

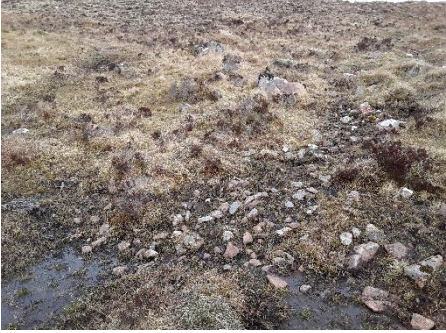
TG	Grid	Note	Photos
88	NM 97958 25218	M11. Potential GWDTE.

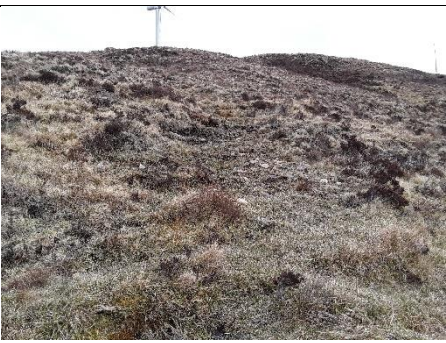
89	NM 98007 25255	M11. Potential GWDTE.

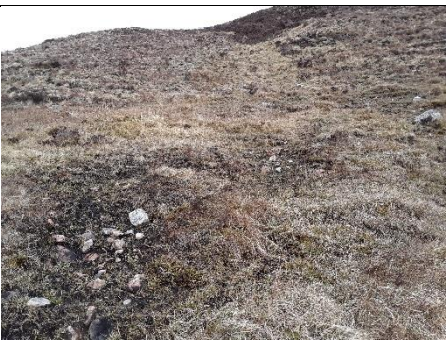
90	NM 98034 25254	M11. Potential GWDTE. All these small springs feed into the fen in the valley.

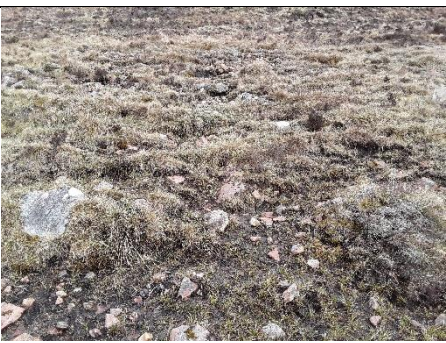
91	NM 98034 25255	M11. Potential GWDTE.

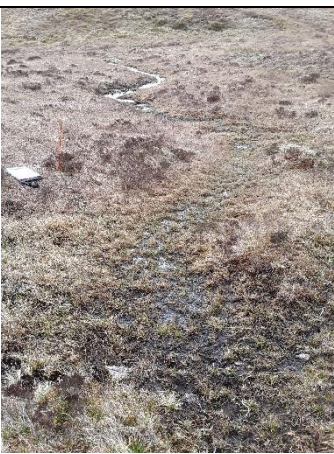
92	NM 98090 25285	M11. Potential GWDTE. This was feeding into the watercourse.

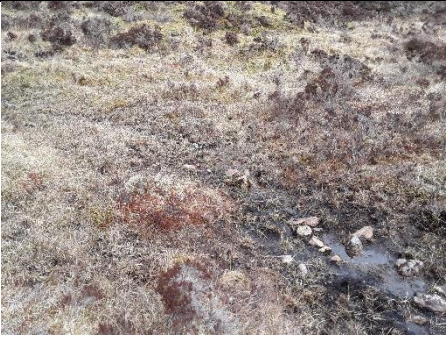
TG	Grid	Note	Photos
93	NM 98099 25291	M11. Potential GWDTE.

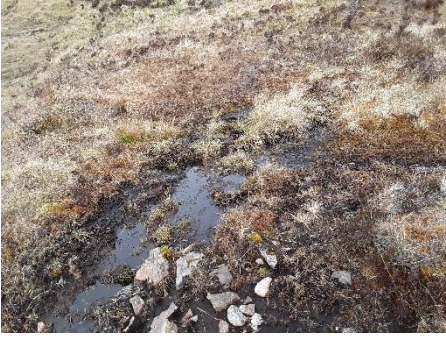
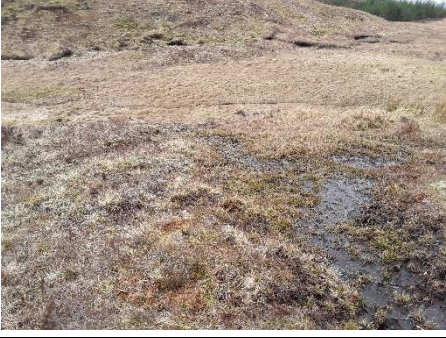
94	NM 98198 25361	M11. Potential GWDTE. This was feeding into a watercourse.

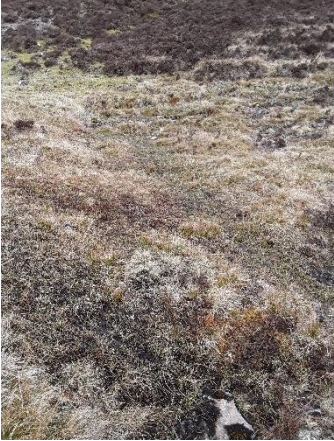
95	NM 98259 25403	M11. Potential GWDTE.

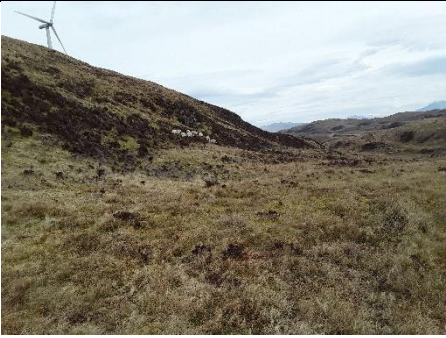
96	NM 98270 25409	Several sheep on the slopes.

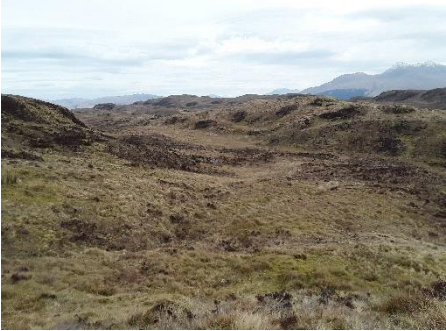
TG	Grid	Note	Photos
97	NM 98325 25452	This hill slope was largely M15 wet heath, but deep peat was present between hillocks. It was Modified, dry and bog-moss depleted.

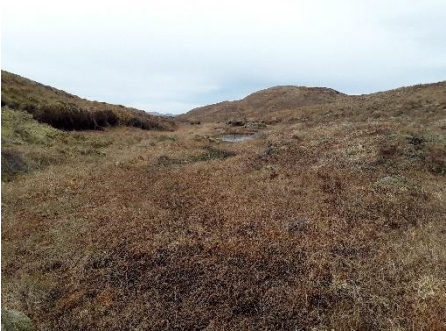
98	NM 97987 25495	Recovering Erosion. Bog pools were common amongst old recovering erosion features. There was a good bog moss layer.

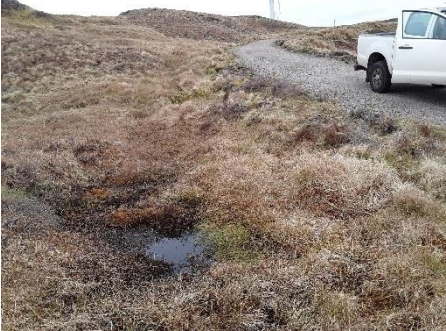
99	NM 97985 25491	Bog-moss and bog pool within ca. 5m from track.

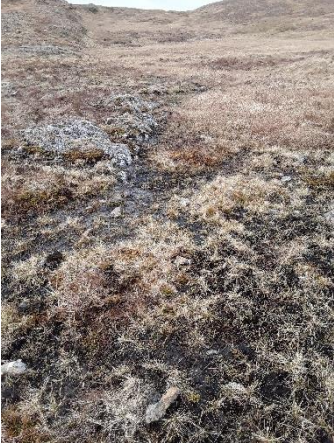
100	NM 97828 25478	M11. Potential GWDTE.

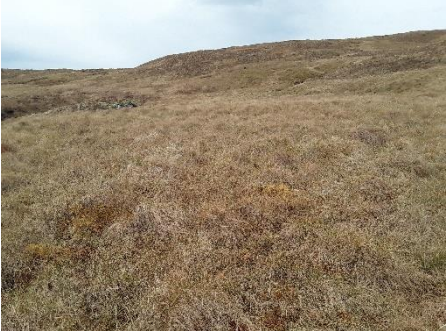
101	NM 97739 25456	Modified. Although bog-moss were frequent the vegetation was tussocky with hare's tail-cottongrass and purple moor-grass.

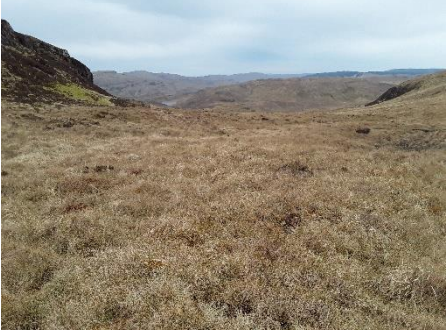
TG	Grid	Note	Photos
102	NM 97477 25290	Modified. Valley with deep peat. The vegetation was tussocky with hare's tail-cottongrass and purple moor-grass. Bog-mosses included red bog-moss and papillose bog-moss. There was some soft rush, cross-leaved heath, and tormentil present.

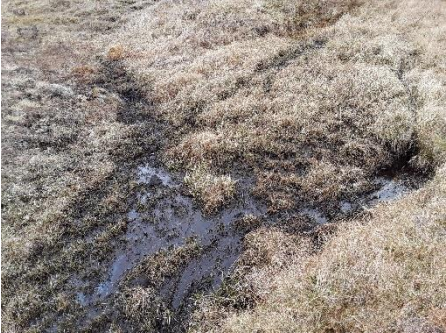
103	NM 97476 25291	M11. Potential GWDTE.

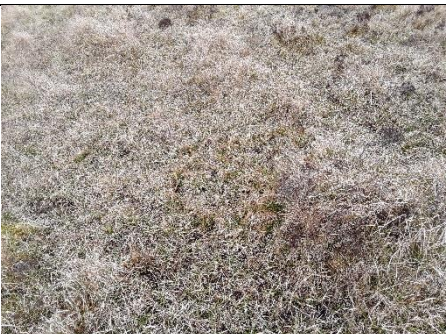
105	NM 97270 25184	M15a. Potential GWDTE. Sedge dominated patch of wet heath with carnation sedge, common yellow sedge and common cottongrass.

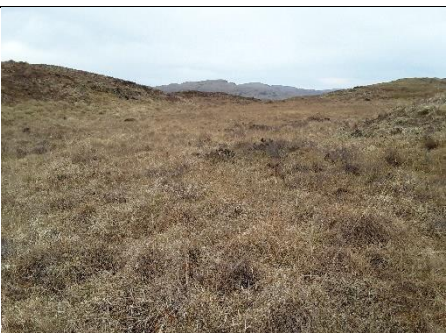
106	NM 97176 24968	Modified. Very tussocky. Purple moor-grass dominated (M25a) with hare's tail-cottongrass and good bog-moss layer. Appeared to be on deep peat.

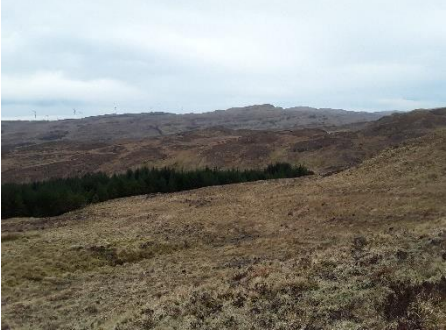
TG	Grid	Note	Photos
107	NM 97146 24855	Modified. Mix of M25a and M15. M25 appeared to be on deep peat.

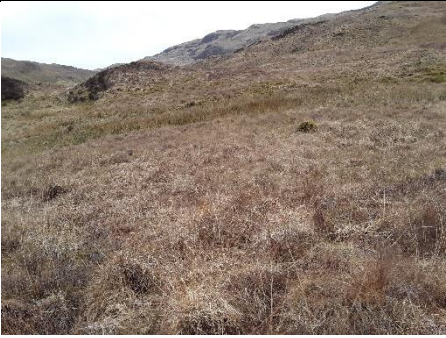
108	NM 96944 24919	Modified. Valley with deep peat. Tussocks of purple moor-grass, heather, hare's tail-cottongrass and cross-leaved heath (M25a).

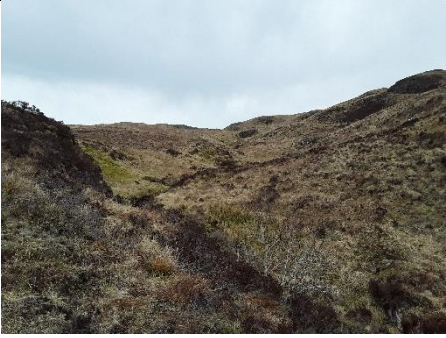
109	NM 97026 25129	Steep sided valley of wet and dry heath. Any pockets or slopes of deep peat modified likely to be wet heath vegetation.

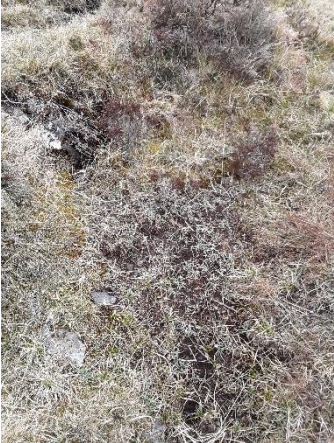
110	NM 96906 25173	M11. Potential GWDTE.

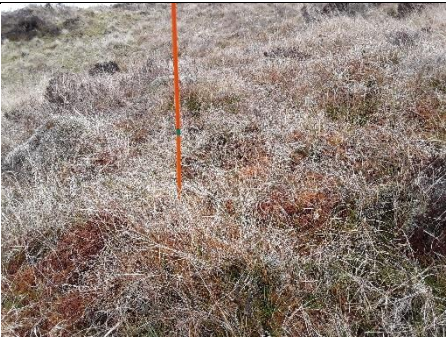
111	NM 96900 25170	Papillose bog-moss and hummocks of red bog-moss were common in wet heath vegetation. Here the peat was only ca. 0.2 m deep.

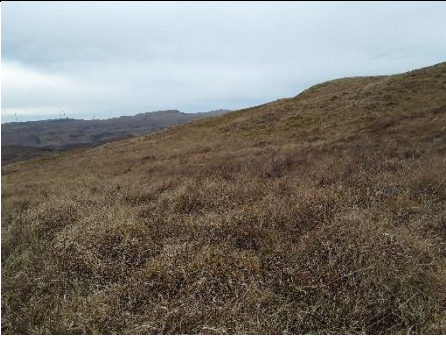
TG	Grid	Note	Photos
112	NM 96776 25252	Modified tussocky M15 on deep peat.

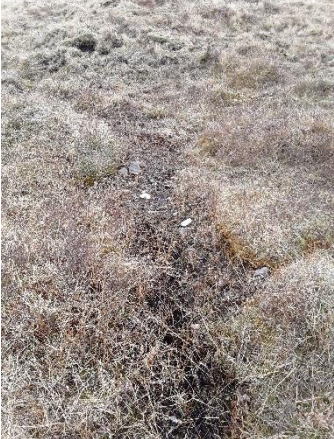
113	NM 96756 25250	M11. Potential GWDTE.

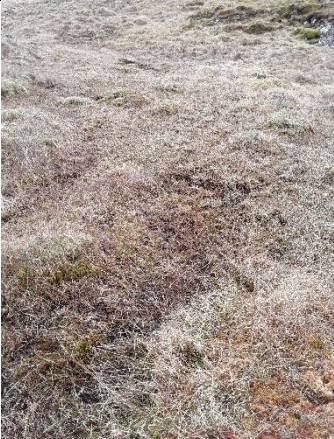
114	NM 96636 25291	M11. Potential GWDTE.

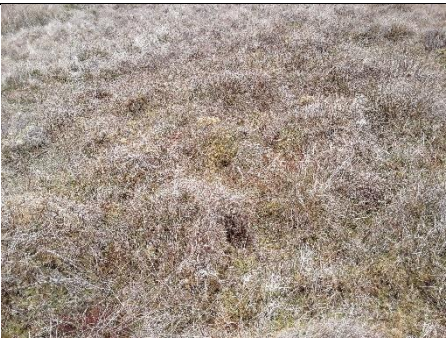
115	NM 96621 25308	Modified. Tussocky hare's tail-cottongrass with blaeberry and mix of red bog-moss and glittering wood-moss with common haircap.

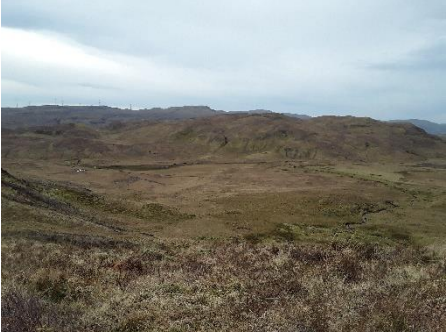
117	NM 96520 25302	Fen in distant valley basin. Potential GWDTE.

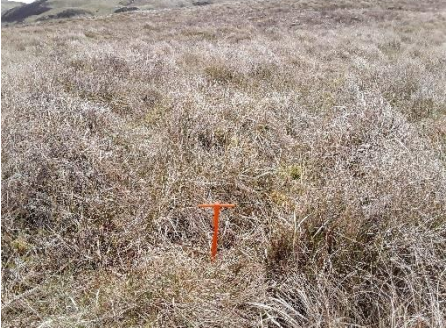
118	NM 96512 25412	The slopes were mainly shallow soil with wet heath vegetation. Occasional deep peat was located in small valleys. Modified. Tussocky hare's tail-cottongrass, purple moor-grass, cross-leaved heath blaeberry and glittering wood-moss.

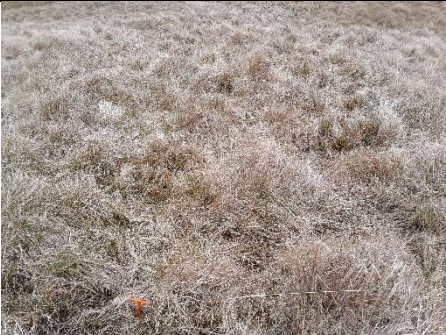
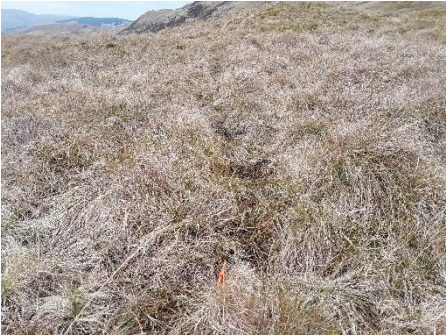
121	NM 96403 25583	Modified. Deep peat with tussocky vegetation. Lots of signs of large ungulates including dung, tracks and prints.

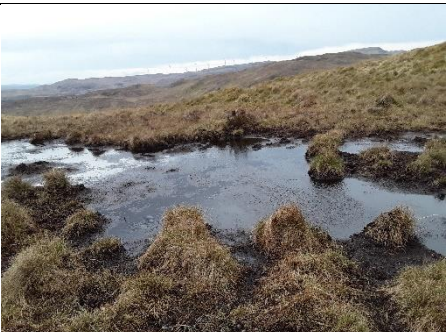
125	NM 96152 25336	Actively Eroding. Bare peat with water on top. Lacking bog-mosses around the edge. Likely dries out in summer months. Surrounded by modified bog.

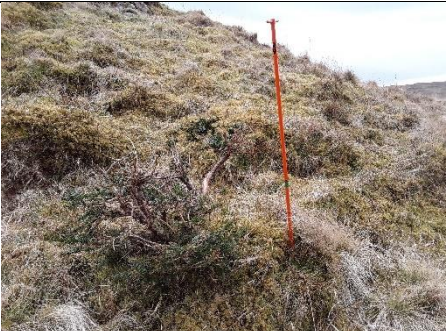
126	NM 96112 25325	Sitka spruce. It was ca. 70 cm tall and had been browsed.

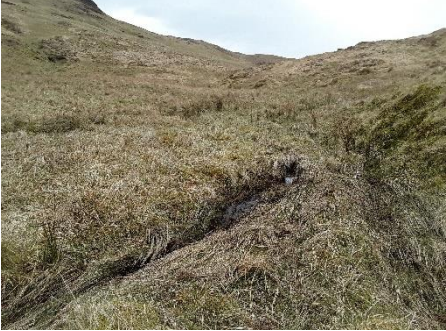
TG	Grid	Note	Photos
127	NM 95988 25227	M23 fen. Potential GWDTE. Water feeding the vegetation likely derived, at least part, from groundwater.

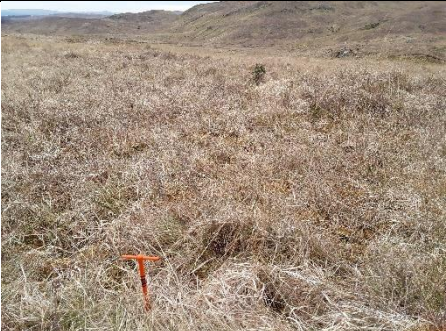
128	NM 96006 25157	Modified. Purple moor-grass dominated vegetation (M25a). Very tussocky. On deep peat. Many of signs of grazing. Occasional sitka spruce present.

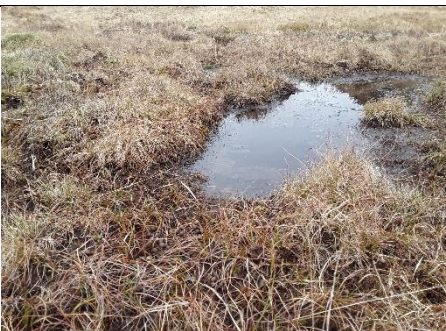
129	NM 95990 25124	Modified. There were occasional bog pools present, but they were species poor M3 pools with bare edges, and often animal dung present.

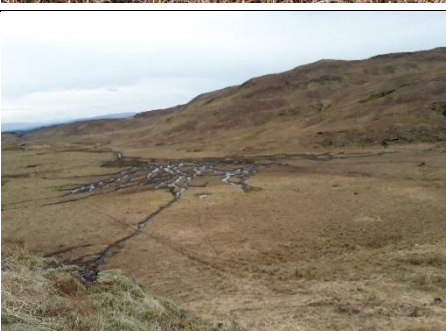
130	NM 95978 24996	View of fen. Potential GWDTE.

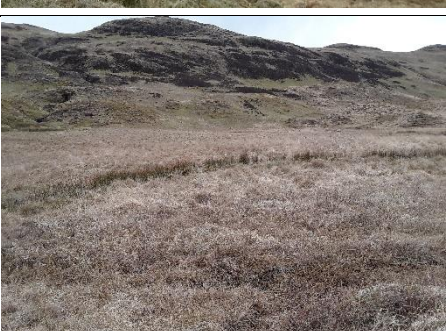
131	NM 95827 24992	Modified. Purple moor-grass dominated (M25a) vegetation in a topographic bowl with soft rush lining watercourse running through it.

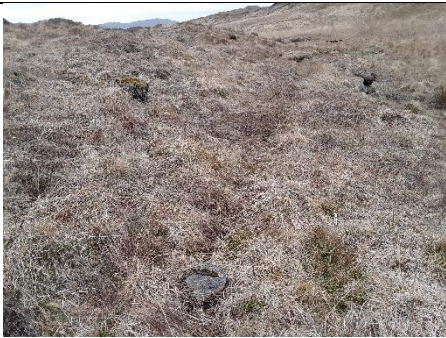
TG	Grid	Note	Photos
132	NM 95806 24982	Well defined animal trails.

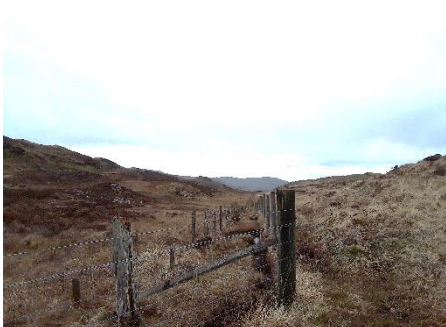
133	NM 95683 24884	Obvious fence line grazing effect. Grazing on HMP side of fence (right side in picture) results in very little heather. Outside HMP area (left in photo) heather was more abundant.

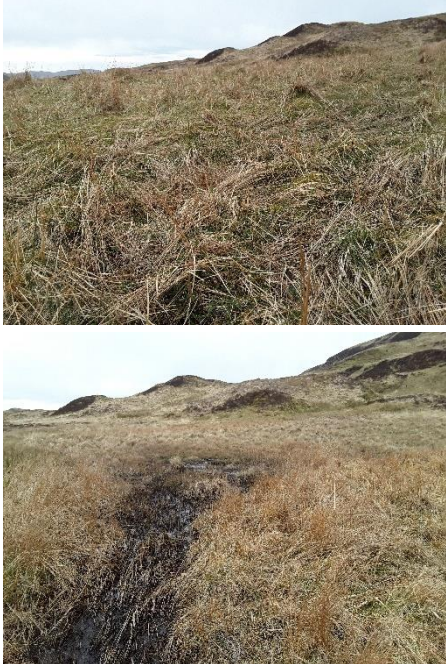
134	NM 95597 24827	Soft rush dominated shallow soils. MG10. Yorkshire fog abundant. Quite dry. M23 was located by the stream.

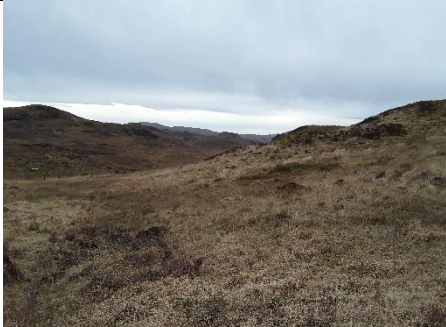
135	NM 95432 24718	Modified. Deep peat areas in basins had purple moor-grass dominated vegetation (M25a). Slopes of M15 wet heath.

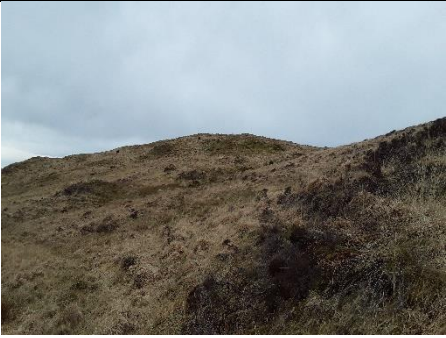
TG	Grid	Note	Photos
136	NM 95335 24611	Several sitka spruce on hill slope. All were less than 1m tall.

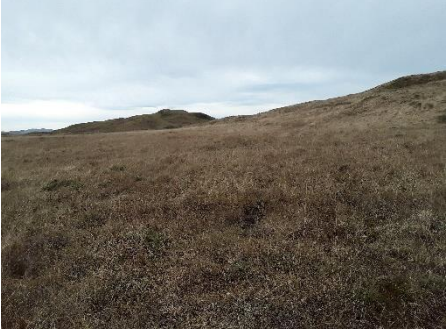
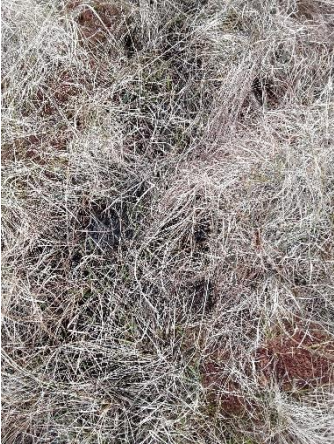
137	NM 95198 24661	Modified. Purple moor-grass dominated (M25a) area. Patches of bare peat with hoof marks. Some bog-mosses and quite wet.

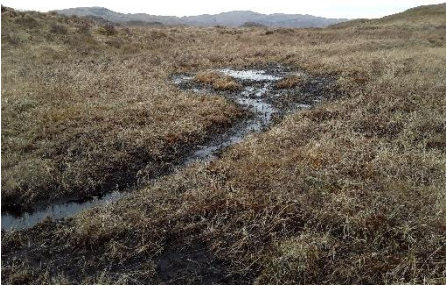
138	NM 95060 24547	Seepage line potential associated with GWDTE.

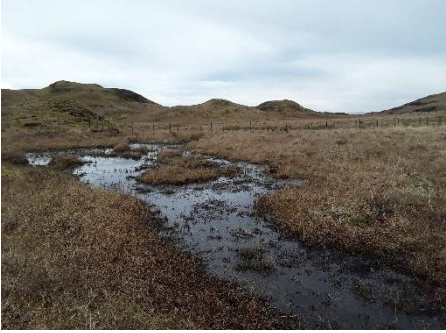
139	NM 95019 24571	Area likely associated with fen. Water was black with bog pondweed. It was sedge rich including abundant common yellow sedge. Potential GWDTE.

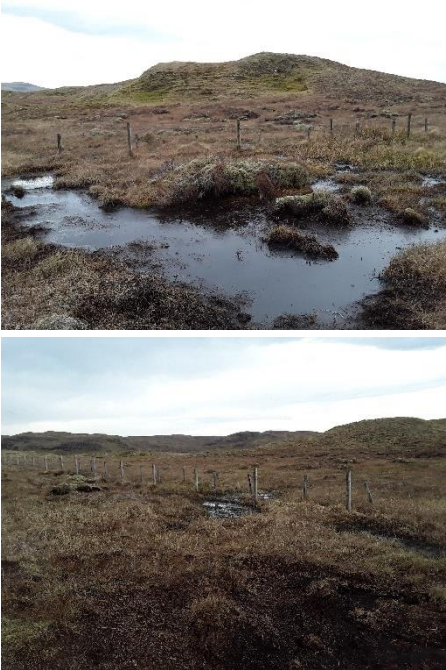
TG	Grid	Note	Photos
140	NM 94821 24611	Area of wet bog, but largely depleted of bog-mosses and some active erosion evident. Bog asphodel and woolly fringe moss were abundant. Modified to Actively Eroding.

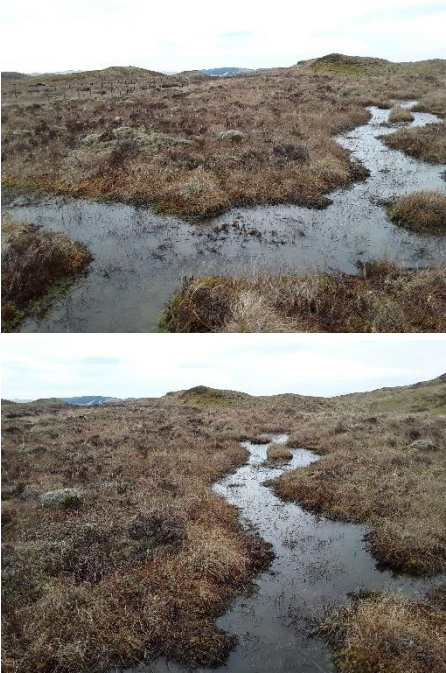
141	NM 94678 24591	Near-Natural. Hummocks and hollow present. Abundant woolly fringe moss with feathery bog-moss. There were lawns and hummock of red bog-moss and papillose bog-moss. This Near-Natural bog was localised.

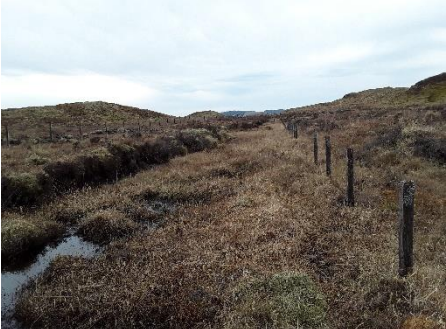
142	NM 94650 24547	Erosion feature between fence lines. It was ca. 1 m deep. There was dry M17b vegetation surrounding it.

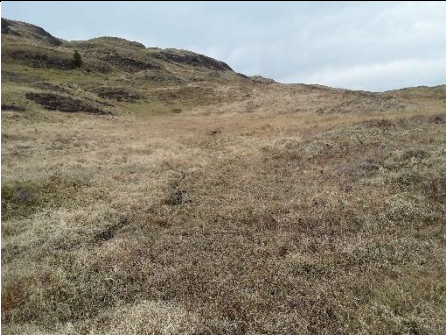
TG	Grid	Note	Photos
143	NM 94600 24609	Modified. M25 on deep peat in basin.

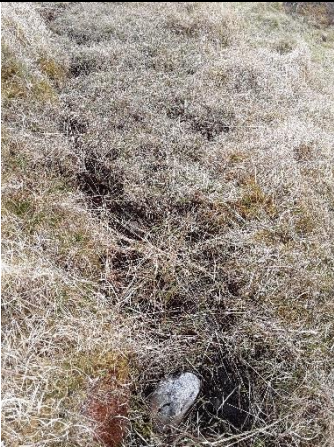
144	NM 94754 24761	M11. Potential GWDTE.

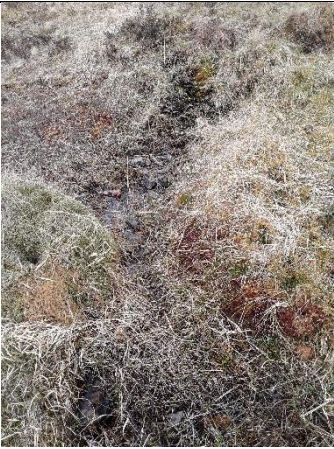
145	NM 94769 24755	M11. Potential GWDTE.

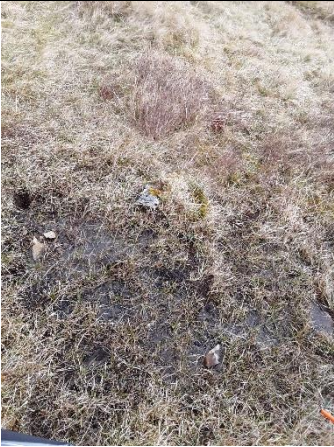
146	NM 95007 24856	M11. Potential GWDTE.

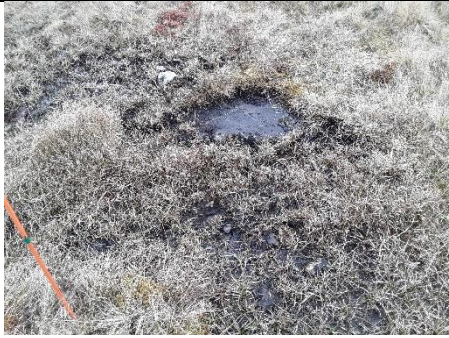
TG	Grid	Note	Photos
155	NM 96893 25565	M11. Potential GWDTE.

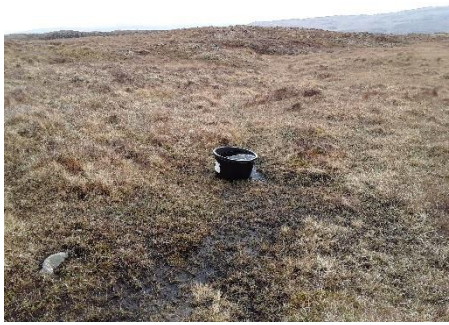
156	NM 97193 25534	Feeding/water buckets were fairly common across site showing modification of bog through management of livestock. This was in a basin of Modified bog.

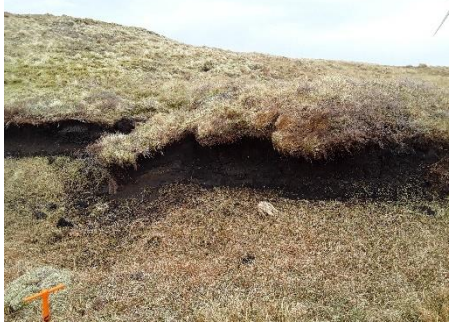
158	NM 97365 25524	Actively Eroding feature. Very long erosion feature (ca. 70 m long). It was ca. 1.5 m high. Blocks of peat were broken off.

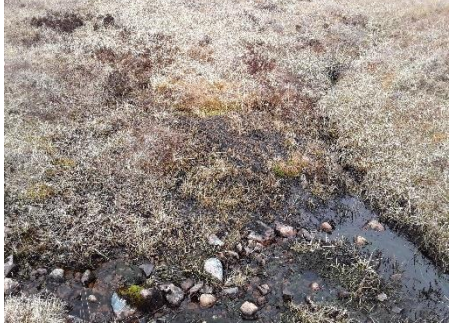
159	NM 97559 25585	M11. Potential GWDTE. Head of burn.

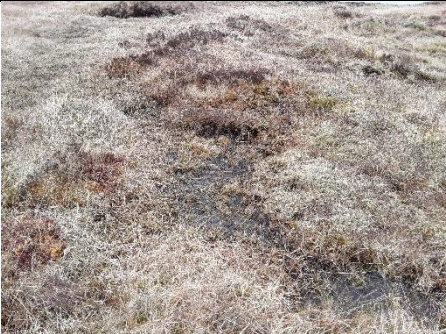
TG	Grid	Note	Photos
160	NM 97749 25558	M11. Potential GWDTE.

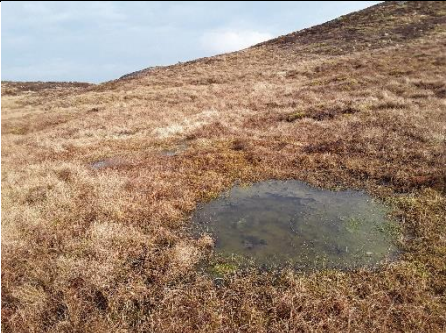
161	NM 97425 25726	Near-Natural. Several small pools and bog-moss abundant.

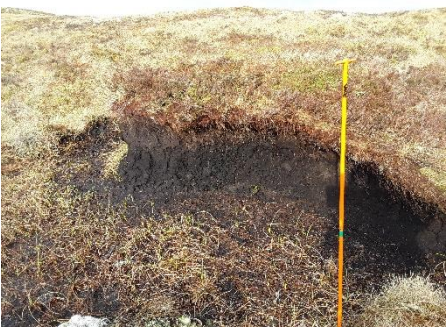
162	NM 97400 25762	Two small erosion features. They were ca. 1 m high, 3 m long and 2 m wide at base.

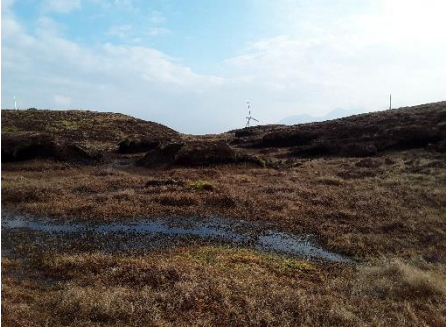
163	NM 97408 25805	Actively Eroding area. Pools at bases of features but all faces were actively eroding. They were ca. 1 m to 1.5 m high and 20 m long.

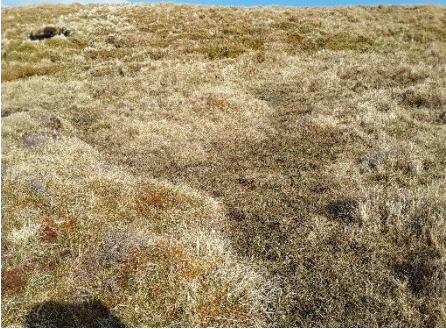
164	NM 96780 25909	M11. Potential GWDTE.

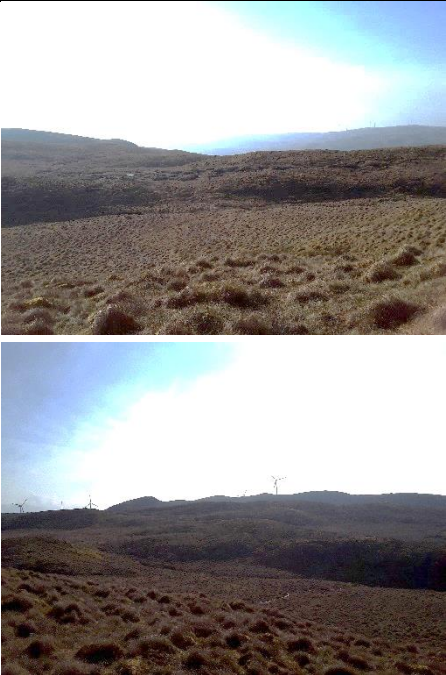
TG	Grid	Note	Photos
165	NM 96730 25919	View of actively eroding area and wind farm.

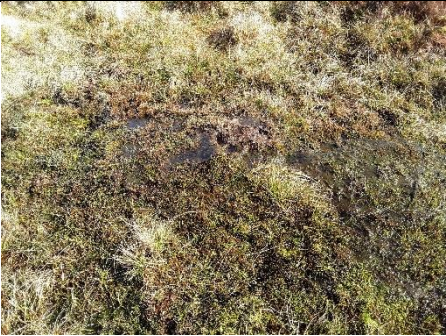
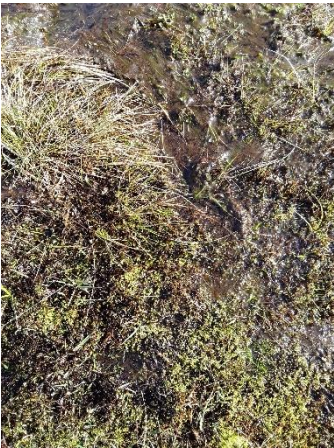
TG	Grid	Note	Photos
168	NM 96513 25935	Spring head (M37). Potential GWDTE. Brown mosses with bulbous rush and common yellow sedge.

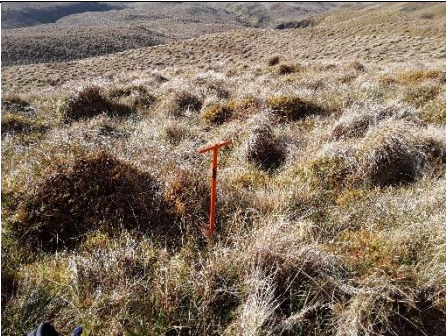
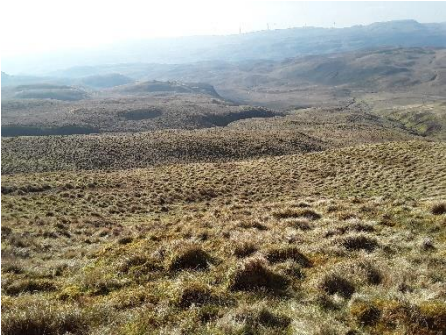
169	NM 96377 25866	Modified. Hill slopes of peat perhaps ca. 70 cm deep. Tussocks of hare's tail-cottongrass dominated. Occasional cowberry, heath rush, common haircap, glittering wood-moss and flat-topped bog-moss with red bog-moss.

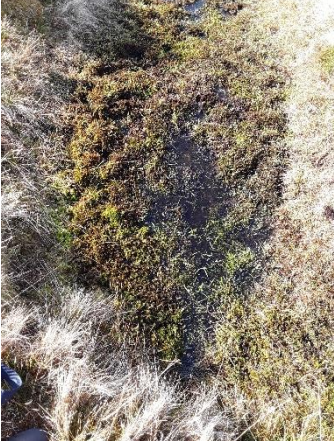
TG	Grid	Note	Photos
170	NM 96337 25894	Spring head (M37). Potential GWDTE.

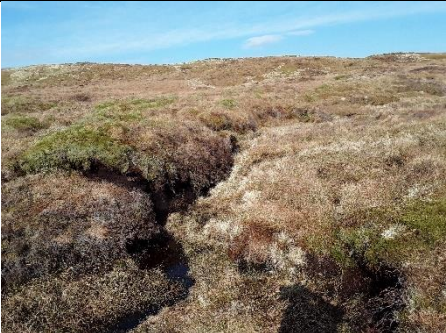
171	NM 96251 25946	Erosion features associated with watercourse. It was ca. 1.5 m high but largely vegetated.

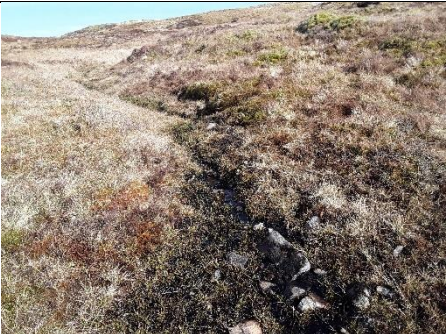
172	NM 96228 25984	M11. Potential GWDTE.

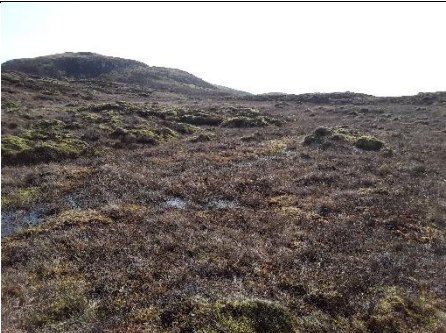
173	NM 96153 26036	Near-Natural bog. There was some undulate dung and a track (so some sign of modification), but wet and bog-moss rich. High altitude bog. Hummocks largely woolly fringe moss.

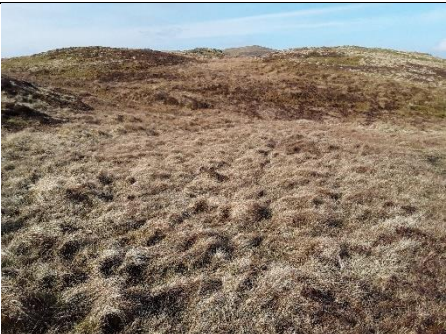
174	NM 96300 26151	Small 10 m wide line of deep peat with M15 going through rocky hills. Modified.

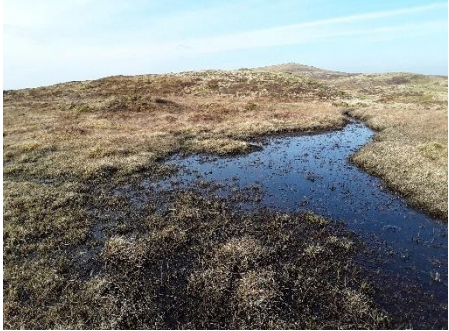
TG	Grid	Note	Photos
175	NM 96357 26139	Pools. Potentially GWDTE. Common yellow sedge around edge of pools with bog pondweed. 1m high erosion features around pool with bare peat exposed.

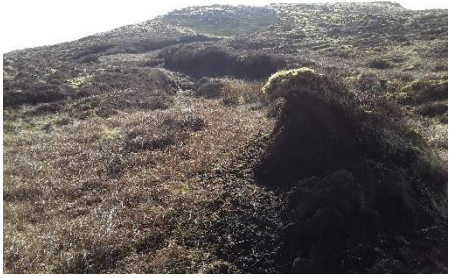
176	NM 96478 26214	Actively Eroding feature next to lochan. It was ca. 1.5 m high and 40 m long. Broken blocks of peat had recently fallen.

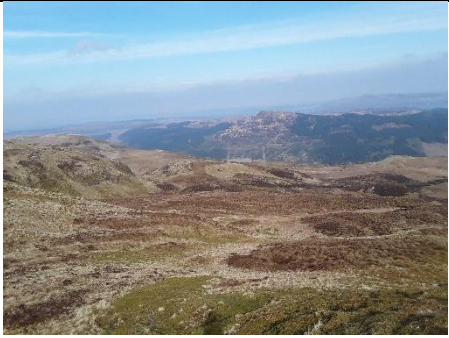
177	NM 96449 26271	Steep slopes. Any pockets of deep peat were Modified to appear as wet heath. Tussocky heather.

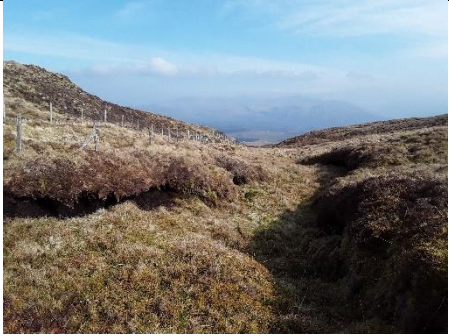
178	NM 96121 26119	Erosion features and gully along this fence line. It was ca. 1 m tall.

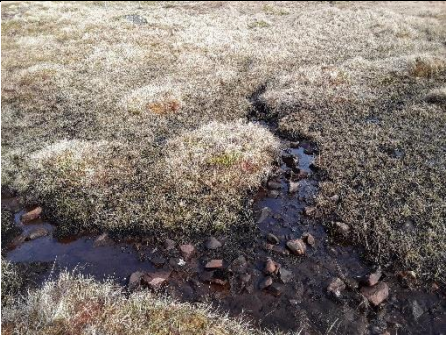
TG	Grid	Note	Photos
179	NM 96086 25995	M11. Potential GWDTE. Near gate.

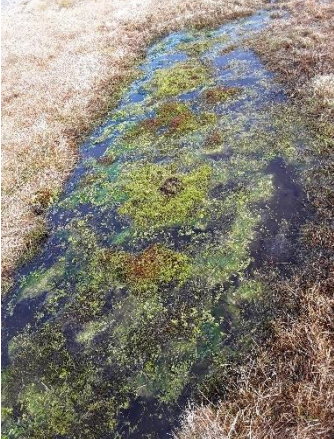
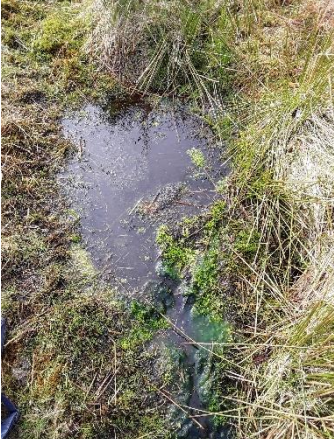
180	NM 95936 26113	Spring head (M37). Potential GWDTE. Surrounding area had bog within a basin between hillocks. Modified.

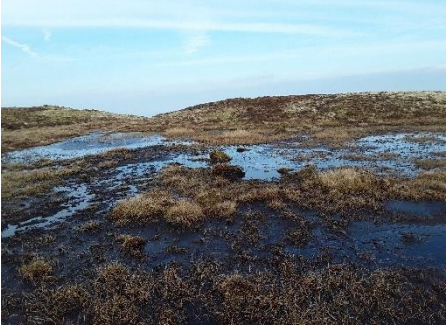
183	NM 95803 26077	This pool was simply water on bare peat. Likely dries out in the summer months. Actively Eroding.

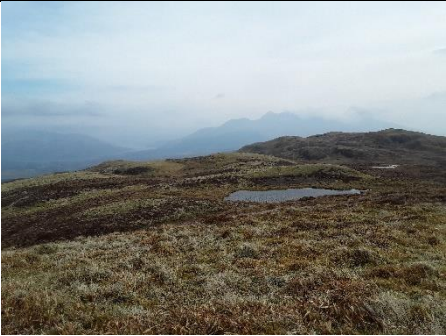
TG	Grid	Note	Photos
184	NM 95777 25996	View of complex of hill tops and erosion features.

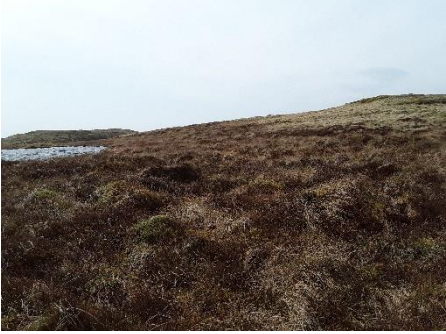
185	NM 95706 25944	Modified. Tussocky heather with hare's tail-cottongrass (M19).

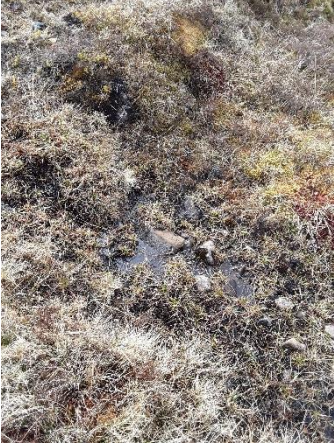
186	NM 95590 25971	M11. Potential GWDTE.

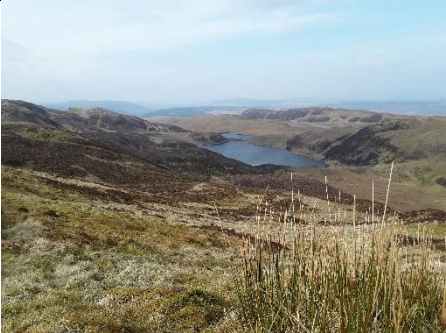
187	NM 95509 25972	The south side of the hillslope (left in photo) was much more sheltered and had an abundance of heather compared to the north side, which was very windy and exposed, with little to no heather (right of photo).

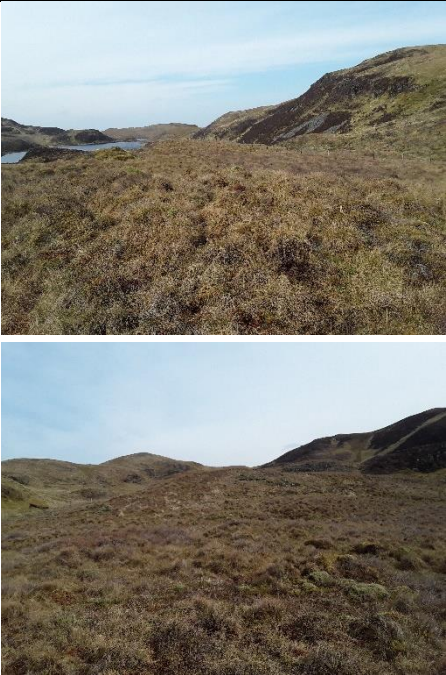
TG	Grid	Note	Photos
188	NM 95237 26059	Modified. Valley with M17a blanket bog. Tussocky. Single pool with bog-mosses around, but area was mostly dry and tussocky. Heather was present but as silvery dead stems. Frost damage.

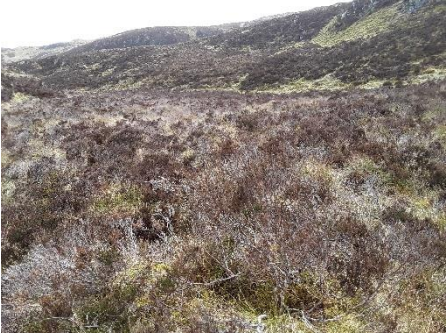
189	NM 95050 25875	Modified. Bowl of tussocky M19. There was no surface water. It was dominated by common cottongrass and hare's tail-cottongrass tussocky with pleurocarp mosses. Surrounded by steep slopes of dry heath (H21).

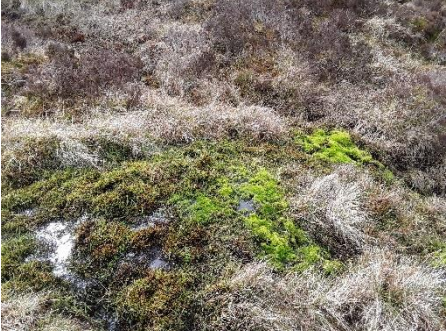
190	NM 94970 25823	Spring head (M37). Potential GWDTE.

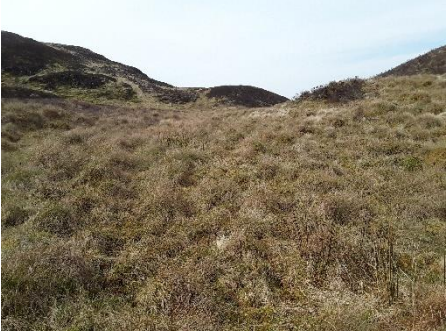
191	NM 94816 25854	Modified. Tussocky hare's tail-cottongrass with common haircap and glittering wood-moss.

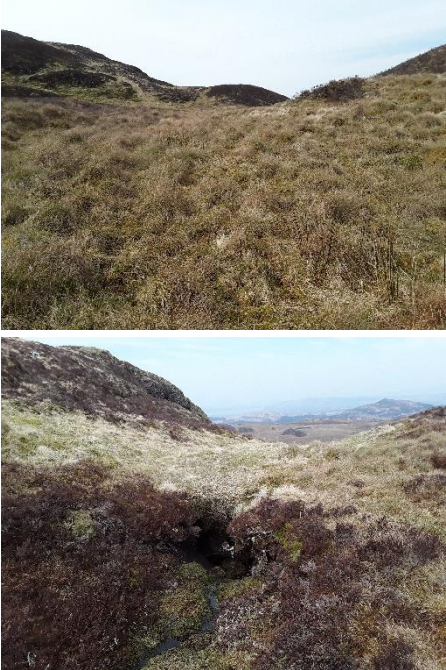
193	NM 94861 25480	Actively Eroding. Bare exposed peat with many hoof marks and dung. Erosion feature was ca. 1 m high.

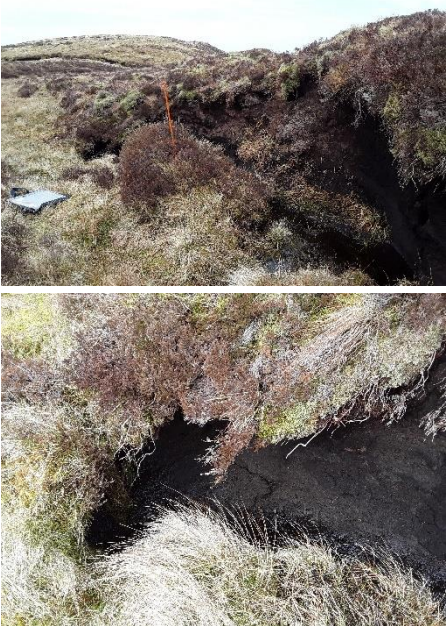
TG	Grid	Note	Photos
194	NM 94887 25420	Actively Eroding. Evidence of underground peat pipes.

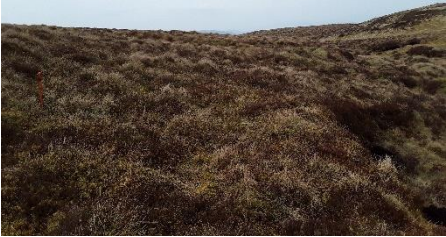
195	NM 94839 25436	Vegetation on top of 1m high erosion gully was very dry with tussocks of hare's tail-cottongrass.

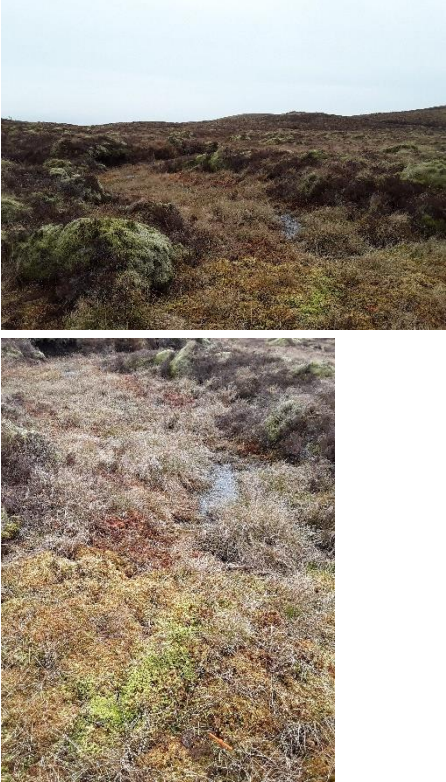
TG	Grid	Note	Photos
197	NM 94741 25412	Recovering Erosion. Eroded, but mostly recovered with woolly fringe moss folder over many old erosion features. Bog-mosses were well established between erosion features.

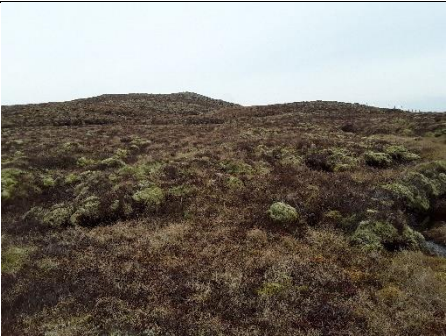
198	NM 94735 25366	Woolly fringe moss hummocks in Recovering Erosion area.

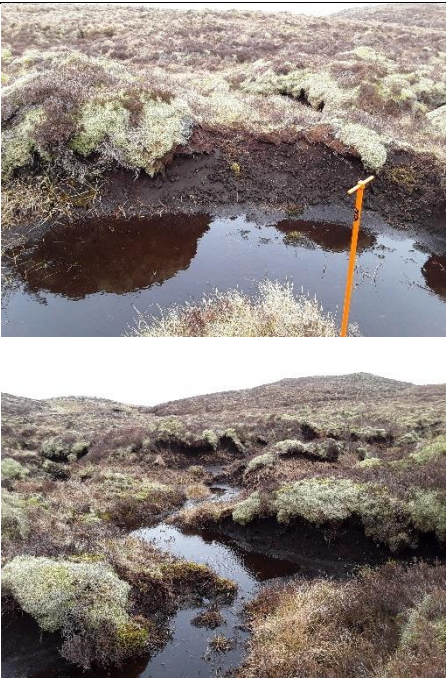
199	NM 94708 25393	Some little patches of Actively Eroding peat present in the Recovering Erosion area. This small erosion feature was ca. 70 cm high.
