Beinn Ghlas Repowering Peatland Condition Assessment Survey Report

Alba Ecology Ltd.

November 2022

This document reports the findings of the PCA undertaken by Alba Ecology Ltd. in April 2022.

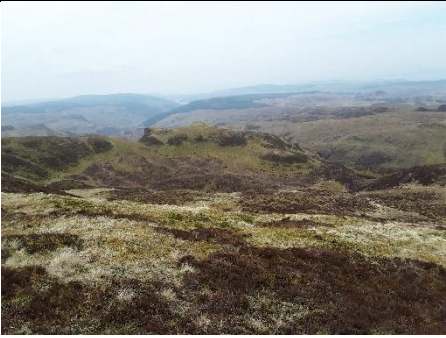
201	NM 94675 25352	Actively Eroding. Feature was ca. 1.2 m high. Peat blocks were recently broken off.

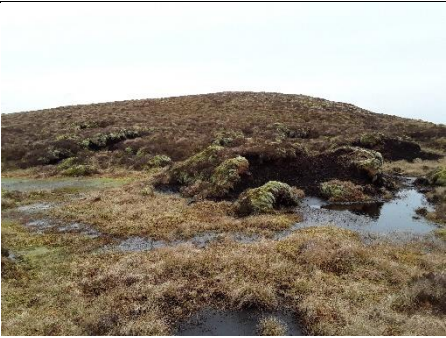
202	NM 94722 25231	Recovering Erosion. Again, small areas of Actively Eroding features coupled with recovering erosion features and large bog pools with bog-moss carpets at the base.

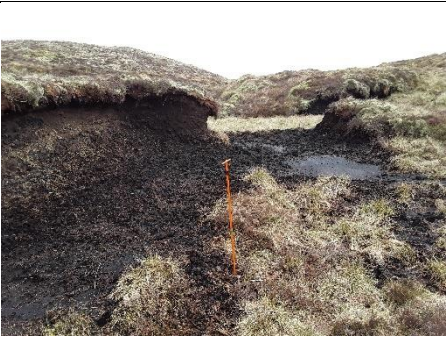
203	NM 94716 25208	Actively Eroding. Feature was ca. 1.5 m high with 2 m of bare peat at base.

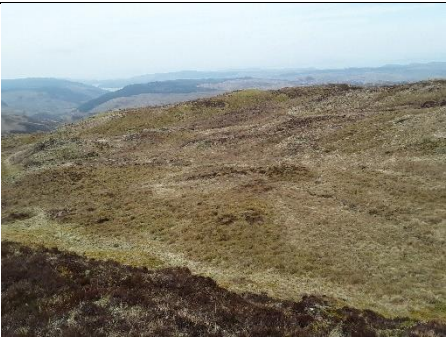
204	NM 94595 25127	View into basin which was tussocky and Modified.

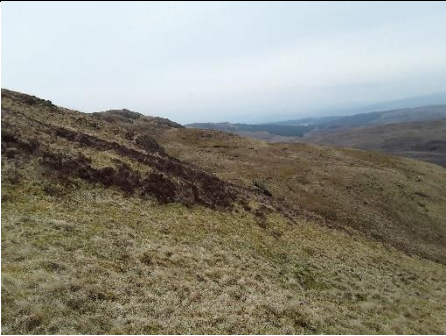
TG	Grid	Note	Photos
205	NM 94768 25134	Large areas of steep hill slopes with apparently shallow soils.

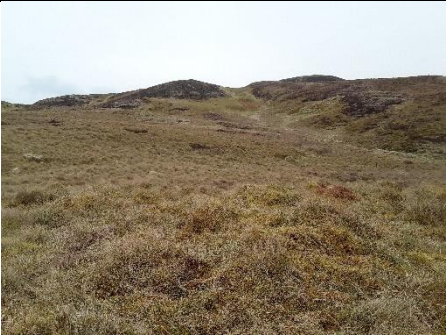
206	NM 94825 25266	Modified. Tussocky hare's tail-cottongrass with blaeberry and cowberry. Damp in places and bog-mosses locally plentiful, but lots of signs of grazing impacts.

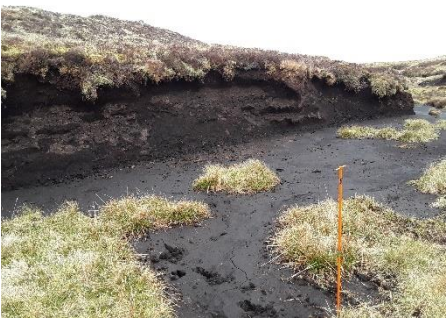
207	NM 95012 25419	Actively Eroding feature. 3 m high erosion feature with ca. 5 m of bare peat at base. Deer hoof marks on bare peat. Very dry vegetation on top.

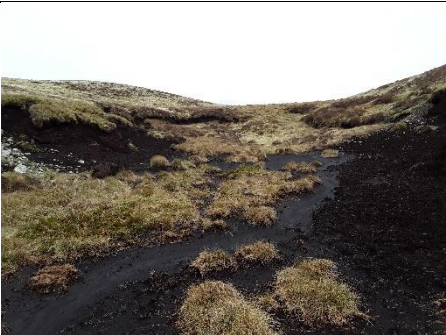
208	NM 95042 25443	On OS map (1:25,000) this area is marked as a lochan. It has been lost. Remains are bare peat pan with occasional hare's tail-cottongrass tussocks and common cottongrass patches. There was ca. 5 m high erosion beside the lost lochan.

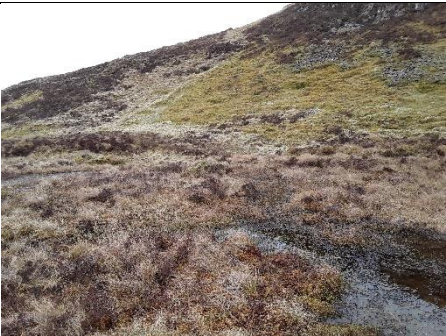
209	NM 95223 25560	Near-Natural bog. Collection of bog pools (M2) with bog-moss lawns around them.

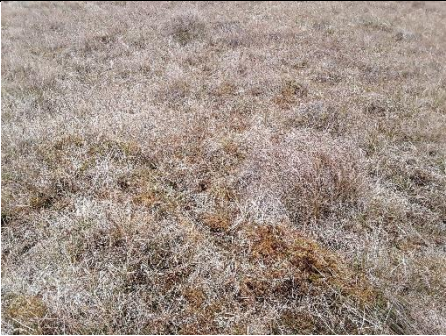
TG	Grid	Note	Photos
214	NM 95327 25469	Some bottle sedge within this basin. Likely remnant of a fen from previous wetter climatic times.

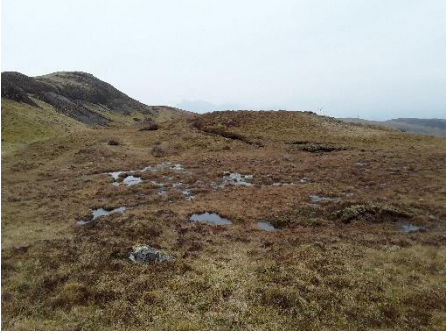
215	NM 95429 25510	Near-Natural bog. View. Surface water evident with bog-mosses abundant. Some old erosion features around outside of this area.

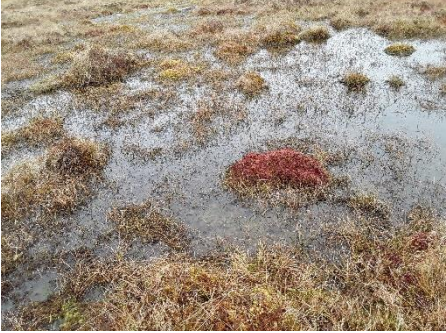
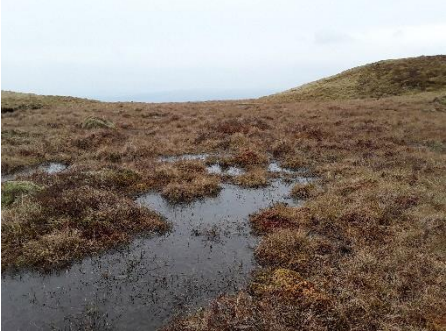
216	NM 95457 25511	Near-Natural bog. Hummocks and hollows with surface water present. Feathery bog-moss was common in the pool. There was a mix of bog-moss species.

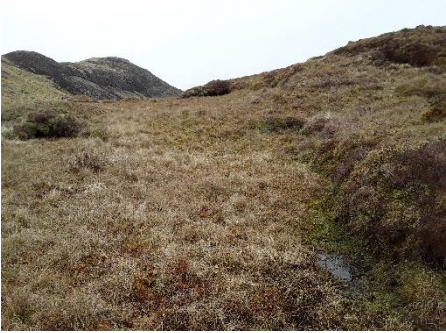
217	NM 95474 25530	Recovering Erosion. Some well vegetated, old erosion features. The vegetation on top of the features was drier than at the base, which was bog-moss rich. Little to no bare peat remaining.

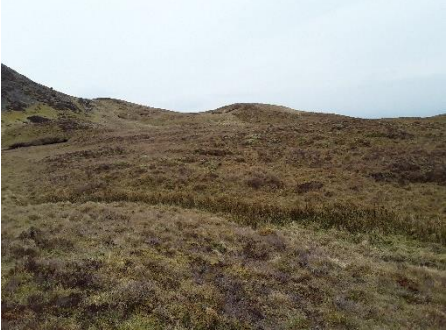
TG	Grid	Note	Photos
218	NM 95563 25576	Modified dry bog vegetation with occasional erosion features.

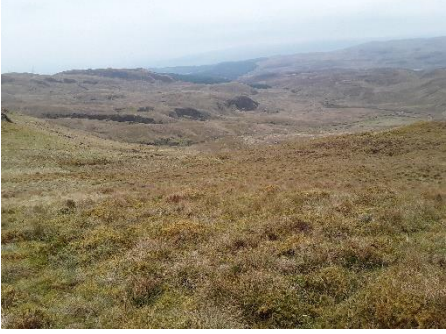
219	NM 95799 25651	Hillslopes with peat depth perhaps ca. 70 cm with tussocky hare's tail-cottongrass vegetation. Modified.

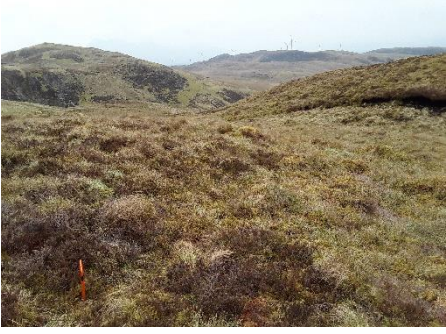
220	NM 95907 25755	Modified. Dry bog vegetation on deep peat. There was an erosion feature to side of hill summit.

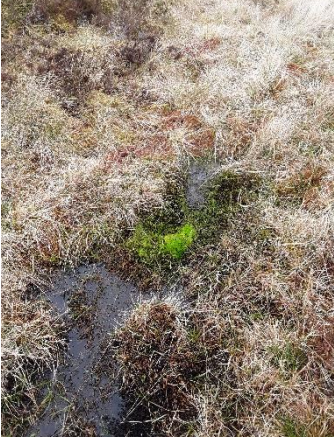
221	NM 95853 25813	Spring head (M37). Potential GWDTE.

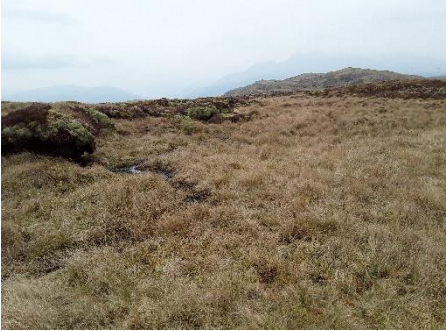
222	NM 95790 25874	Recovering Erosion features with tussocky modified bog below and dry veg on top. Modified.

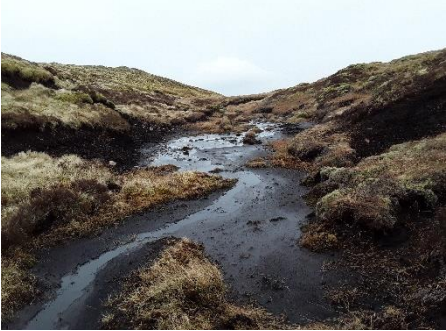
TG	Grid	Note	Photos
223	NM 95753 25850	Actively Eroding. This small area of bare peat may have a lochan. The erosion features were ca. 2 m high with 2-3 m wide bare peat at base.

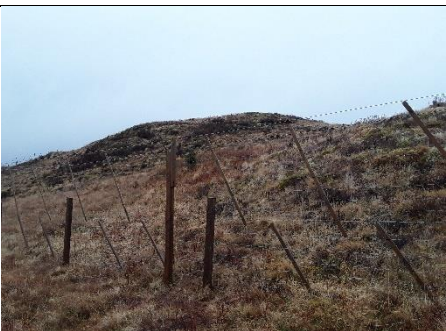
225	NM 98427 25902	Did not enter fenced area. Recent plantation with trees about 1 m high.

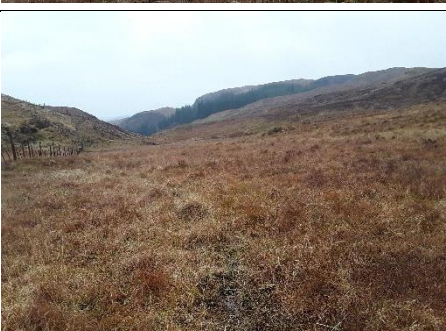
226	NM 98457 25772	Lightly Modified. Bog-moss rich, wet underfoot not tussocky but signs of deer and little to no surface water.

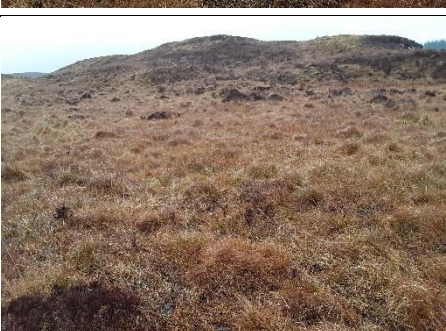
227	NM 98843 26114	Modified. Tussocky with many recent signs of deer and sheep. Small patches of bare peat were common.

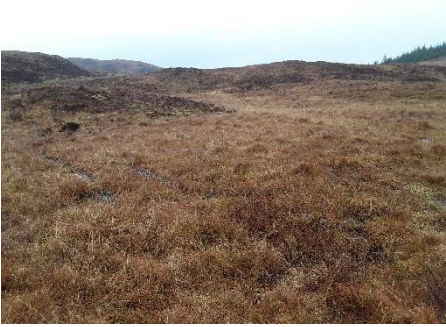
TG	Grid	Note	Photos
228	NM 98971 26087	Lightly Modified. Some shallow pools and bog-mosses with woolly fringe moss hummocks. But clear evidence of modification as bog-mosses were somewhat depleted, bare peat patches present and vehicle tracks were going through the vegetation. Sheep/deer signs were common.

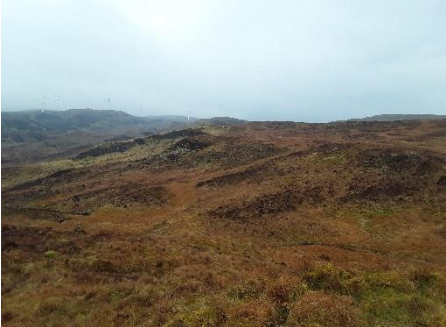
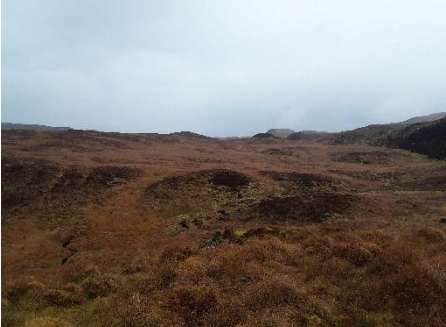
229	NM 98969 26267	View across site. Acid grassland in borrow pit. Deep peat set between hillocks of mainly wet heath.

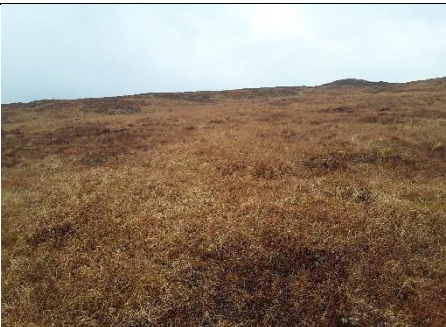
230	NM 98935 26387	Lightly Modified. Very wet, but heavy rain all night, and few actual pools. Deer/sheep signs evident.

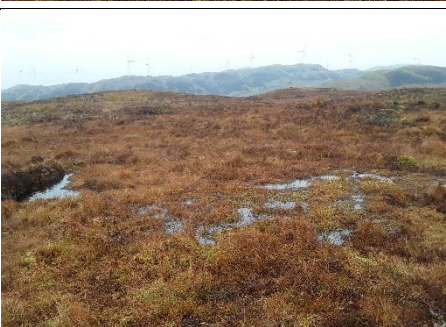
231	NM 98770 26437	Near-Natural. Bog-moss rich and wet. Microtopography present, but not many hummocks of bog-moss.

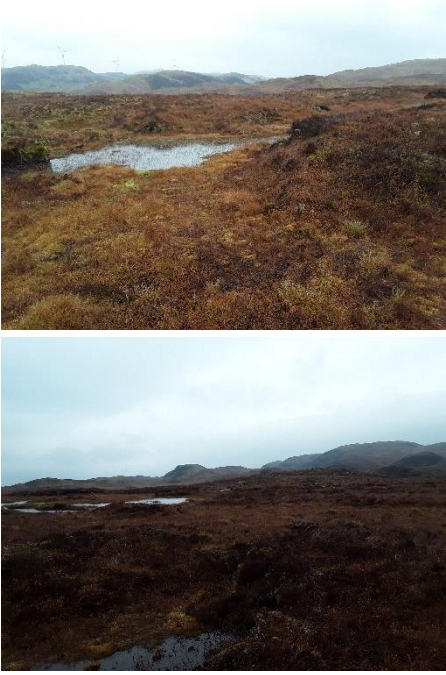
TG	Grid	Note	Photos
232	NM 98743 26447	Recovering Erosion. Old, mostly recovered erosion features with many pools and lawns of bog-moss at the base.

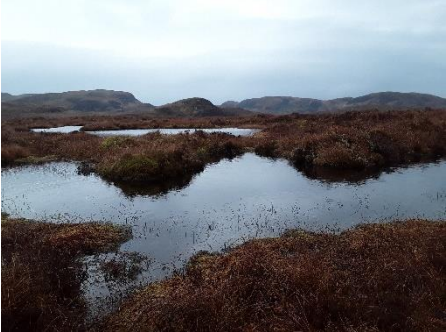
233	NM 98750 26499	Example of Near-Natural bog.

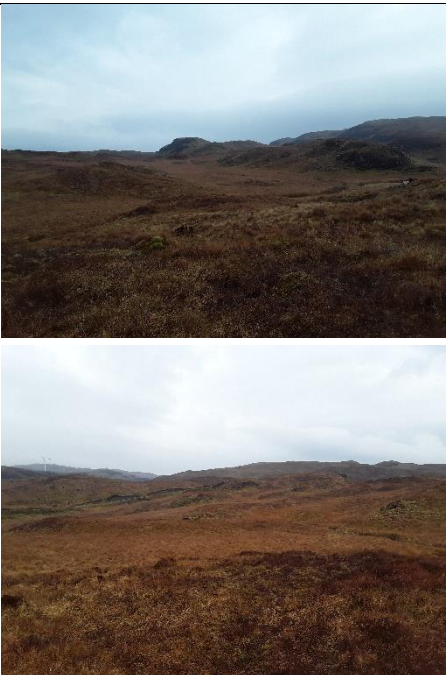
234	NM 98728 26565	View of bog going through wet heath hill slopes. Dry heath on very steep slopes.

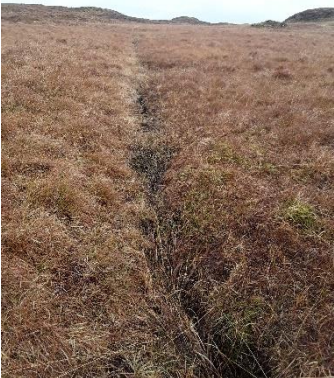
TG	Grid	Note	Photos
235	NM 98744 26721	Lightly Modified. Wet, with frequent to abundant bog-moss and occasional pools, but fairly tussocky vegetation and the mosses layer was more depleted than the example of Near-Natural bog.	 
236	NM 98741 26736	Old drainage ditch, very straight. It was ca. 0.7 m wide and 0.7 m deep. Limited drainage.

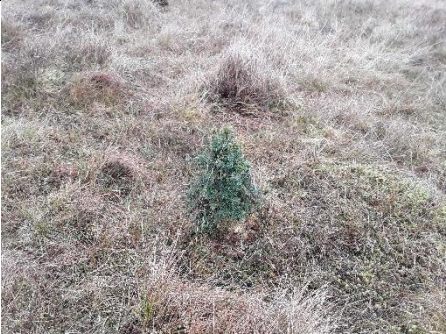
237	NM 98743 26841	Sitka spruce ca. 40 cm tall.

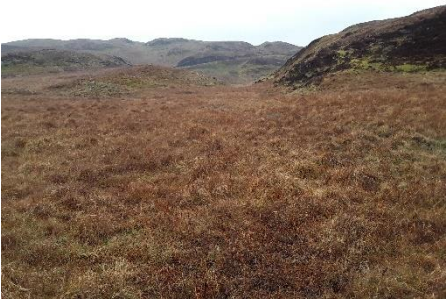
238	NM 98726 26917	Steep section here tussocky and Modified.	 
239	NM 98664 26963	Modified basin. Tussocky.

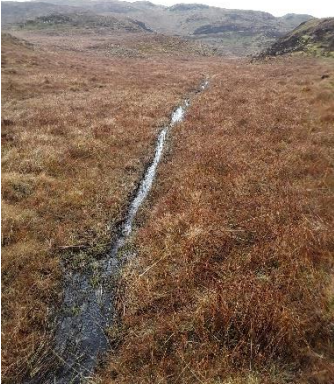
TG	Grid	Note	Photos
240	NM 98688 26968	Historic drainage feature that was very straight.

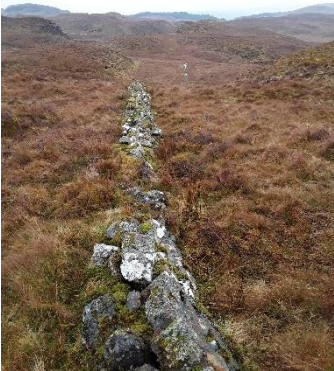
241	NM 98778 27059	Stone wall. Historic land use.

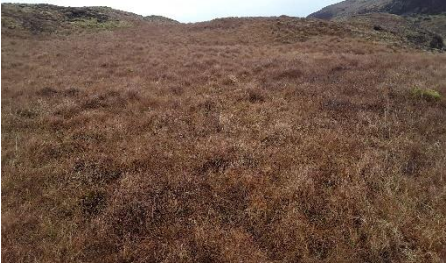
242	NM 98864 27084	Lightly Modified. Bog-moss was frequent to abundant. Wet underfoot. Many signs of sheep/deer including a feeding bucket.

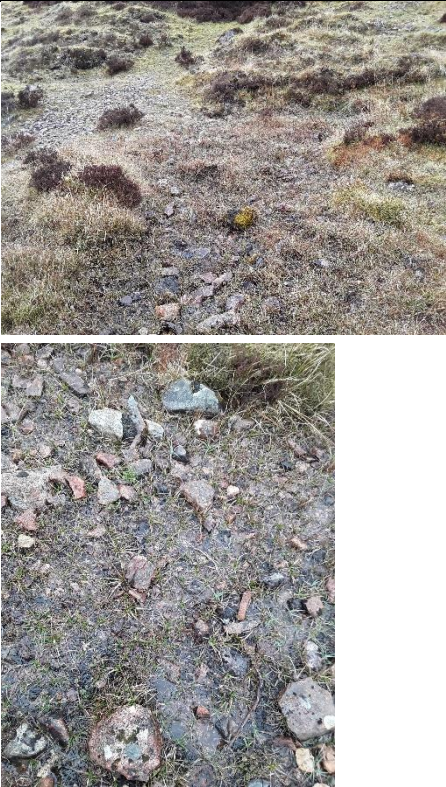
TG	Grid	Note	Photos
244	NM 98689 27046	M11. Potential GWDTE. Including yellow saxifrage.

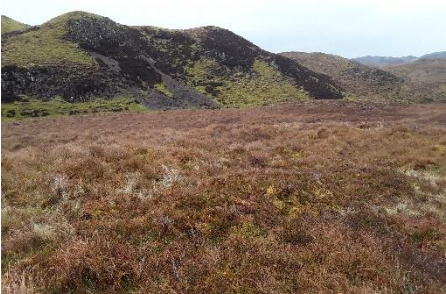
245	NM 98602 27120	Lightly Modified.

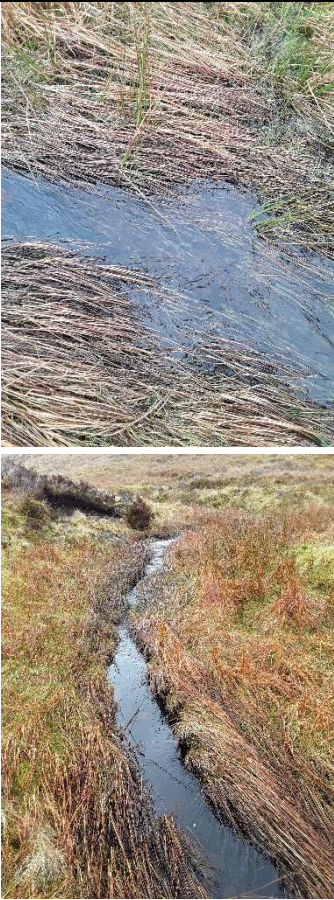
TG	Grid	Note	Photos
247	NM 98471 27029	Fairly clear water coming off this area but some sign of peat staining.

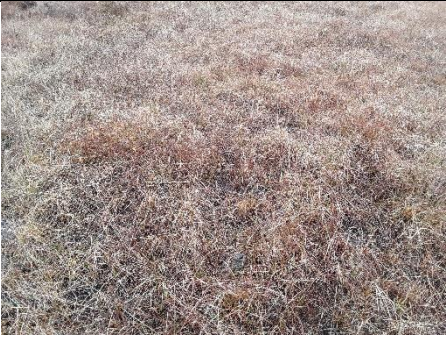
248	NM 98516 26862	Lightly Modified. Very wet, but no pools or surface water. Bog-mosses were abundant. Sheep signs common.

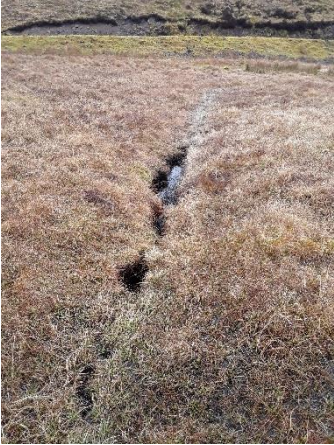
249	NM 98496 26848	Old drainage ditch. It was straight and ca. 0.2 m wide and 0.5 m deep. Some limited drainage still likely.

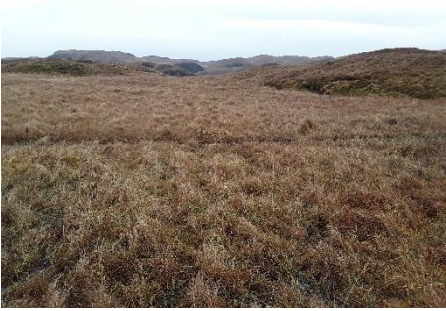
TG	Grid	Note	Photos
250	NM 98561 26550	Lightly Modified. Some soft rush, bog myrtle and bottle sedge (M23) along watercourse.
