**Beinn Ghlas Wind Farm:  
Survey of fish habitats**

Commissioned Report to Alba Ecology Ltd.,

October 2022

**Waterside Ecology**

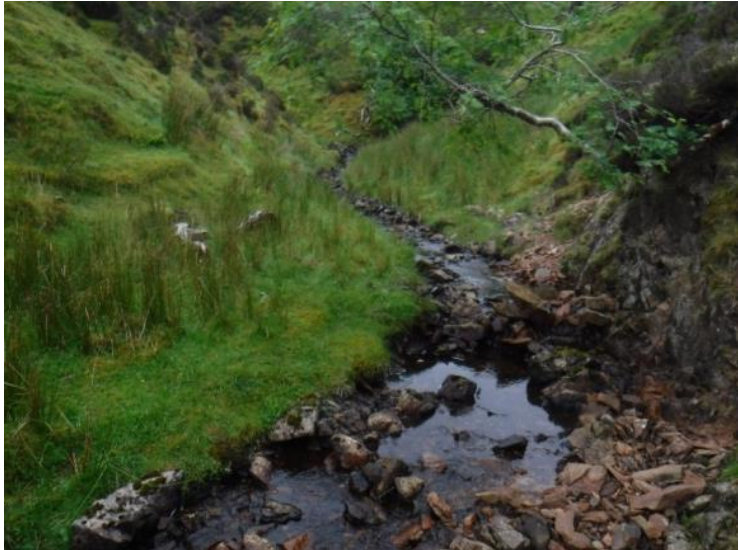
| Stream | Date surveyed | NGR downstream | NGR upstream |
|--|---|--|---|
| <p>Stream A holds some suitable habitat for juvenile trout, but lacks pools or bankside cover for adults. The lower part of the survey reach is around 1 m wide and entrenched between steep banks. Flow is mainly shallow (5-10 cm) run and glide with step-pool sequences. The substrate is a mix of unstable boulder, cobble and pebble with bedrock; bedrock accounts for around 40 % of the substrate. Upstream of the confluence at NM 97842 26855, the tributaries become very small (wet width &lt;80 cm) but still provide some juvenile trout habitat. However no fish were seen anywhere in the survey reach. This stream is a headwater tributary of the River Lonan. Downstream of the survey reach the stream falls steeply through an entrenched wooded ravine, and is highly unlikely to be accessible to fish from further downstream. No fish were seen during the survey.</p> | | | |
| | | <p>Low-Moderate (though potentially fishless).</p> <p>Habitat appears suitable for trout but none were seen during the habitat survey.</p> | |

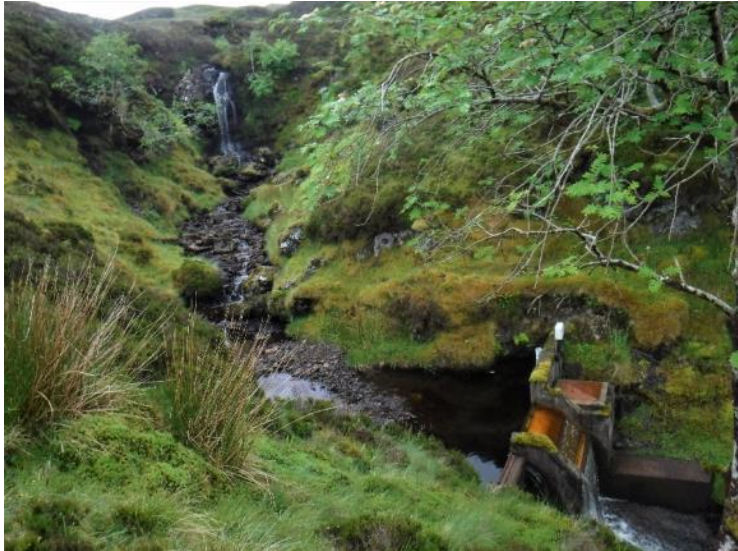
| Stream | Date surveyed | NGR downstream | NGR upstream |
|---|---|--|---|
| <p>Another headwater tributary of the River Lonan, this stream is similar in character to Stream A, with unstable mixed juvenile habitat, shallow flow, and a substrate of bedrock, boulder, cobble and pebble. Wet width is 1-2 m in the lower part of the survey reach, decreasing upstream. As with Stream A, it appears inaccessible from the River Lonan.</p> <p>This stream is dammed at NM 9758 2681, and water is abstracted. The dam is impassable to fish. A short distance upstream of the dam is a waterfall, which at 5 m high is also impassable. Although there is some reasonably good fish habitat in the survey reach, including small amounts of spawning substrate, it is fragmented and due to lack of access from downstream may also be fishless. No fish were seen during the survey.</p> | | | |
| | | <p>Low-Moderate (though potentially fishless).</p> <p>Habitat appears suitable for trout but none were seen during the habitat survey.</p> | |

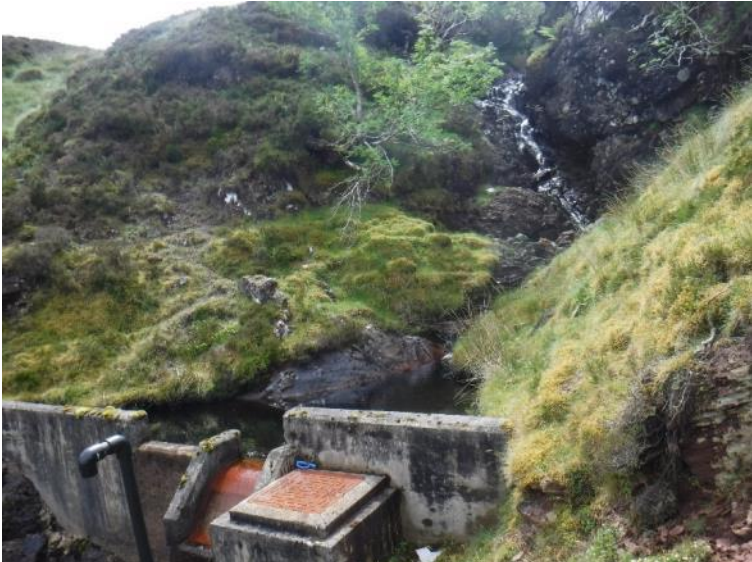
| Stream | Date surveyed | NGR downstream | NGR upstream |
|--|---|--|---|
| <p>Poor, unstable mixed juvenile habitat, with a substrate of angular cobble and boulder with much bedrock. Wet width is 0.8-1.2 m in the lower part of the survey section.</p> <p>This stream is heavily abstracted, with very little compensation flow. The intake dam at NM 9737 2690 is impassable, and there are impassable waterfalls both upstream and downstream of the dam. Even in the unabstracted reach this is a small, steep, shallow stream holding poor quality habitat.</p> <p>Given the fragmentation of the habitat and the heavy abstraction regime, it seems unlikely that this stream is able to support trout. No fish were seen during the survey.</p> | | | |
| | | <p>Low.</p> <p>No fish seen and fish likely to be absent or at very low density.</p> | |

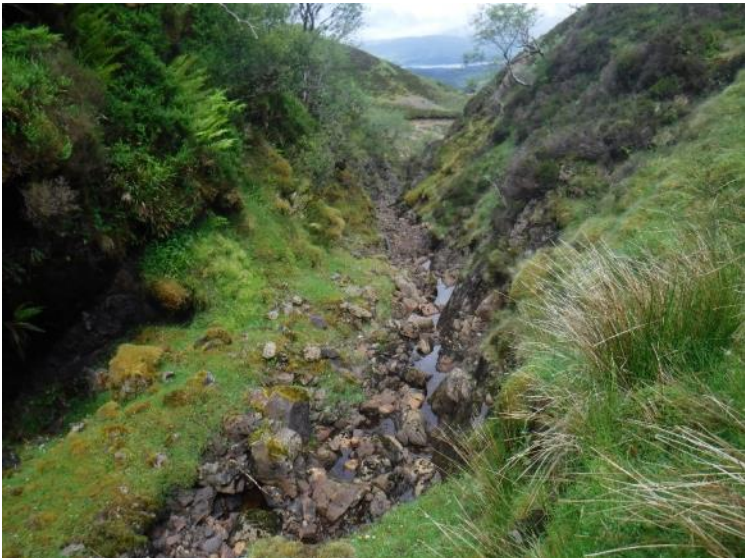
| Stream | Date surveyed | NGR downstream | NGR upstream |
|--|---|--|---|
| <p>Like streams B and C this stream is abstracted, with an intake dam at NM 9701 2706. The watercourse in the survey reach is steep and entrenched between high rocky banks, with a substrate of tumbled boulders and bedrock. At the time of survey there was virtually no compensation flow over or through the dam, and the streambed was largely dry in the abstracted reach.</p> <p>It seems very likely that this stream is fishless</p> | | | |
| | | <p>Low.</p> <p>No fish seen and fish likely to be absent or at very low density.</p> | |

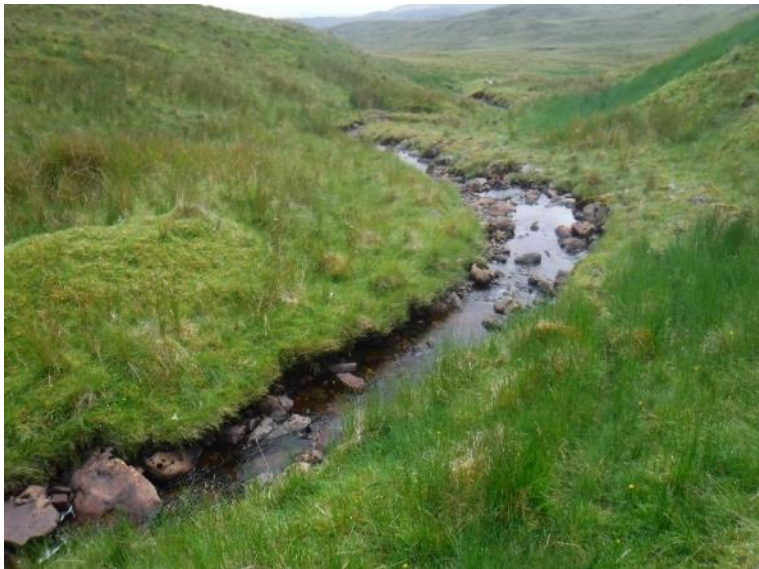
| Stream | Date surveyed | NGR downstream | NGR upstream |
|---|---|--|---|
| Stream E is a tributary of Eas Ruadh, which it joins 300 m upstream of the confluence of Eas Ruadh and Garbh Allt. The lower reaches of the stream are moderate gradient and hold good mixed juvenile trout habitat. The substrate is largely boulder, cobble and pebble, with run flow and shallow pools. Wet width is 1 – 1.5 m. Some overhead cover is available along the banks. A complex of small waterfalls and rock steps at NM 9625 2523 may be impassable under all or most flow conditions. Upstream of this obstacle the stream steepens with step-pool sequences and more frequent obstacles. The stream becomes increasingly entrenched between steep banks and the proportion of bedrock in the substrate increases. No accumulations of spawning substrate were found. Trout were seen in the lower reaches of this stream. | | | |
| | | Moderate. Some good mixed juvenile trout habitat. No substantial areas of spawning substrate. | |

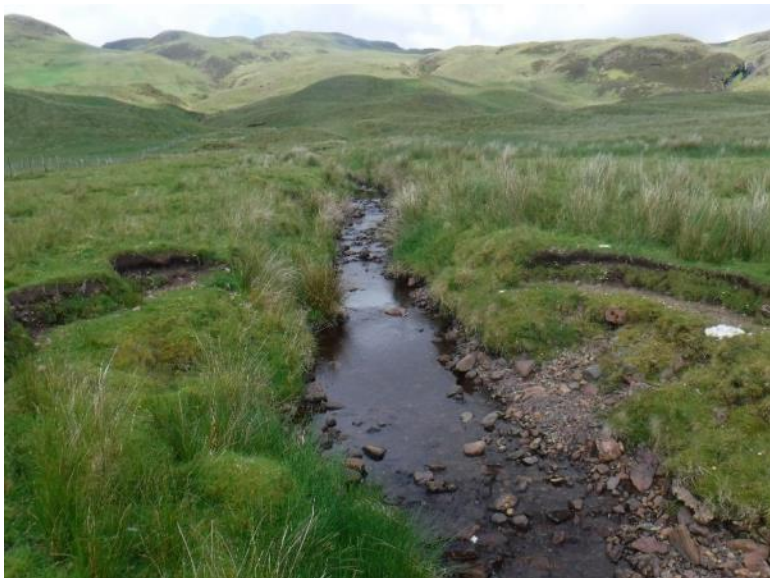
| Stream | Date surveyed | NGR downstream | NGR upstream |
|---|---|--|---|
| Section 1 of Eas Ruadh is immediately outside the red line boundary, and runs from the confluence with Stream E to the confluence with Garbh Allt. This low-gradient reach holds good quality trout habitat, with shallow run and glide flow over a fairly stable substrate of mixed boulder, cobble and pebble. There is plenty of instream and bankside cover. Wet width is between 1.5 and 2 m. Spawning substrate is available in patches but there are no significant spawning accumulations. Trout were seen. | | | |
| | | Moderate-High.<br>Good quality mixed juvenile trout habitat. Small areas of spawning substrate. | |

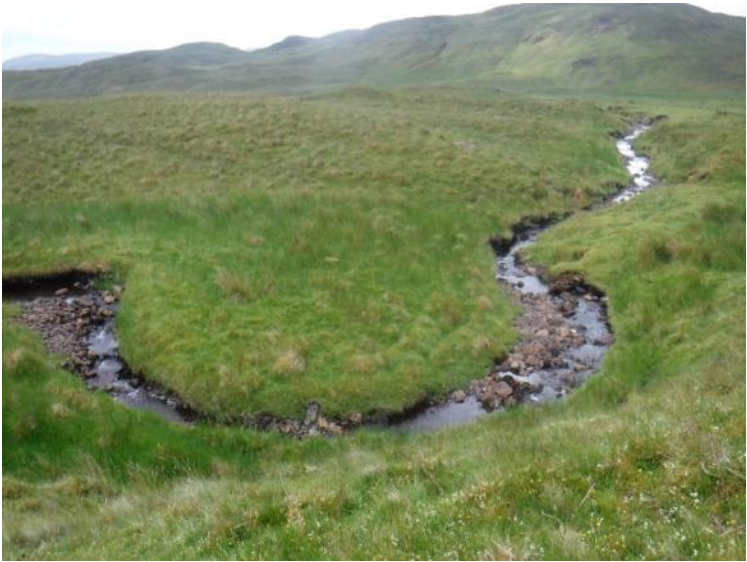
| Stream | Date surveyed | NGR downstream | NGR upstream |
|---|---|---|---|
| <p>The low gradient section of Eas Ruadh upstream of the confluence with Stream E holds good quality mixed juvenile trout habitat with shallow pool and run flow over a fairly stable substrate of mixed boulder, cobble and pebble. There is plenty of good cover among boulders and along banks. Wet width is 1-1.5 m. Small patches of spawning substrate are available. No fish were seen but this reach is accessible from downstream where trout were observed to be present.</p> <p>A 4 m high waterfall at NM 9641 2525, upstream of the confluence with stream F, is impassable. Above the obstacle the gradient increases and the stream becomes deeply entrenched. The substrate is dominated by bedrock, and the stream flows in step-pool sequences with frequent obstacles.</p> | | | |
| | | <p>Moderate-High.</p> <p>Good quality mixed juvenile trout habitat. Small areas of spawning substrate.</p> | |

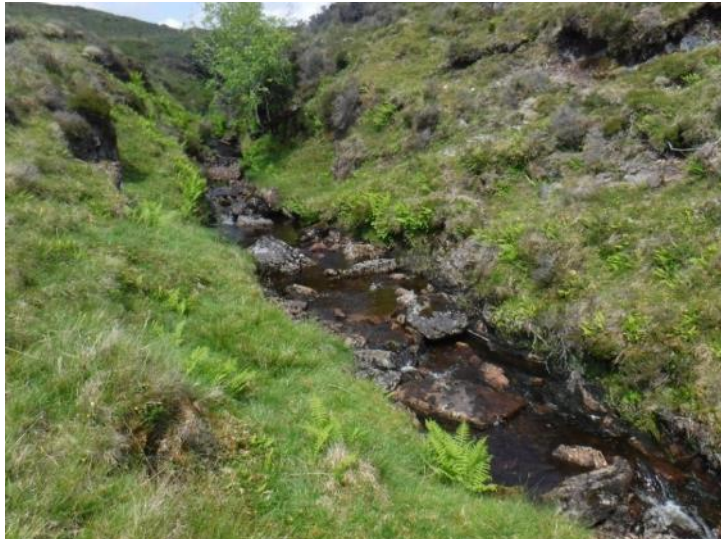
| Stream | Date surveyed | NGR downstream | NGR upstream |
|---|---|---|---|
| Stream F is a tributary of Garbh Allt, but a bedrock cascade at the confluence may be impassable to trout. The habitat is mainly stable mixed juvenile habitat with boulder, cobble and pebble substrate, interspersed with short, steep bedrock sections. The latter are mostly passable, but a substantial bedrock chute at NM 9699 2496 is probably impassable to trout moving upstream. There are frequent small patches of spawning habitat. There are impassable obstacles on both branches upstream of the confluence at NM 97080 25017. Although there is some quite good trout habitat in this stream and spawning substrate is available, the habitat is rather fragmented and probably not connected to the good habitat in Garbh Allt. No fish were seen during the survey. | | | |
| | | Moderate. Some good stable mixed juvenile trout habitat with small patches of spawning substrate, however no fish were seen during the survey and stream appears inaccessible from Garbh Allt. | |

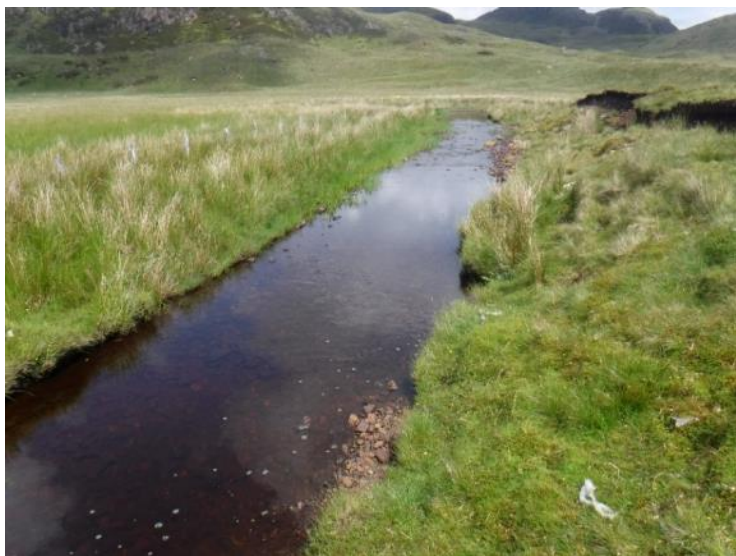
| Stream | Date surveyed | NGR downstream | NGR upstream |
|---|---|--|---|
| Garbh Allt is not within the proposed developable area, however it receives runoff from all the smaller streams draining the southwestern part of the site, and holds very good trout habitat. The stream is mainly 2-4 m wide, with shallow run and glide flow over a substrate of cobble, pebble and boulder. Gradient is shallow in the upper half of the survey reach; the lower half of the reach is a little steeper and more entrenched, with more boulders, some bedrock, and some deeper pool habitat. The lower gradient section holds substantial accumulations of good spawning substrate, amounting to around 20 m <sup>2</sup> , in a series of short runs between NM 96552 24782 and NM 96496 24818. Trout fry were numerous in these areas at the time of the habitat survey. | | | |
| | | Good quality trout habitat, with some important spawning areas. | |

If access can be agreed, we strongly recommend that baseline survey should also include at least one site in Garbh Allt. Although it lies outside the red line boundary it receives run-off from several streams within the site and it was clear from limited observations during the current survey that it supports large areas of good quality trout habitat.

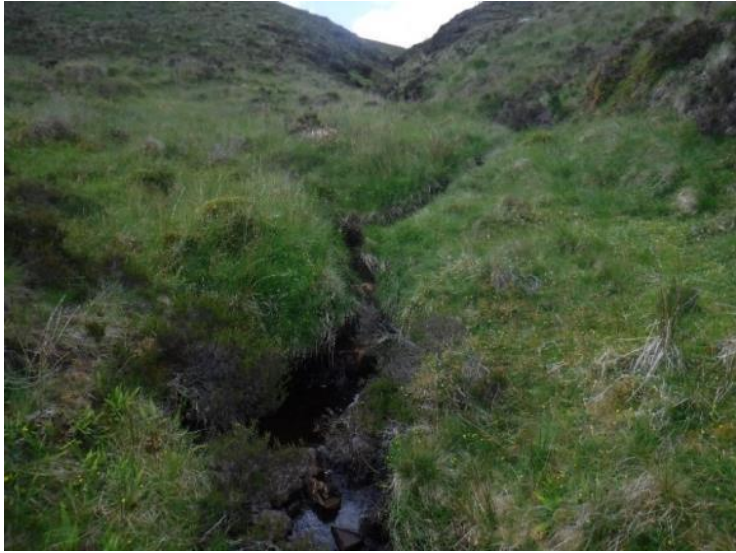
| Stream | Date surveyed | NGR downstream | NGR upstream |
|--|---|--|---|
| This is a very small first order stream. Much of it is peat channel or dispersed flow through boggy ground, making it largely unsuitable for fish. There is a short reach of mixed juvenile habitat upstream of the main boggy area, but this is broken by frequent obstacles, and its lack of connectivity to better habitat downstream makes it unlikely to support fish. No fish were seen during the survey. | | | |
| | | Low.<br>No fish seen, likely to be absent. | |

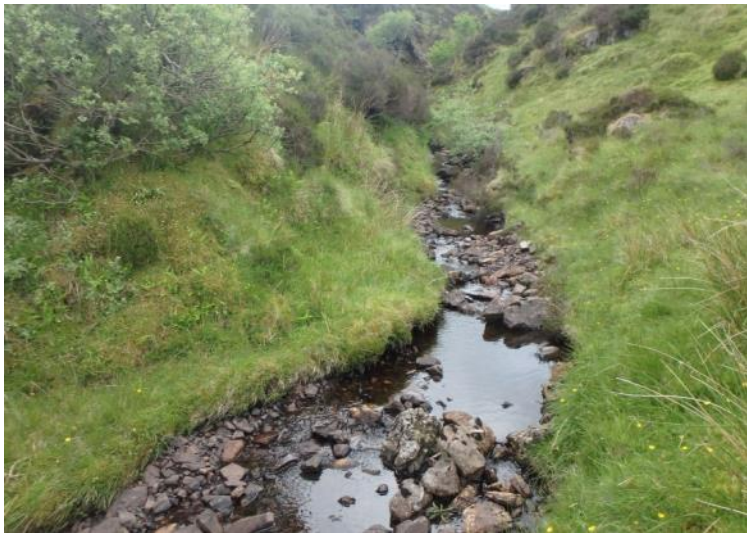
| Stream | Date surveyed | NGR downstream | NGR upstream |
|---|---|---|---|
| This stream flows into Laggan Burn at NM 9892 2524 (outside the red line boundary). The survey commenced approximately 0.5 km upstream of Laggan Burn and extended for 150 m up to the confluence of the two headwater channels. It is not known if the surveyed reach is accessible from Laggan Burn. The stream has a typical wet width of 1 m and a bed width of 1.3 m. Shallow pools are linked by little runs and steps. No obstacles are present in the section and habitat appeared well suited to trout. However, despite the low, clear water no fish were seen. Depth at the time of survey was typically 5 to 15 cm. No spawning habitat was recorded and substrates are predominant cobble, boulder and pebble. | | | |
| | | Low - moderate (though potentially fishless).<br>Suitable habitat for trout but no fish seen. Lacks spawning substrate. | |

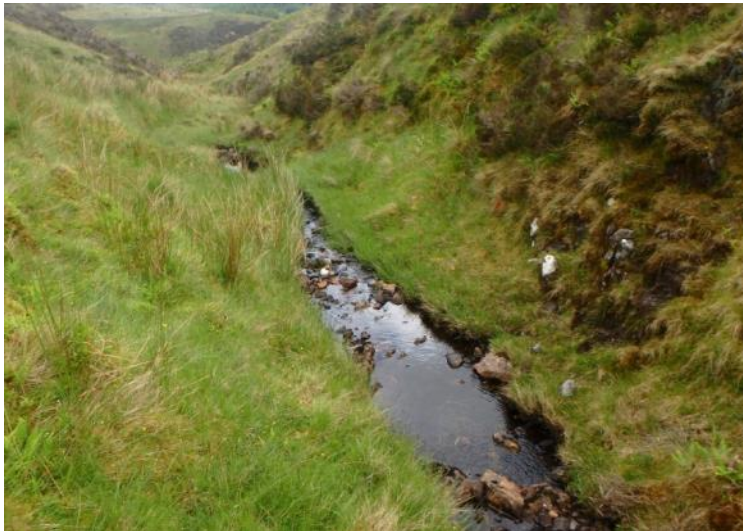
| Stream | Date surveyed | NGR downstream | NGR upstream |
|---|---|---|---|
| This is the western fork of the headwaters of Stream H. It is a small, first order stream. A series of cascades at NM 9852 2548 renders it inaccessible from section 1. There are several further impassable obstacles up to 2 m in height through the survey section. Depth is mainly 5 to 10 cm and the channel has a typical wet width of 0.5 m. It is entrenched and substrate is bedrock-dominated. Habitat quality for trout or eels is very poor due to lack of depth and cover and no fish were seen. No spawning habitat was recorded. | | | |
| | | Low.<br>Inaccessible and bedrock-dominated. | |

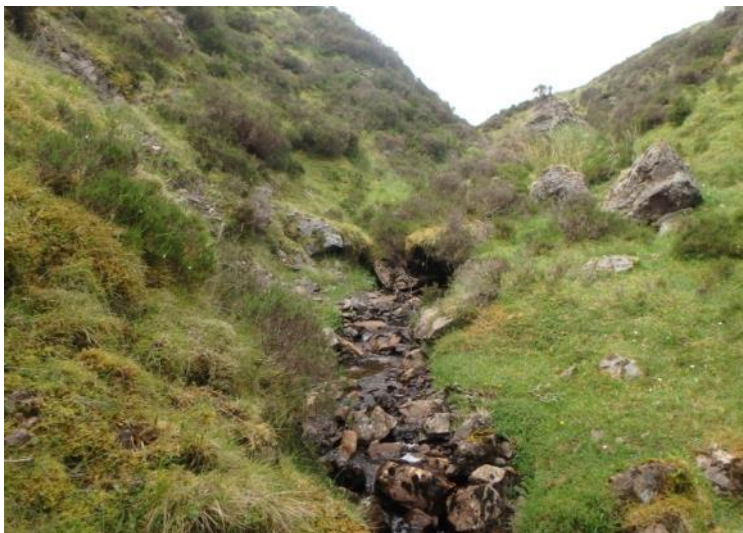
| Stream | Date surveyed | NGR downstream | NGR upstream |
|---|---|--|---|
| This is the north fork of the headwaters of tributary 3. It is a small, first order stream. Depth at the time of survey was mainly less than 5 cm. Substrates are largely boulder and bedrock. The channel appears unsuited to fish production. | | | |
| | | Low.<br>Very poor quality habitat. Much bedrock.<br>Almost certainly fishless. | |

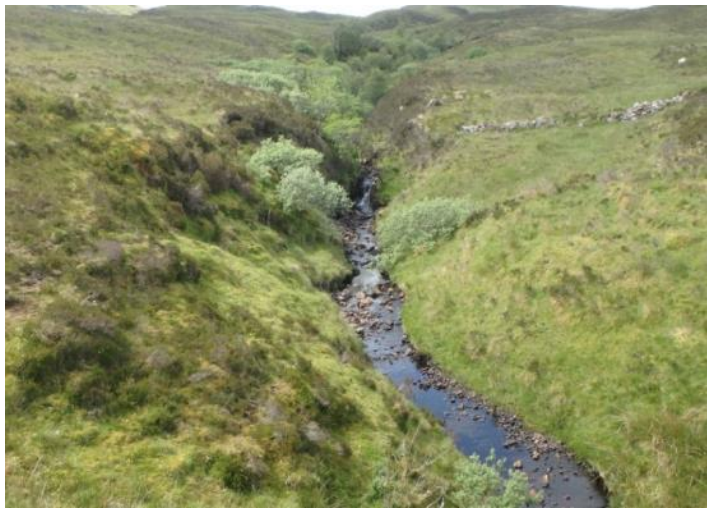
| Stream | Date surveyed | NGR downstream | NGR upstream |
|---|---|---|---|
| <p>This stream flows into Laggan Burn at NM 9876 2601. Immediately upstream of the confluence it passes through a culvert, which seems likely to be passable at moderately elevated flows. A longer culvert at NM 9866 2605 also appears passable. The first 200 m of stream above the confluence are stony mixed juvenile habitat with runs and glides, as pictured below. Upstream of this the channel is deeply entrenched between bedrock banks. Between NM 9860 2608 and NM 9854 2613 there are several rocks steps up to 0.8 m high. These lack plunge pools and appear impassable, so any fish entering the stream from Laggan Burn are likely to be restricted to the first 200 to 250 m of channel. The stream has a wet width of 1.0 to 1.5 m. At the time of survey water depth was mainly between 5 and 15 cm, with pools to 30 cm. Substrate in the lower 200 m is mainly angular, unstable cobble and pebble. There is a high proportion of bedrock in the entrenched reaches further upstream. Overall habitat quality for juvenile trout – both fry and parr - was judged to be moderate. Spawning habitat is lacking, as are suitable pools for adult trout.</p> | | | |
| | | <p>Low to moderate.</p> <p>Small, limited access due to natural obstacles. No fish seen. If present, trout are likely to be at low density.</p> <p>Inaccessible to migratory salmonids.</p> | |

| Stream | Date surveyed | NGR downstream | NGR upstream |
|---|---|---|---|
| | | <p>No specific sensitivities in section.</p> <p>Downstream impacts into better reaches of Laggan Burn should be avoided.</p> | |

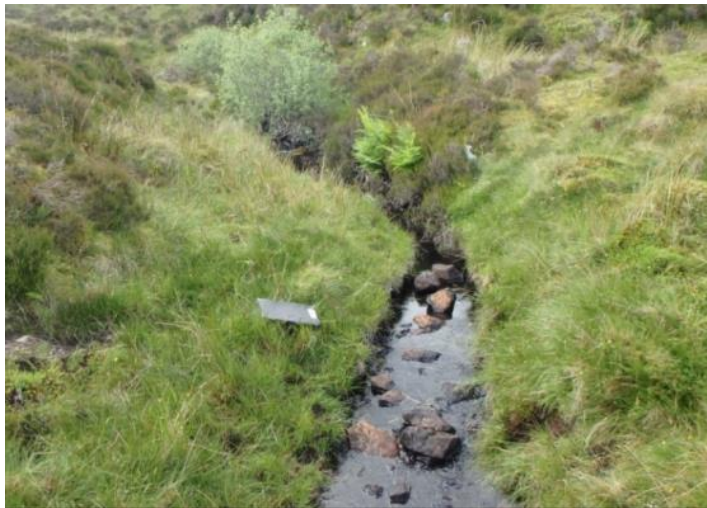
| Stream | Date surveyed | NGR downstream | NGR upstream |
|---|---|---|---|
| <p>Upstream of the entrenched reach described above the gradient eases and the stream meanders through a 1 m wide channel in rough pasture. Flow types are run, glide and pool sequences. Depth throughout is mainly between 5 and 10 cm with pools to 30 cm. Small patches of gravel and pebble are present and would permit spawning. A short distance downstream of the existing track at NM 9834 2604 the gradient increases and the stream becomes entrenched with a substrate of embedded boulder and little bedload. This appears to be the limit of any potentially productive fish habitat. As it is small and shallow the stream is probably best suited to trout fry. However no fish were seen and trout, if present, seem likely to persist at very low density.</p> | | | |
| | | <p>Low - moderate (though potentially fishless).</p> <p>Habitat appears suited to trout but none seen. Obstacles near downstream end of section.</p> <p>Inaccessible to migratory salmonids.</p> | |

| Stream | Date surveyed | NGR downstream | NGR upstream |
|---|---|---|---|
| | | <p>No specific sensitivities in section.</p> <p>Downstream impacts into better reaches of Laggan Burn should be avoided.</p> <p>Any crossings/culverts should be passable unless fish shown to be absent.</p> | |

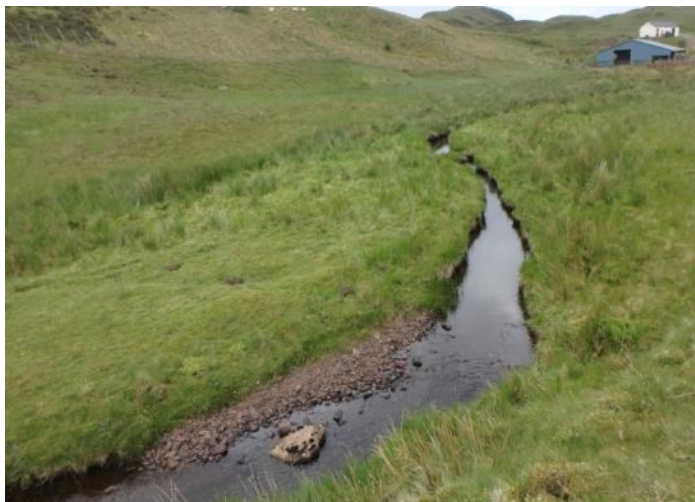
| Stream | Date surveyed | NGR downstream | NGR upstream |
|---|---|---|---|
| Laggan Burn, section 1 | 23/06/2022 | NM 98826 25802 | NM 98621 26275 |

| Stream | Date surveyed | NGR downstream | NGR upstream |
|---|---|---|---|
| <p>Laggan Burn flows directly into Loch Nant. This survey section is approximately 1 km upstream of Loch Nant. Here gradient is moderate and the stream meanders through heavily-grazed rough pasture. Flows comprise glide, riffle and run sequences. Depths are typically between 5 and 20 cm with shallow pools to 50 cm. Substrates are mainly of cobble and pebble with some gravel. There is good spawning potential at tails of pools and glides. Undercut turf provides cover for trout alongside the banks. Larger cover for eels is poor. Wet width ranges from 1 to 2 m. The upstream end of the survey section is a 30 m long section of steep, entrenched, boulder filled channel. At the time of survey there was no surface flow and this presented an impassable obstacle to upstream fish movement. It was judged likely to be permanently impassable, even at high flow, due to extreme turbulence and the presence of numerous rock-steps and sumps.</p> | | | |
| | | <p>Moderate</p> <p>Trout appeared plentiful. Good spawning potential.</p> <p>Inaccessible to migratory salmonid species due to waterfalls in the River Nant.</p> | |

| Stream | Date surveyed | NGR downstream | NGR upstream |
|---|---|---|---|
| | | <p>Presence of good quality spawning habitats at pool tails. Good juvenile trout habitats.</p> <p>Some areas of rapid bank erosion – these should not be exacerbated e.g. by damage from heavy machinery.</p> <p>Any crossings must be passable for fish.</p> | |

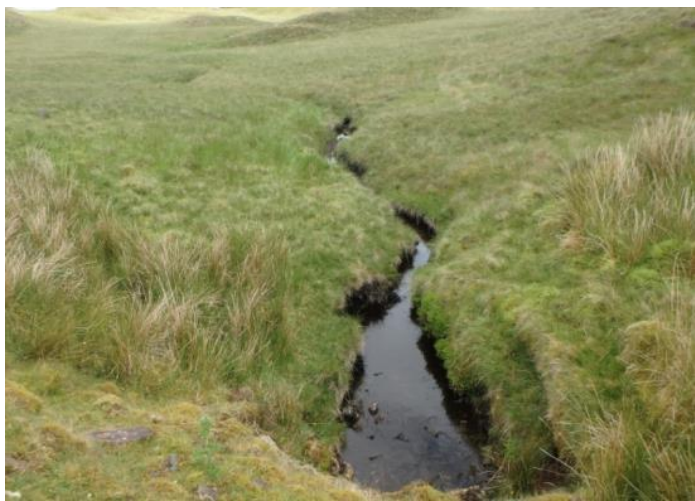
| Stream | Date surveyed | NGR downstream | NGR upstream |
|--|---|---|---|
| Laggan Burn, section 2 | 23/06/2022 | NM 98621 26275 | NM 98913 26784 |

| Stream | Date surveyed | NGR downstream | NGR upstream |
|--|---|---|---|
| <p>Upstream of the dry streambed described above, the stream is around 1 m wet width. Flow types are mainly run and glide with substrates of cobble and pebble. Depth 10 to 15 cm with pools to 40 cm. The stream passes under the existing track via a pipe culvert (NM 9868 2615) that appears passable. Upstream of the track the channel has a very low gradient and is incised between vertical banks of peat/soil. Width varies from 0.5 to 1.0 m. Flow types are mainly glide with some runs and shallow pools. Small substrates predominate and there appears to be little bedload. Many of the soft substrate reaches are filled with vegetation. Upstream of the confluence at NM 9890 2678 both forks flow partially beneath the turf. No well-defined spawning areas were recorded but pockets of gravel are present in runs that could permit spawning by trout. Instream cover is provided by vegetation and overhead cover from undercut banks is plentiful. However no fish were seen.</p> | | | |
| | | <p>Moderate (though potentially fishless).</p> <p>Habitat appears suited to trout but none seen upstream of impassable obstacle at bottom of section.</p> <p>Inaccessible to migratory salmonids.</p> | |

| Stream | Date surveyed | NGR downstream | NGR upstream |
|--|---|---|---|
| | | <p>No specific sensitivities in section.</p> <p>Downstream impacts into better reaches of Laggan Burn should be avoided.</p> <p>Soft banks potentially prone to damage from machinery.</p> <p>Any crossings/culverts must be passable for fish unless shown to be absent.</p> | |

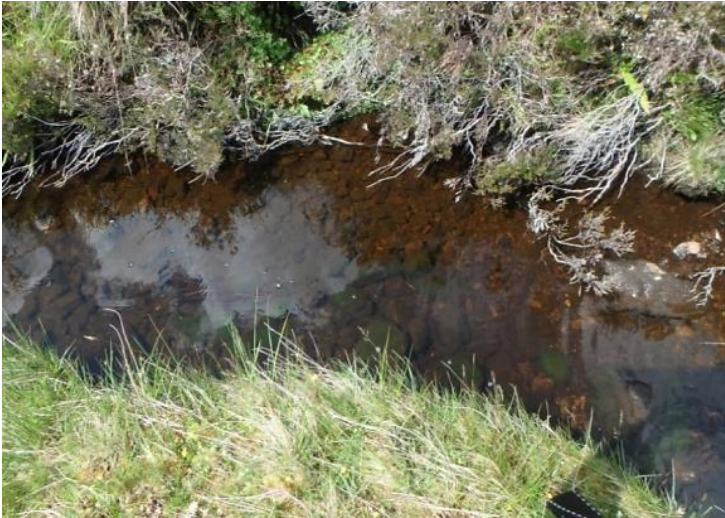
| Stream | Date surveyed | NGR downstream | NGR upstream |
|---|---|--|---|
| <p>This stream flows from Loch Bealach an Fiodhain to enter Laggan Burn at NM 9877 2603. It is a small stream with a wet width typically ranging from 0.4 to 1.0 m. A 2 m high cascade at the confluence with Laggan Burn includes steep steps lacking plunge pools and appears impassable for upstream migrants. Dominant substrate types are cobble and pebble with scattered boulders and a few patches of bedrock. Depth is typically 10 to 25 cm. The banks are stable with turf overlying boulders. Some overhead cover is present. No substantial areas of spawning habitat were recorded but small patches of gravel and pebble are widespread and would provide spawning opportunities for resident trout.</p> <p>Trout were seen at several locations during the survey. Habitat quality for trout fry was judged moderate to good. Habitat quality for larger parr is moderate as the survey reach is largely shallow. Some cover for eels is present.</p> | | | |
| | | <p>Moderate</p> <p>Habitat is well suited to trout, which are present.</p> <p>Inaccessible to migratory salmonids.</p> | |

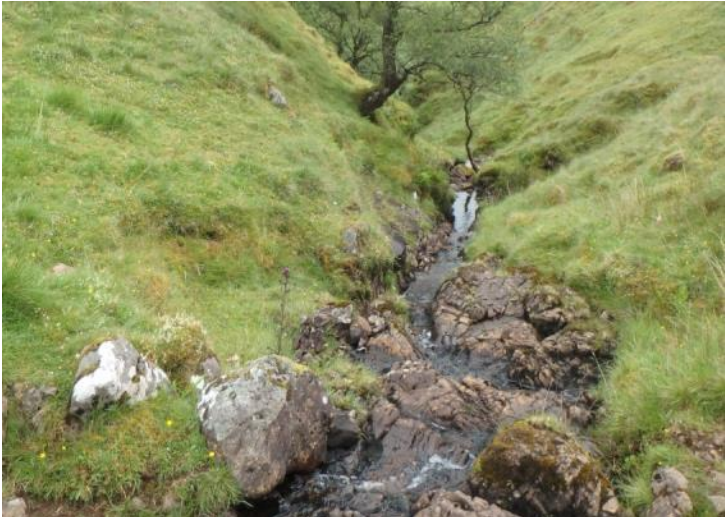
| Stream | Date surveyed | NGR downstream | NGR upstream |
|---|---|--|---|
| <p>Wet width 0.4 to 0.9 m. Depth typically 5 to 15 cm. Lower 250 m of surveyed reach are entrenched with much bedrock. A reach of dry streambed some 70 m up from the bottom of the survey section appears impassable. Other substrates mainly angular, shattered cobble and pebble. Bank faces steeply sloping with some bedrock. There is little or no overhead cover alongside the banks. Upstream of NM 9847 2704 the gradient decreases and the stream meanders through rough pasture. Flow types are runs (depth ~5 cm) and little pools to 20 cm deep. Undercut turfs provide overhead cover.</p> <p>No fish were seen in the stream. No discrete areas of spawning habitat were recorded. Habitat quality for trout was judged to be poor, both for fry and parr and reach is inaccessible. Little cover is available for eels.</p> | | | |
| | | <p>Low.</p> <p>No fish seen and fish likely to be absent or at very low density.</p> | |

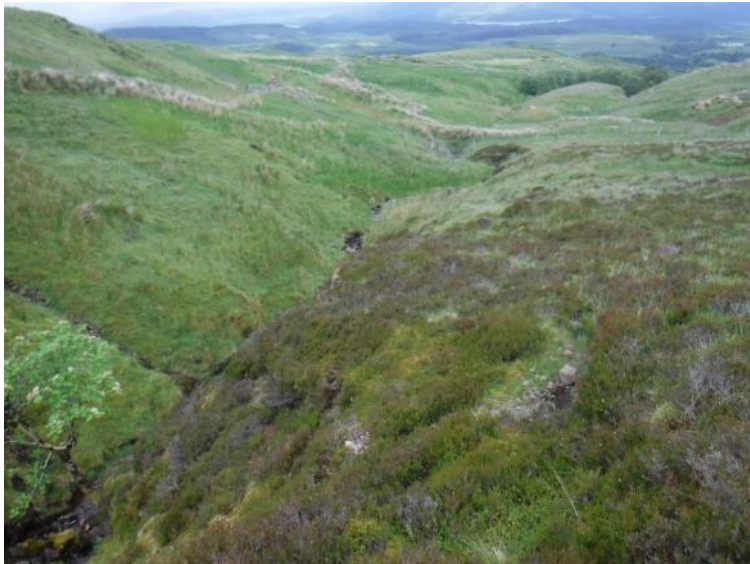
Stream C

NM 9741 2694, looking downstream.

Shallow mixed juvenile habitat; entrenched.

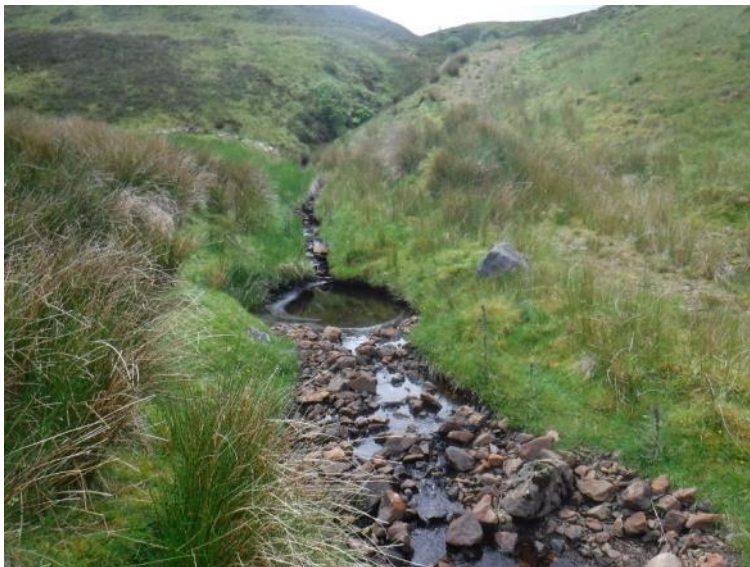
Stream D

NM 9707 2732

Mixed juvenile habitat; very heavily abstracted.

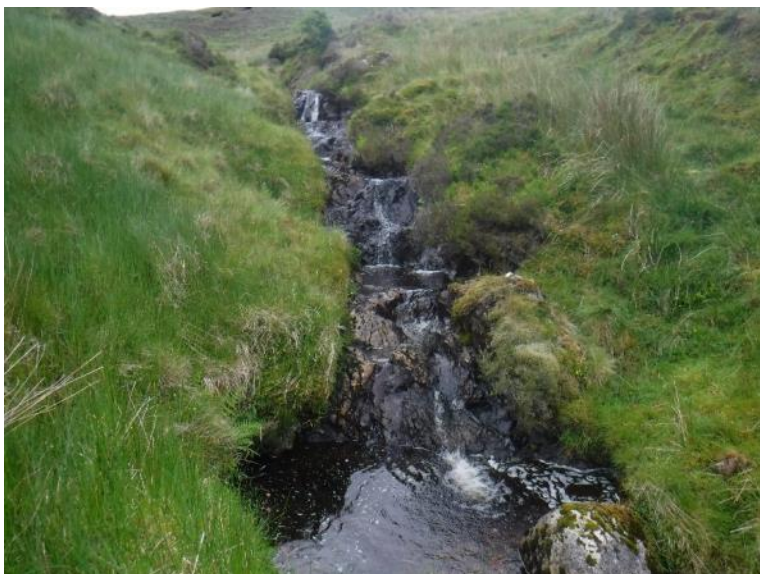
Stream E

NM 9641 2525

Series of obstacles at point where stream begins to steepen. Probably impassable in most flows due to shallow plunge pools

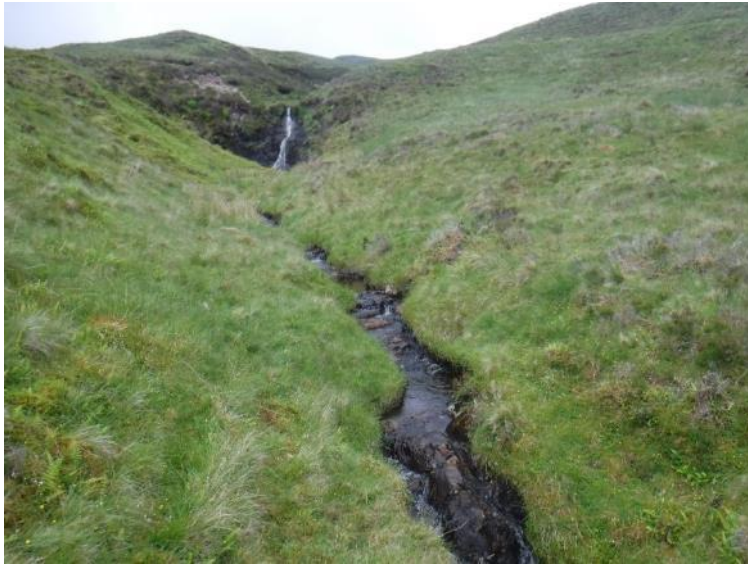
Eas Ruadh, section 2

NM 9651 2523

Narrow stream with much bedrock.  
Waterfall in background is 4 m high  
and impassable for trout.

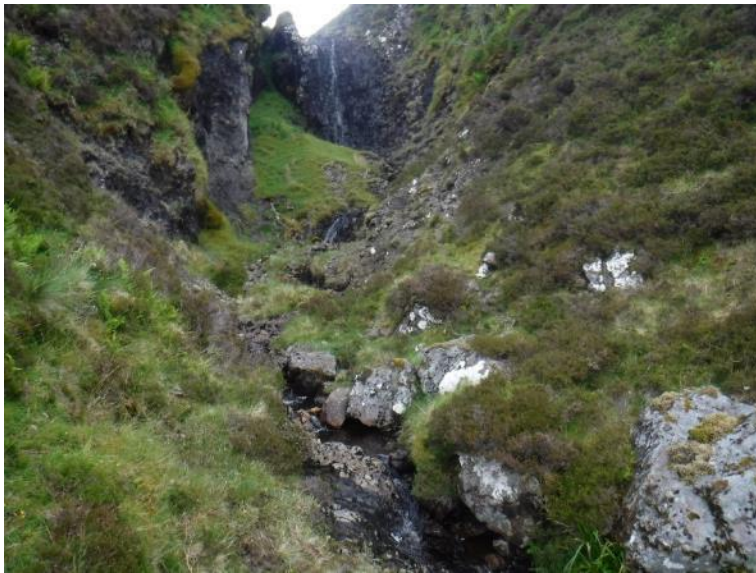
Stream F

NM 9651 2524

The stream rises steeply to an  
impassable 8 m high waterfall.

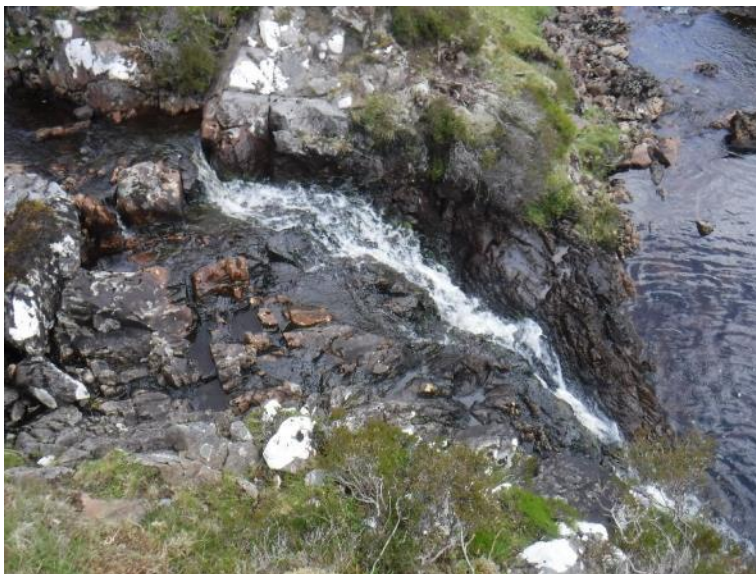
Stream G

NM 9680 2466

Impassable obstacle at confluence  
with Garbh Allt

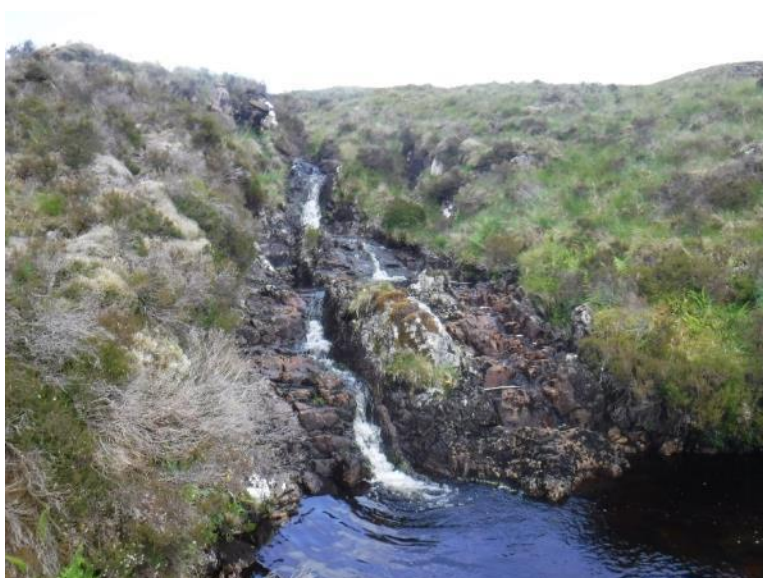
| | <p>Stream G<br/>NM 9699 2496<br/>Impassable obstacle</p> |

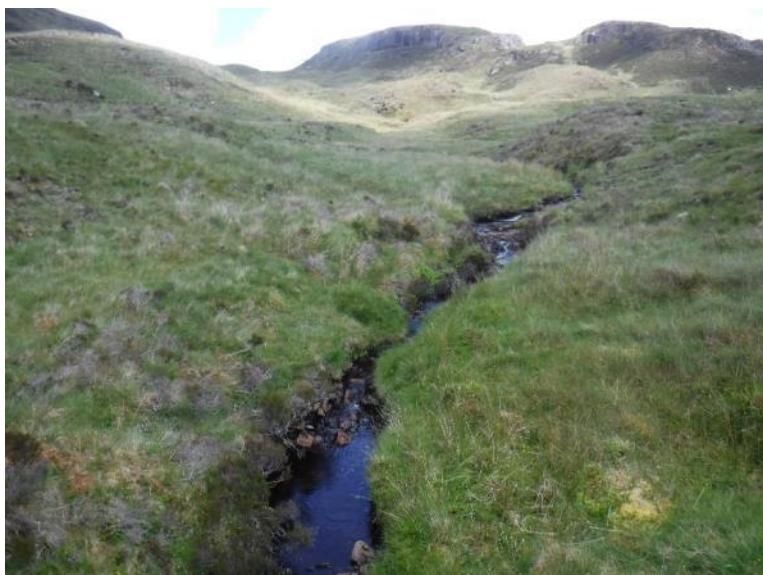
| | <p>Stream G<br/>NM 9699 2496<br/>Immediately upstream of obstacle in above photo: mixed juvenile habitat</p> |

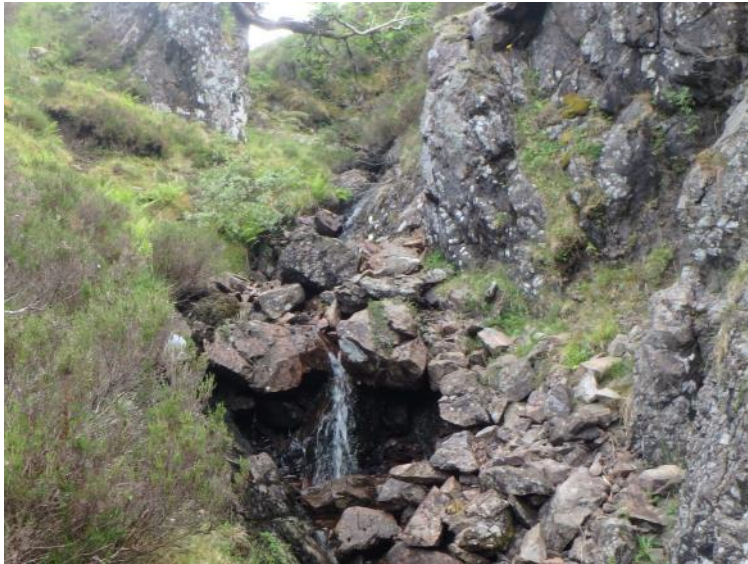
Stream I, section 2

NM 9852 2548

Impassable cascades at downstream end of section.

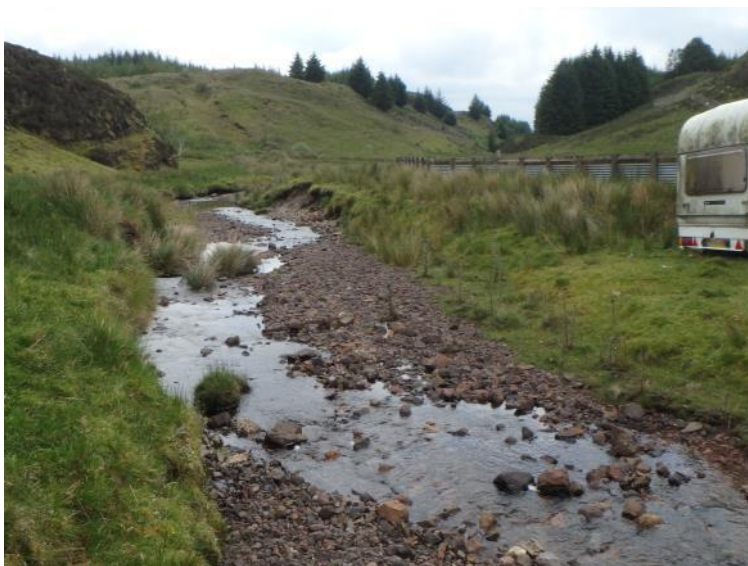
Laggan Burn, section 1

NM 9877 2601

Rapid erosion of bank faces, deposition on point bars.

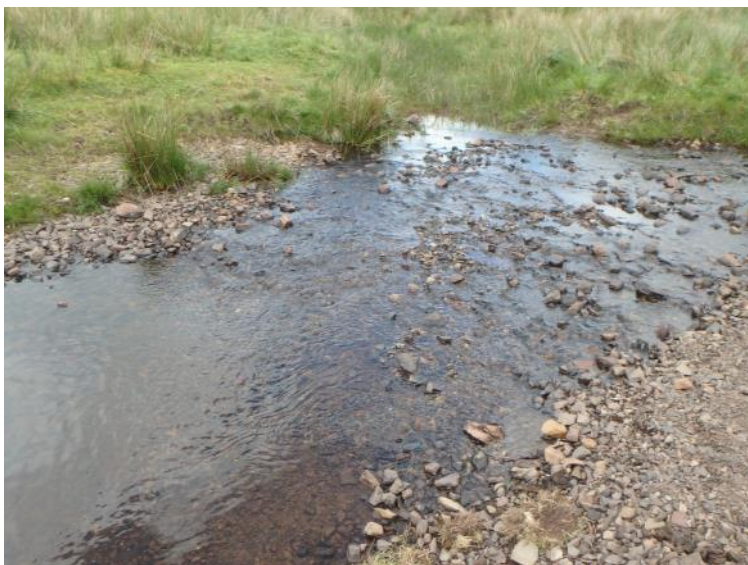
Laggan Burn, section 1

NM 9879 2592

5 m<sup>2</sup> of spawning habitat at tail of glide

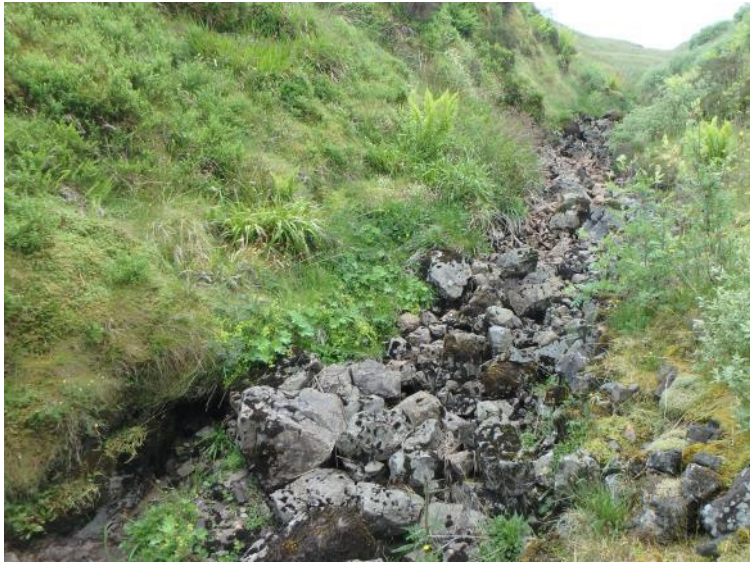
Laggan Burn, section 1

30 m of steep, dry stream bed. Likely to be permanently impassable due to sums and rock-steps.

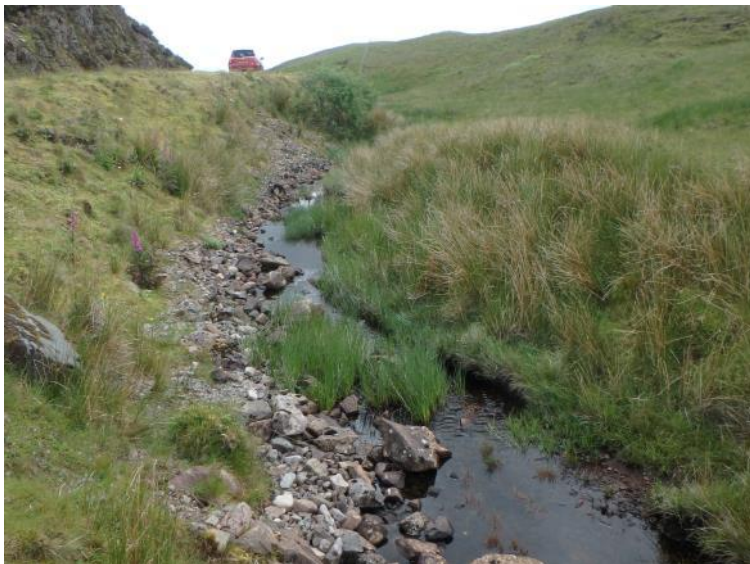
Laggan Burn, section 2

Looking downstream at NM 9891 2678  
Shallow mixed juvenile habitat

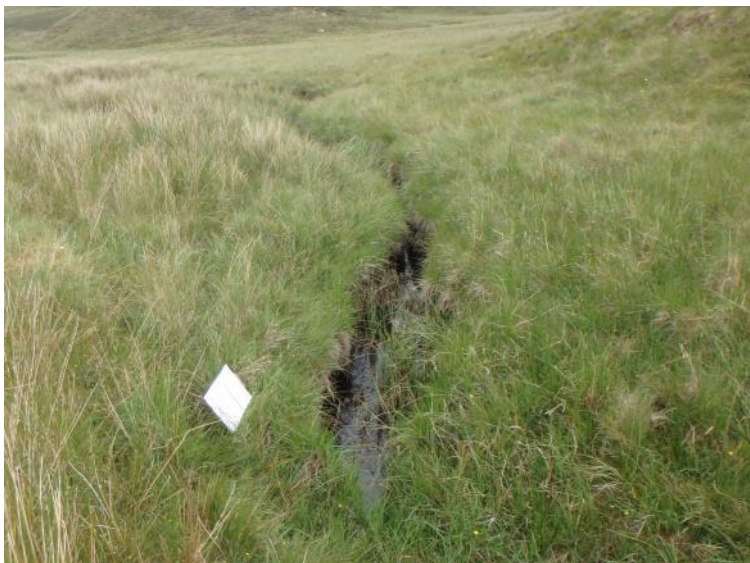
Laggan Burn, section 3

NM 9873 2664

Narrow channel with soft sediments,  
partly filled with vegetation

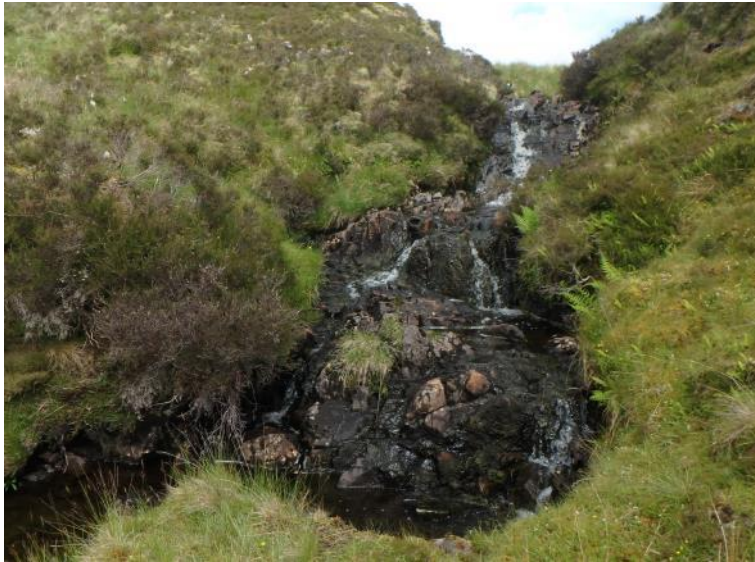
Stream J

NM 9878 2604

Cascade immediately upstream from Laggan Burn confluence. Total height approximately 2 m. Highest vertical step is 1.3 m.

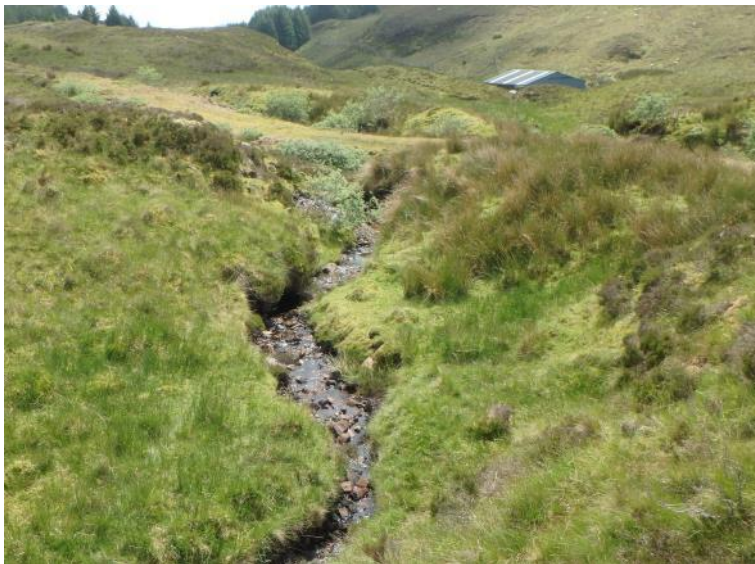
Stream J

NM 9880 2616

Looking downstream towards Laggan Burn

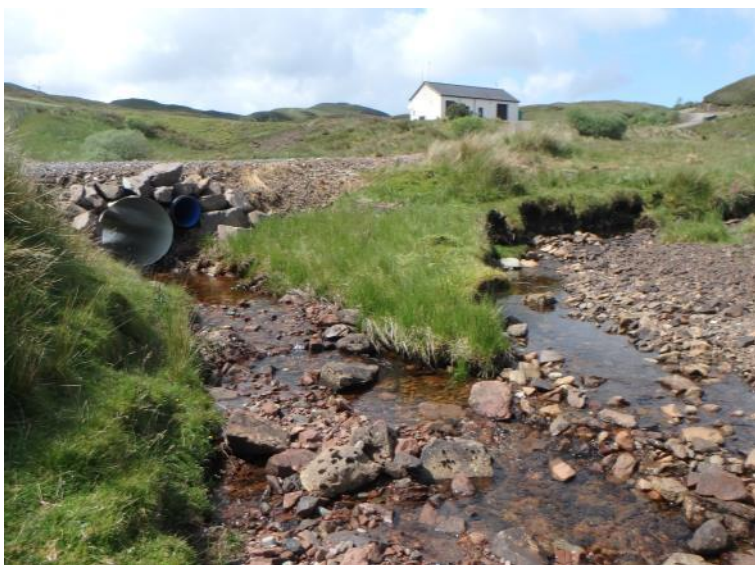
Stream I, section 1

NM 9875 2600

Confluence with Laggan Burn. Stream I flows beneath the track through the culvert.

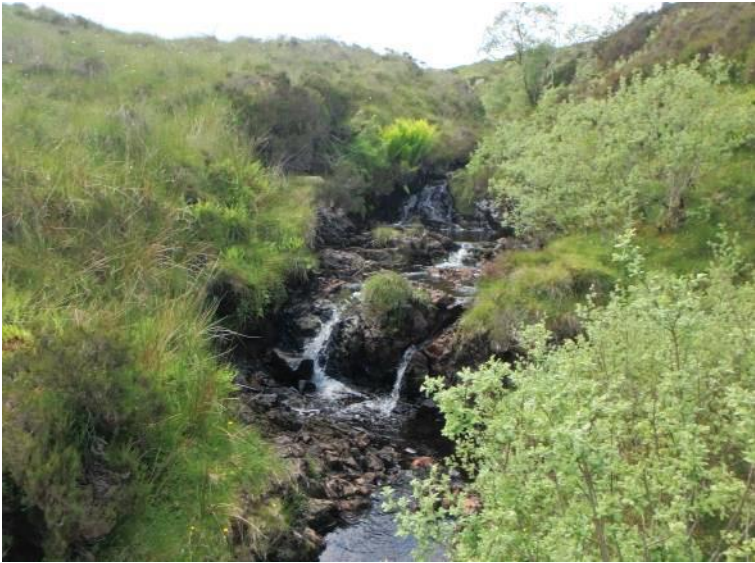
| | <p>Stream I, section 1</p> <p>NM 9854 2613</p> <p>Entrenched with rock steps. Height of pictured step is approximately 0.8 m. No plunge pool (falls onto bedrock slab).</p> |

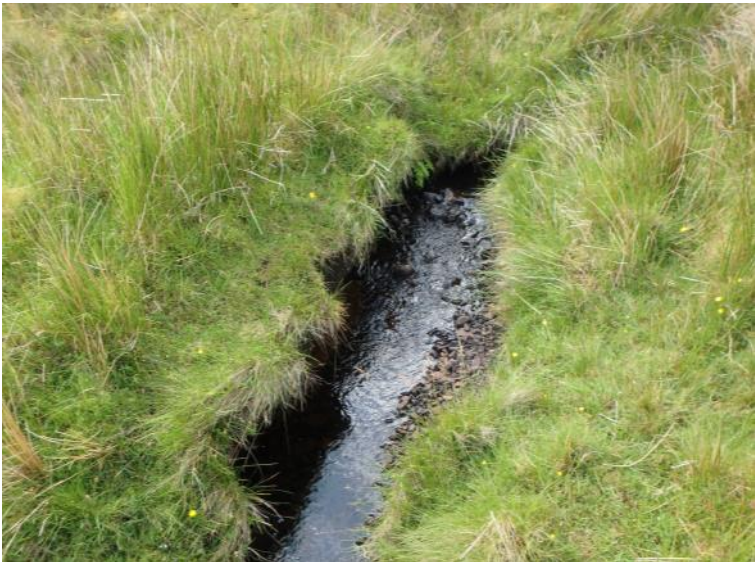
| | <p>Stream I, section 2</p> <p>NM 9834 2604</p> <p>Typical shallow habitat. Some spawning potential but no fish seen.</p> |

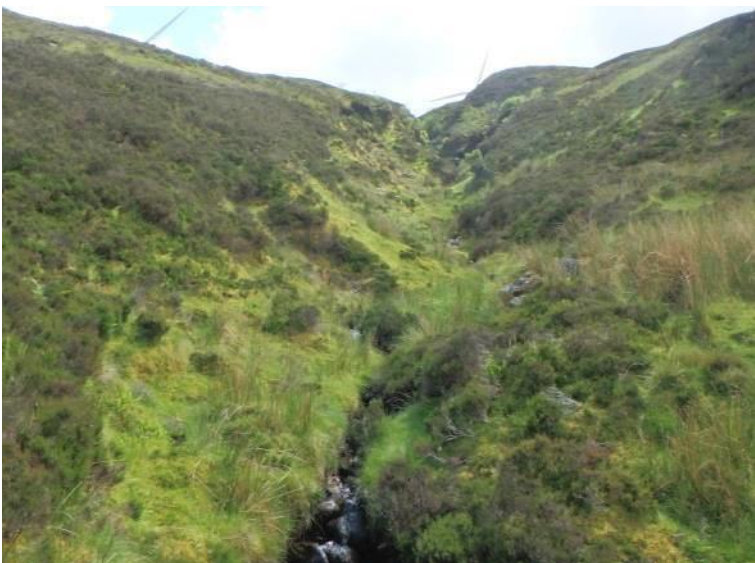
| | <p>Stream I</p> <p>NM 9804 2604</p> <p>Looking upstream: entrenched first order stream with little productive potential.</p> |

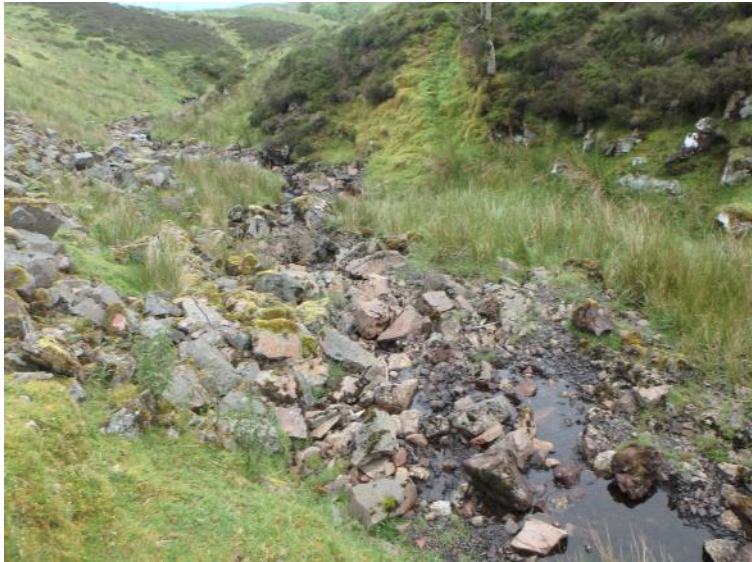
Allt Nathais  
NM 9837 2719  
Section of partially dry streambed.
