**Beinn Ghlas Wind Farm:  
Survey of fish habitats**

Commissioned Report to Alba Ecology Ltd.,

October 2022

**Waterside Ecology**

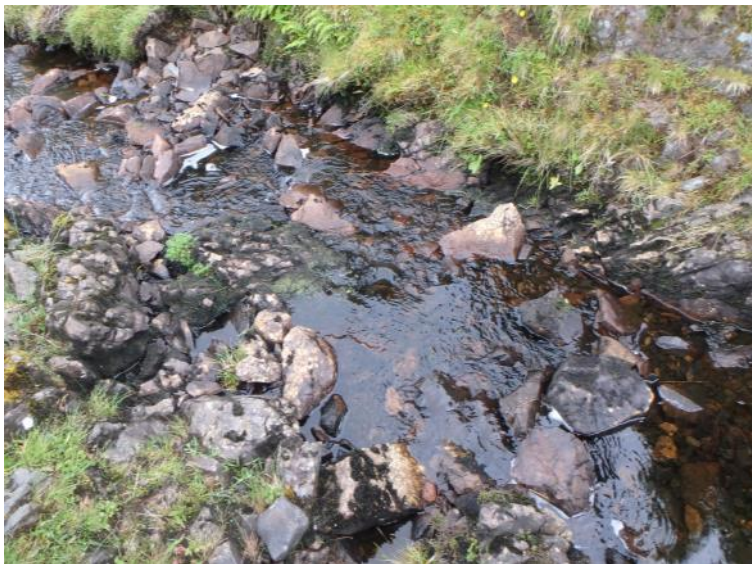
Allt Nathais  
NM 9843 2709  
Typical stream habitat in better areas  
– 5 to 10 cm deep with cobble  
substrate.

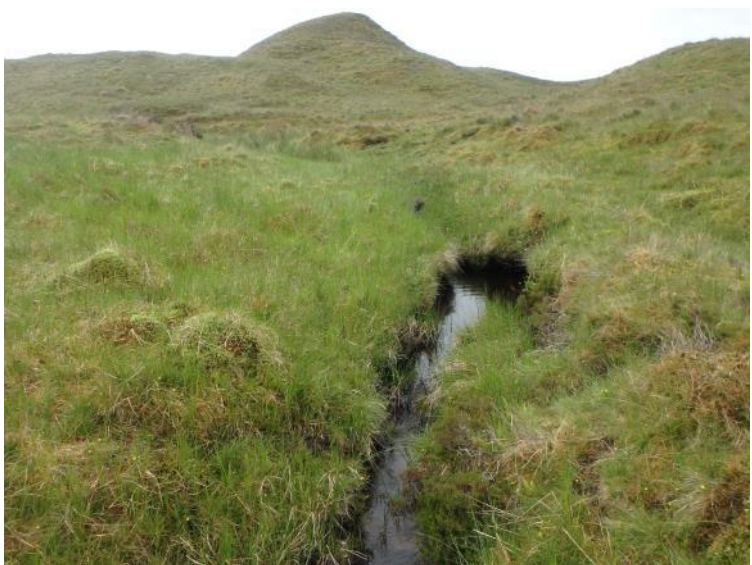
Allt Nathais  
NM 9847 2704  
Low gradient meanders in rough  
pasture. Partly filled with emergent  
vegetation. Some flow beneath turf.
