## Appendix 8.4 Peat Landslide Hazard and Risk Assessment Beinn Ghlas Wind Farm Repowering

Argyll & Bute, Scotland  
Nadara Ltd

22-FEC-023-D-001v03

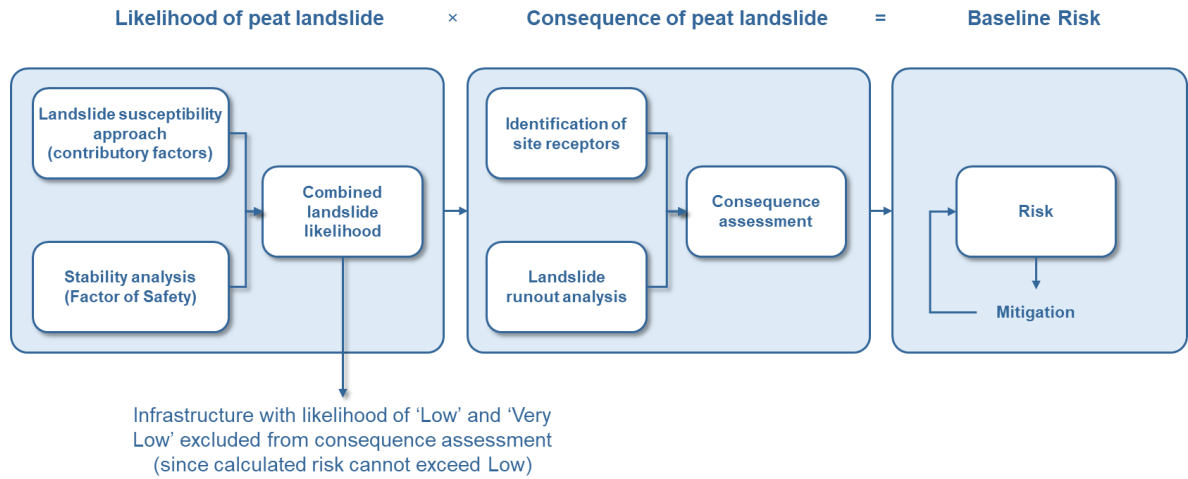
To reflect these limitations, both approaches are adopted and outputs from each approach integrated in the assessment of landslide likelihood. **Error! Reference source not found.** Plate 1.2 shows the approach:

**Plate 1.2 Risk assessment approach**

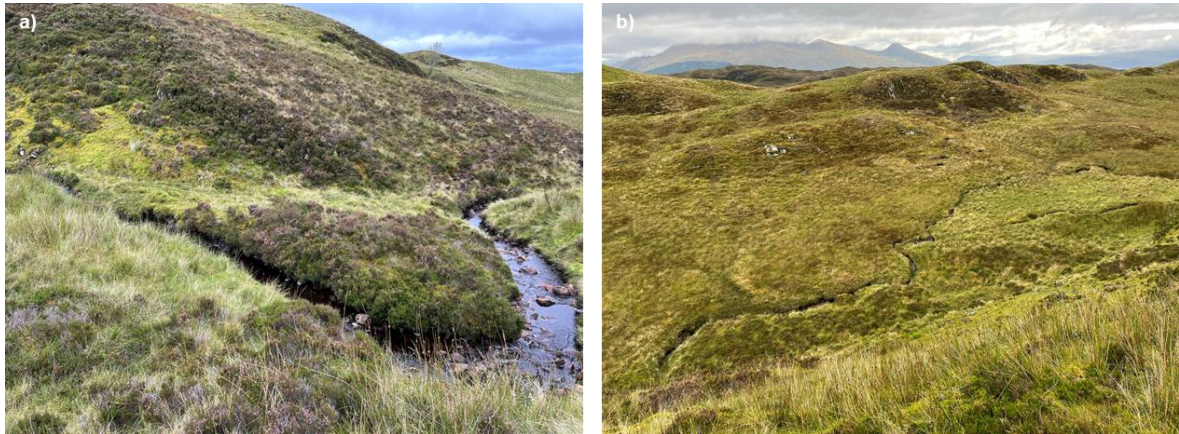
**Plate 3.2 a) a minor un-named watercourse, b) a summit headwater tributary of Garbh Allt**

Along the northeast side of the Site, a series of minor watercourses fall northeast, the southernmost joining Laggan Burn and the northern watercourses being unnamed tributaries of the River Lonan. Watercourses are relatively minor in cross-section and have little capacity to convey material, even in their lower reaches (see Plate 3.2 for examples).

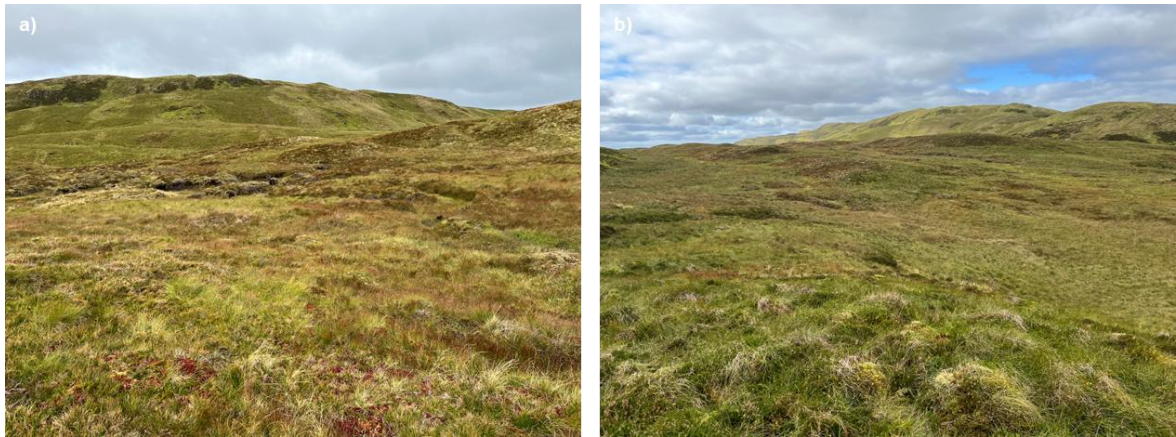
**Plate 3.2 a) and b) typical ground conditions on undulating plateau**

The majority of the Site comprises localised areas of peat on flatter ground extending into thinner organic soils over ridge sideslopes with few discernible features of geomorphological interest (e.g. Plate 3.2).

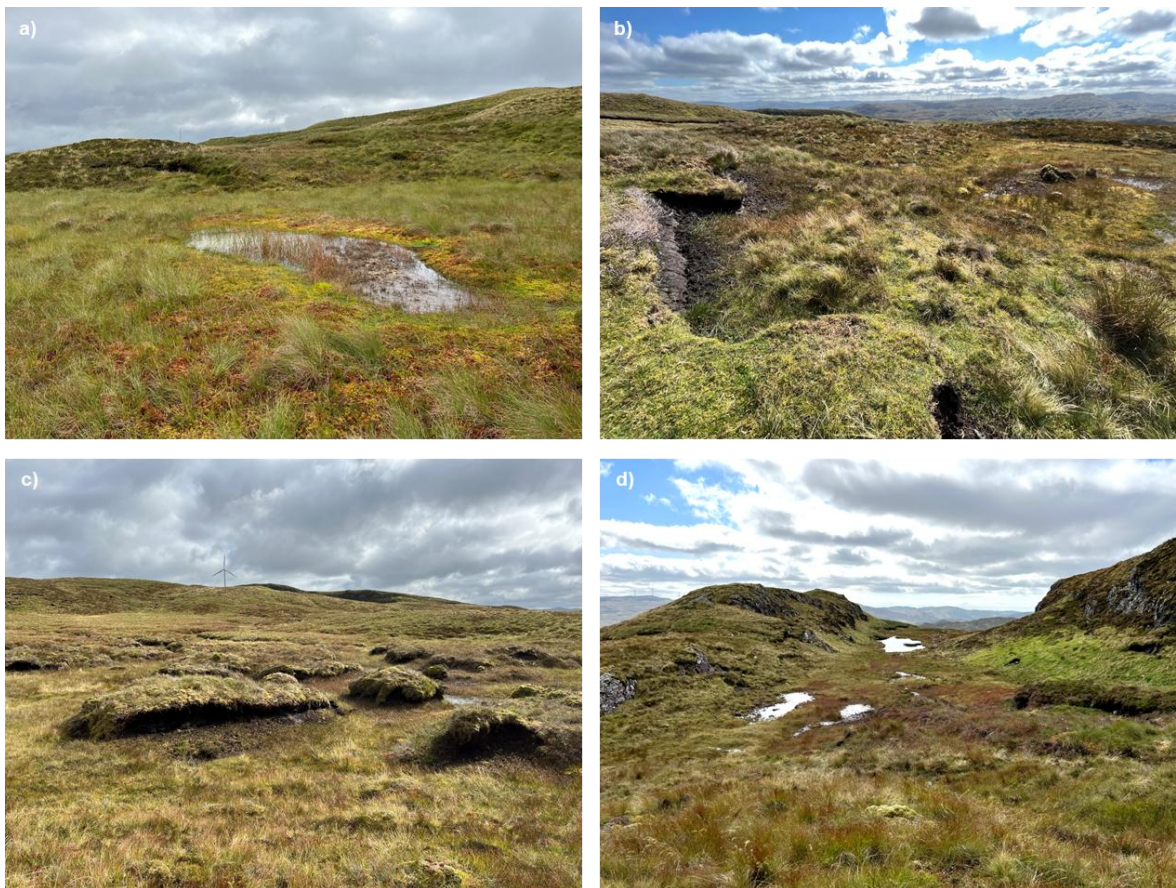
**Plate 3.3 a) an isolated bog pool on the summit, b) very small-scale and minor instability (the 'slip' is c. 3 m across), c) partially recovered area of haggging, d) bog pools amongst haggging at Creag an Fhithich**

There are occasional small-scale bog pools (e.g. Plate 3.3a, 3.3d) but no major bog pool complexes. While there are one or two very small-scale instances of minor instability (Plate 3.3b), there was no evidence of previous peat landslides or incipient failure.

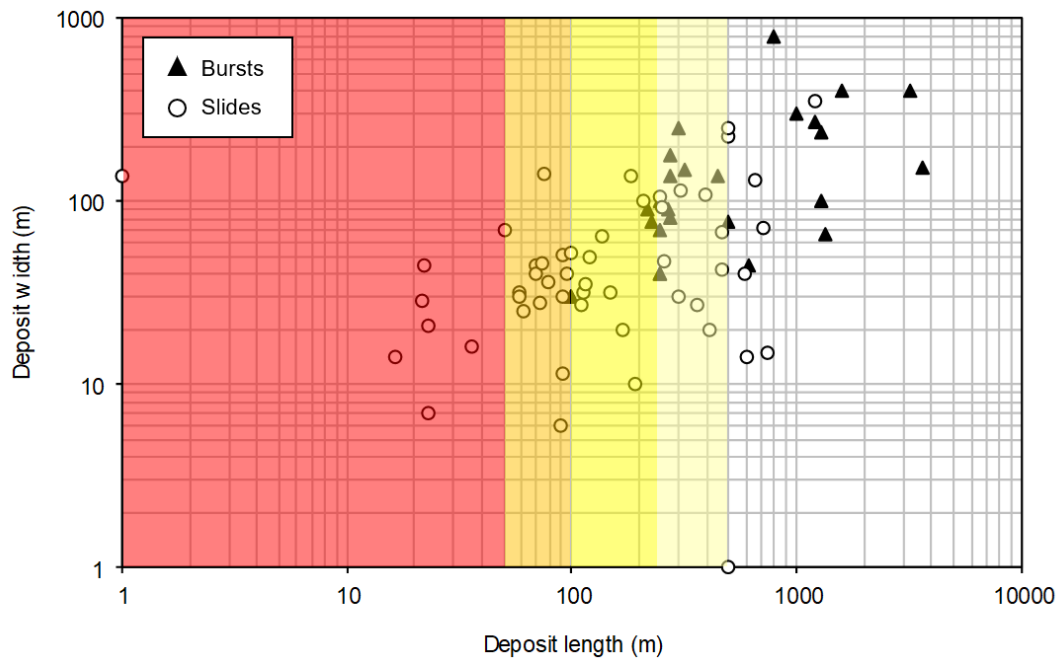
**Plate 5.1 Runout distances for published peat landslides (after Mills, 2002), colours on the plot correspond to runout pathway zones on Figure 8.4.10**

Figure 8.4.10 shows in purple all infrastructure locations that overlap with moderate likelihoods, based on the combined landslide likelihood scores described in Section 4. Runout zones are shown in colours corresponding the distances shown on Plate 5.1 below.
