Beinn Ghlas Outline Biodiversity Enhancement and Habitat Management Plan Walkover Survey Report - November 2023

November 2023

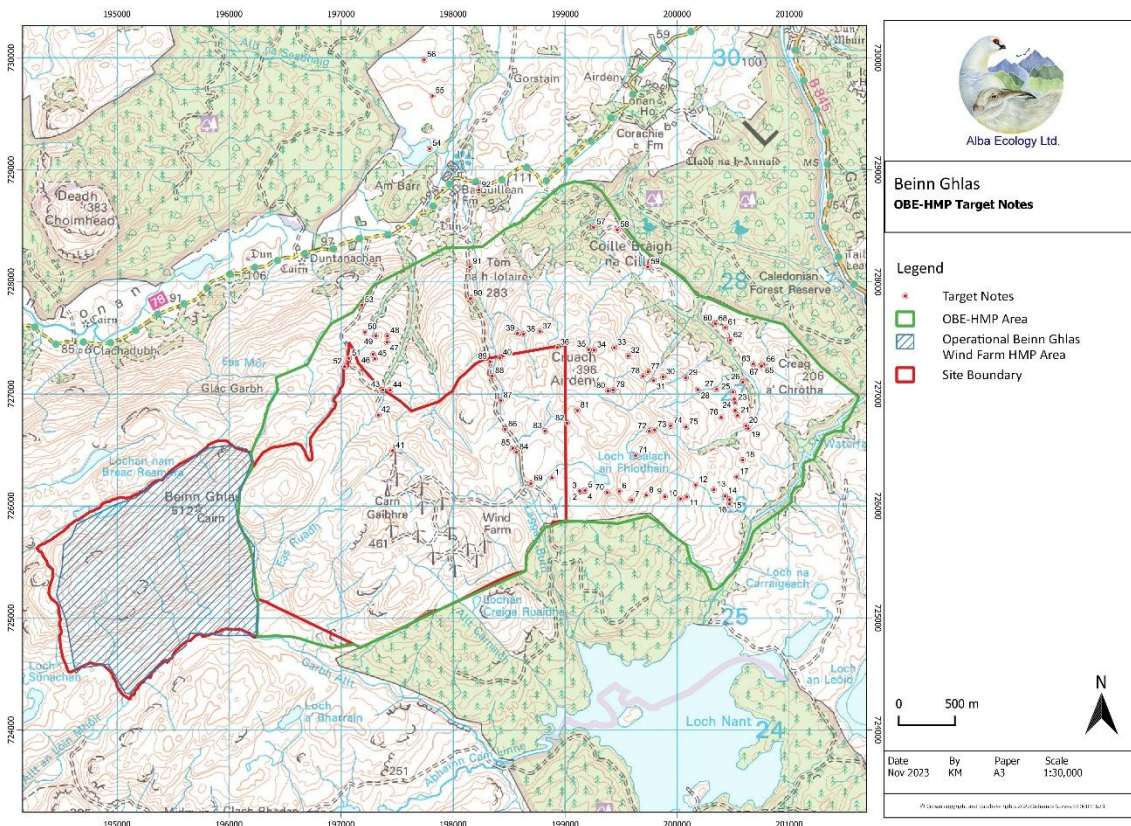
Figure 1: OBE-HMP Area

The wider OBE-HMP Area and parts of the Application Boundary were walked in November 2023 to assess for potential biodiversity enhancement and peatland restoration opportunities. The main area that was walked was between the Application Boundary (red line in Figure 1) and the OBE-HMP boundary line (green line in Figure 1).

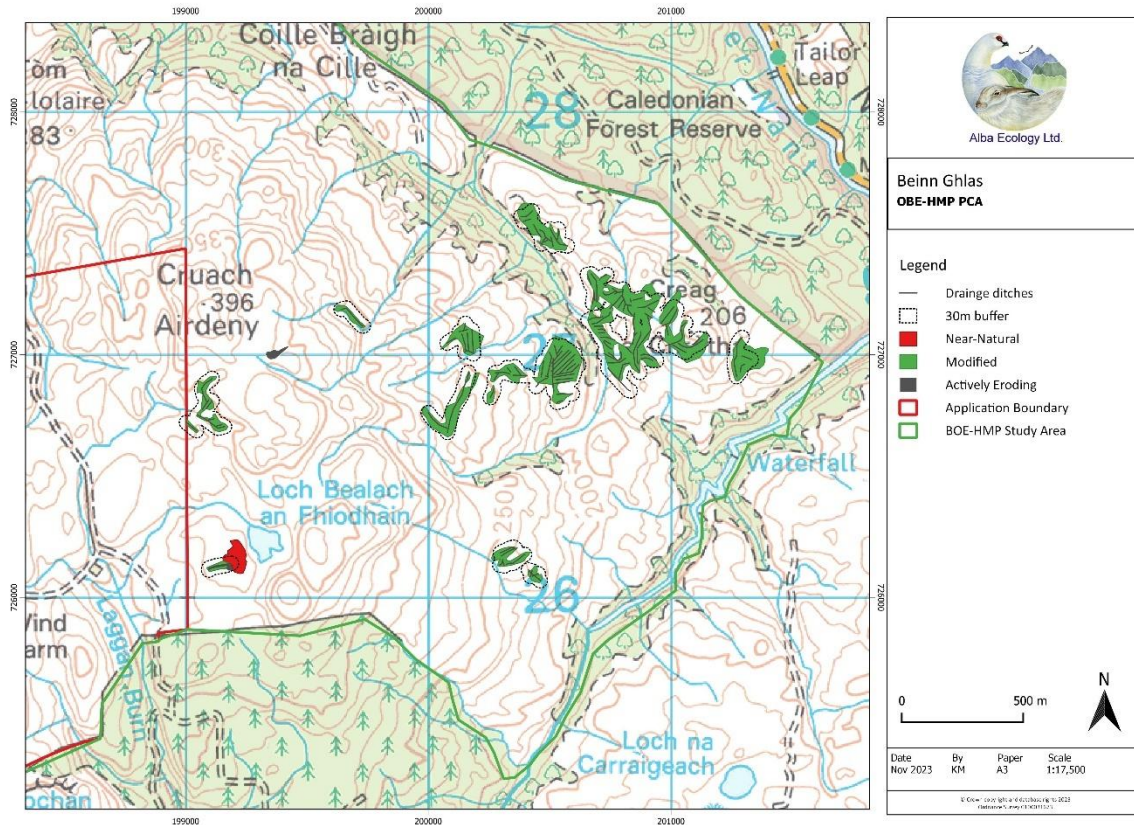
Figure 2: Drainage Ditches and PCA mapped in the wider OBE-HMP Study Area in November 2023

A total of 7,221m of drainage ditches were mapped in the wider OBE-HMP Study Area in November 2023 (e.g. Target Note 13 and 44). A 30m buffer was placed around the drains, resulting in the majority of the mapped blanket bog being considered to be in a Modified and Drained condition (Figure 2). These Modified and Drained bog habitats, were in some areas, degraded to purple moor-grass dominated stands (NVC community M25a over deep peat), whereas other areas there was a generally species poor blanket bog vegetation characterised by heather, cottongrasses and some bog-mosses (NVC community M17). The vast majority of drains were well vegetated, often lined with rushes.

There was a very small amount of Actively Eroding blanket bog, with erosion features c. 50-100m long and c. 1m deep (e.g. Target Note 79 and 80).

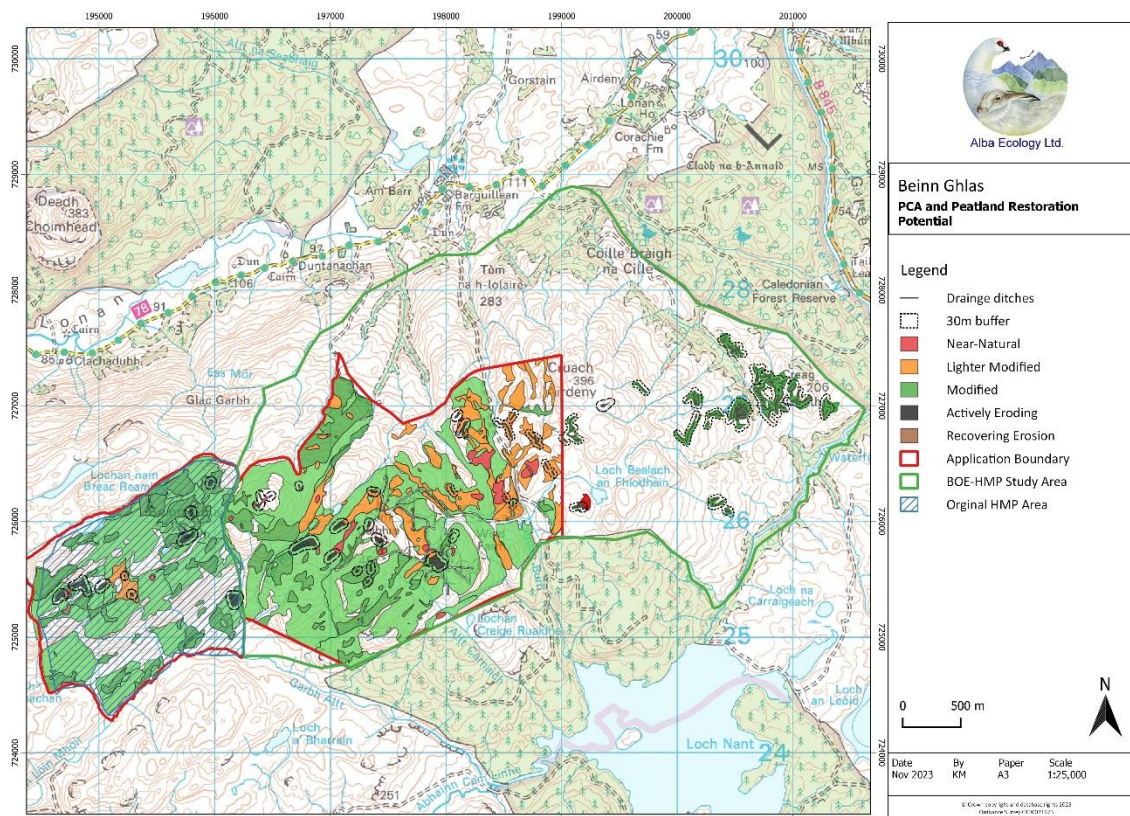
Figure 3: PCA and 30m Buffer around Drainage Ditches and Actively Eroding Blanket bog in the OBE-HMP Study Area

There was a total of c. 720m of drainage ditches identified as part of the Beinn Ghlas PCA survey report. An additional c. 7,220m were identified in the November 2023 giving a total of 7,940m of drainage ditches with the potential for peatland restoration in the whole of the OBE-HMP Study Area (including the Application Boundary). Using a 30m buffer, a total of c. 43ha of surrounding habitat (including a mixture of blanket bog and wet heath) could potentially be rewetted as a consequence of drainage ditch blocking (Figure 3).

There was a total of 6.2ha of Actively Eroding blanket bog identified as part of the Beinn Ghlas PCA survey report. An additional 0.3ha were identified in November 2023 giving a total area of actively eroding blanket bog of 6.5ha that is suitable for peatland restoration in the whole of the OBE-HMP Study Area (including the Application Boundary) (Figure 3). Placing a 30m buffer around this area results in an additional c. 24.2 ha of surrounding habitat that could potentially be re-wetted as a consequence of restoring the Actively Eroding blanket bog.

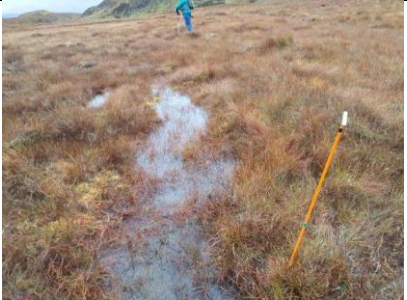
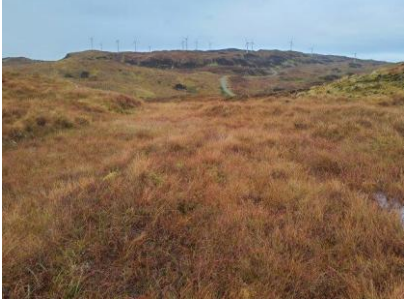
3	NM 99130 26133	Another historic drainage ditch which could be dammed to reduce drainage from the surrounding blanket bog. Second photo shows drainage route downslope.

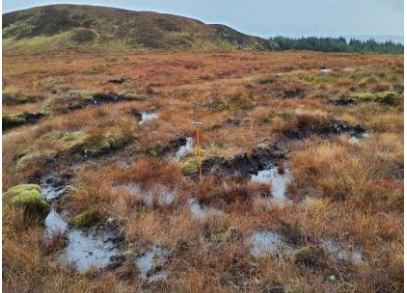
4	NM 99177 26135	High-quality Near-Natural blanket bog in overall area, but there were also some small (<0.5m) erosion features. These could be removed though cross-tracking.

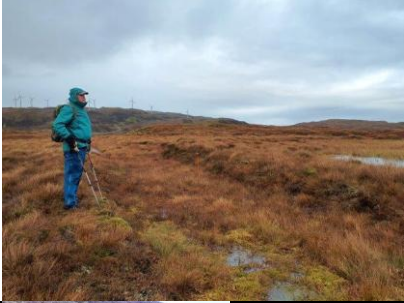
5	NM 99178 26138	A clear linear feature which may have been an old peat cutting. It is connected to the drains further downslope. Dams could be used here to prevent drainage from the surrounding bog habitat.

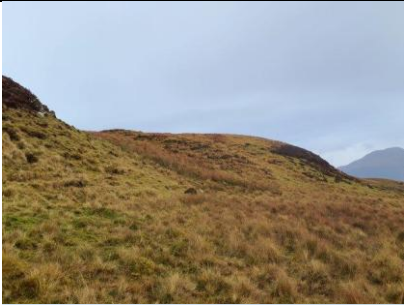
7	NM 99595 26053	Could have native woodland planting/natural regeneration in these acid grassland and dry heath hill slopes.

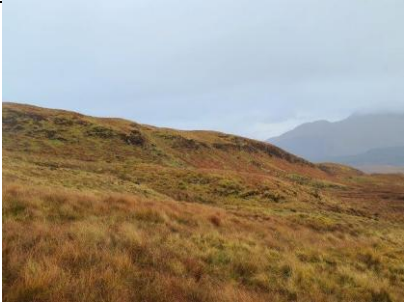
8	NM 99724 26095	Hill slopes with bracken could be planted with native tree species or natural regeneration could be encouraged through reduced grazing. Sheep were seen grazing on the acid grassland.

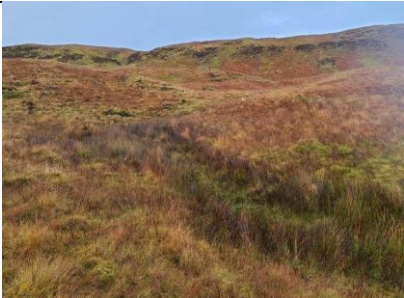
9	NM 99889 26082	Riparian planting of shrubs such as eared willow would be possible along unmarked burns where shallow soils allow. Native tree planting/regeneration would be suitable on hills behind.

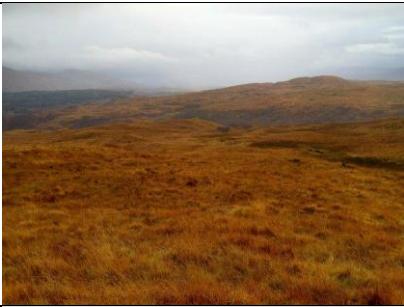
10	NM 00030 26063	Large area on the lower slopes of wet heath (M15b) and purple moor-grass dominated marshy grassland. These slopes would be suitable for native tree planting.

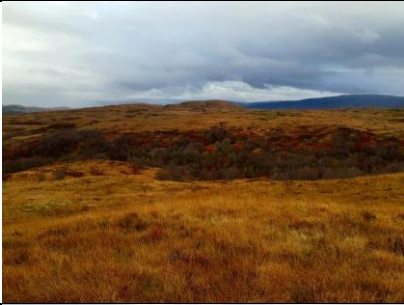
15	NM 00468 26056	View across to opposite hillslope, shows W11 birch woodland, which, in the absence of grazing could be more widely present in the east of the OHMP Study Area.

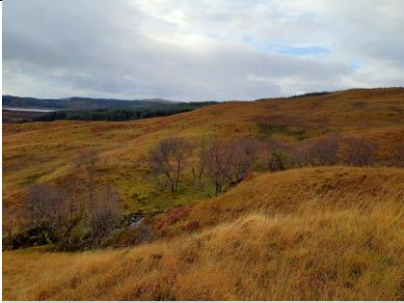
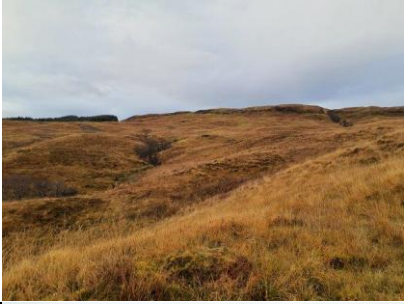
16	NM 00468 26017	View of riparian birch woodland that could be reinforced by infilling gaps and widened, where appropriate, and lengthen up the watercourse.

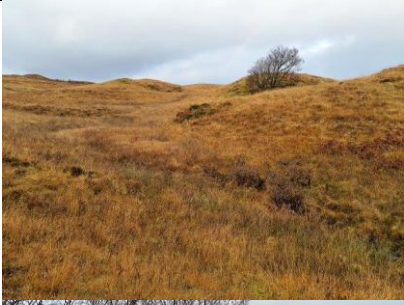
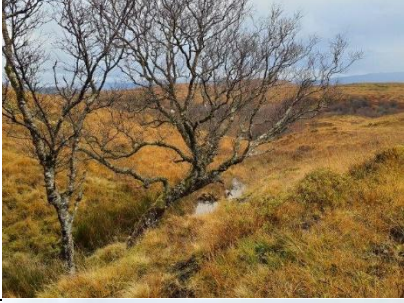
17	NM 00531 26258	Watercourse suitable for riparian planting. Birch and willow scrub present in patches. This could be reinforced with careful planting with suitable, locally sourced trees and scrub species.

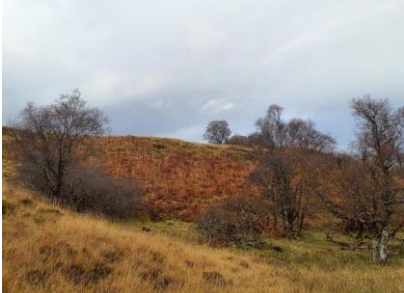
18	NM 00585 26409	Patches of bracken around the trees on slopes. Formed as network with woodland and acid grassland.

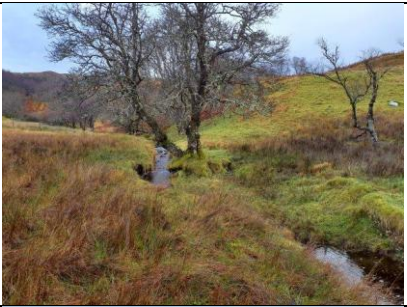
19	NM 00634 26690	Recommend reinforcing the native riparian woodland with birch, willow, aspen and alder. Fill gaps and widen.

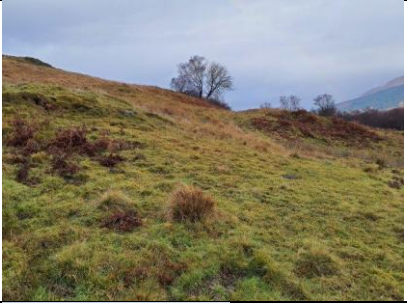
20	NM 00614 26716	Hill slopes with patches of bracken and acid grassland could be planted with native trees or be allowed to naturally regenerate to woodland through grazing management/fencing.

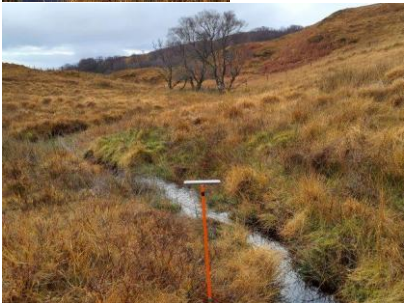
22	NM 00517 26851	Fast flowing watercourse from drained area above. It was c. 0.5m wide, 0.5m deep. Riparian woodland could be reinforced along here.

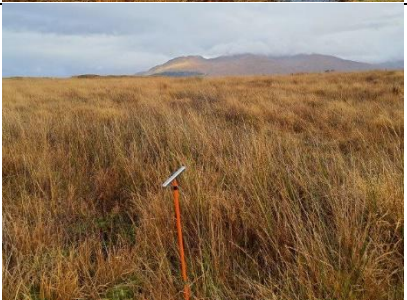
23	NM 00517 26922	Old drainage ditches, well vegetated with rushes, relatively firm ground. Could block with plastic dams or similar, to ensure existing drainage is impeded, potentially rewetting a sizeable area.

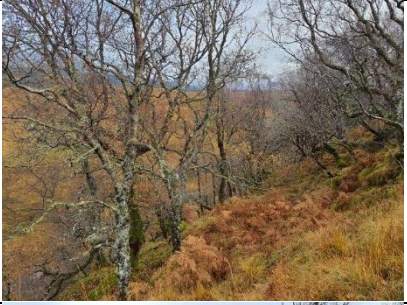
26	NM 00586 27103	Native oak and birch woodland (W11) on steep inaccessible slopes.

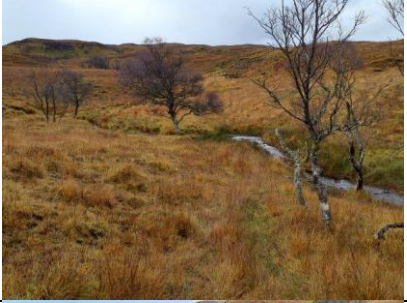
27	NM 00353 27041	Recommend widening and reinforcing riparian woodland.

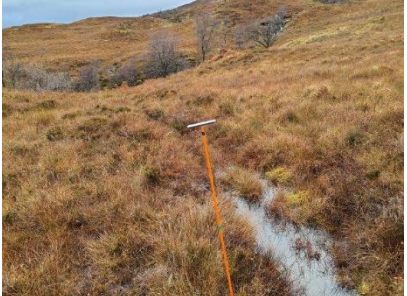
28	NM 00184 27037	Drainage ditch c. 0.5m 1m wide. Deep in places with clearly flowing surface water. This could be blocked with e.g. plastic dams.

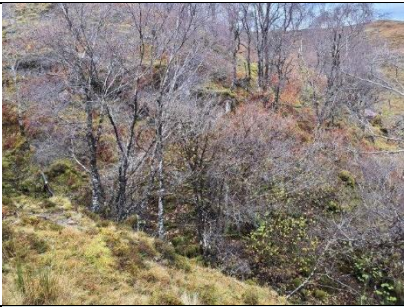
29	NM 00076 27143	Some aspen present within this riparian woodland remnant. Reinforce.

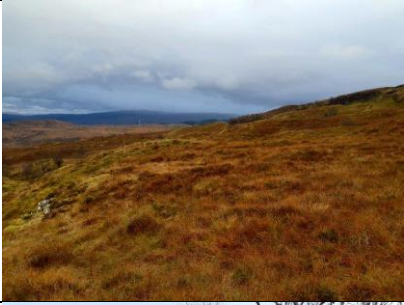
30	NM 99874 27151	Hill slope suitable for native woodland planting/allowing natural regeneration of woodland.

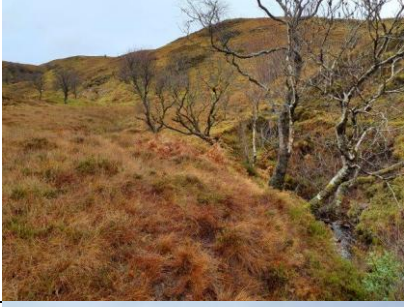
31	NM 99789 27118	Reinforce woodland riparian. Holly present with the birch at this location.

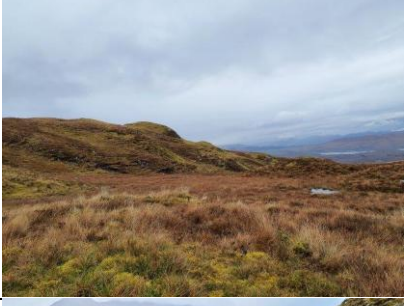
32	NM 99561 27339	Hillslopes of largely wet heath (M15b), marshy grassland (M25a-b), acid grassland (U4 or U5). There were pockets of isolated bog habitat in topographical basins. The bog was generally either purple moor-grass dominated M25a on deep peat (wet modified bog) or poor M17 in a Modified (and Drained) condition. Sheep were commonly seen in the area.

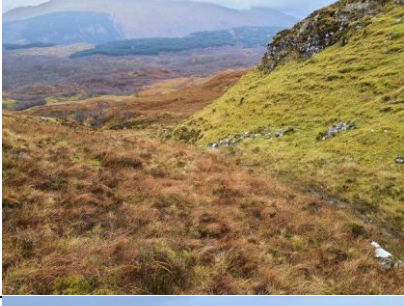
33	NM 99439 27412	Watercourse could be planted with native, locally sourced birch and willow.

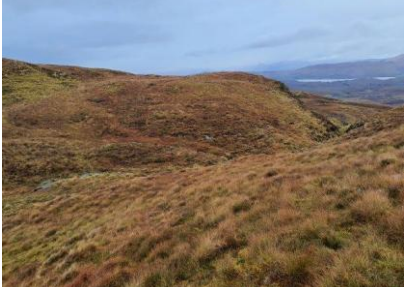
34	NM 99259 27390	Riparian woodland planting suitable. Birch was seen downstream. Avoid planting on areas with deep peat.

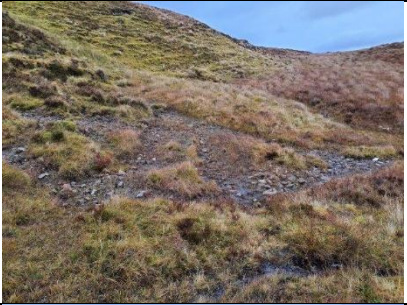
35	NM 99210 27395	Large M10 GWDTE. Triangle 10m c. 10m long on each side.

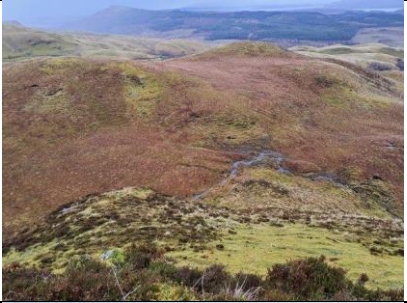
36	NM 98931 27414	View of natural watercourse features including the head of the unnamed watercourse. There were no clear drains in the surrounding blanket bog (M17).

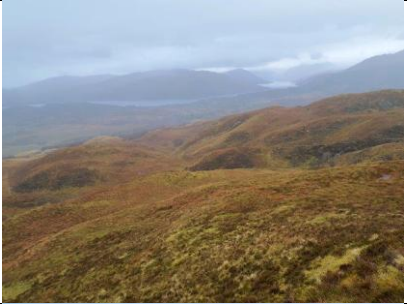
37	NM 98774 27555	Viewpoint. Whilst some bog habitat was present there were no meaningful restoration opportunities in this area.

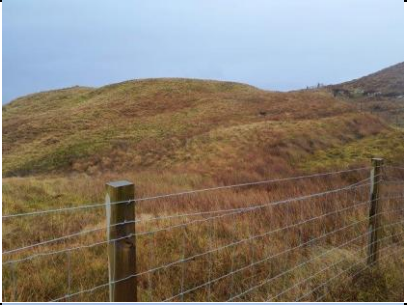
38	NM 98629 27531	Acid grassland dominated beyond the fence-line.

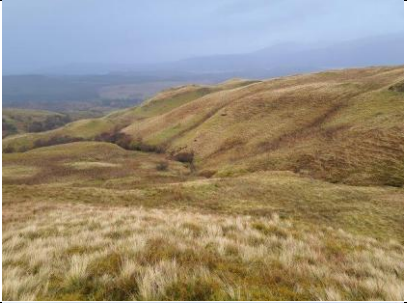
39	NM 98575 27539	View of existing riparian woodland which could be expanded. The grassy slopes could also be planted with native tree species or encouraged to naturally regenerate if grazing pressure was reduced.

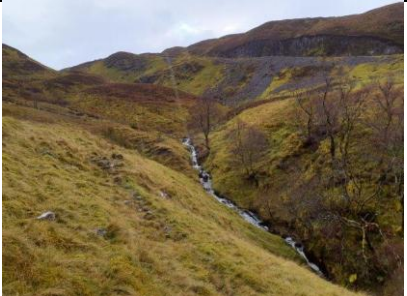
40	NM 98417 27320	Recommend reinforcing the existing riparian woodland habitat along this watercourse.

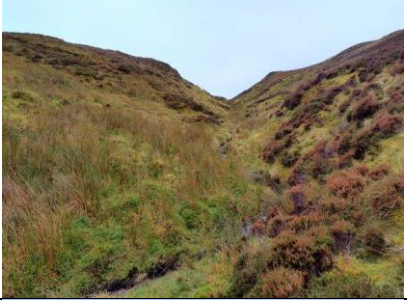
41	NM 97461 26492	Riparian planting potential along this watercourse.

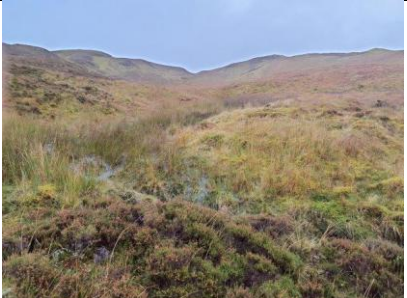
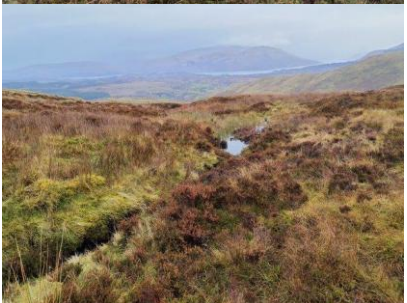
42	NM 97333 26810	Potential for riparian planting. Upstream then downstream photos. Occasional riparian birch were noted downstream.

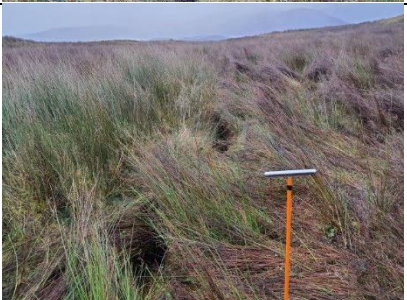
45	NM 97301 27312	Series of drainage ditches in rush pasture (MG10). Soft rush and sharp flowered rush with occasional tufted hair grass. Ditches were c.0.5m wide. Soil was apparently <1m deep. Habitat was not blanket bog.

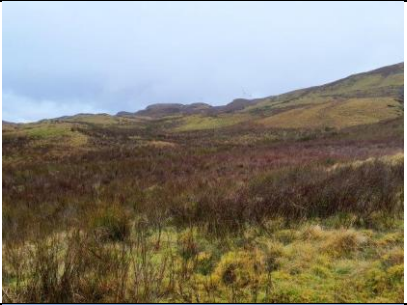
46	NM 97286 27352	View of drained MG10 area.

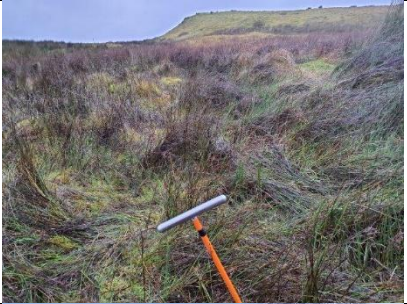
48	NM 97414 27517	Soils apparently less than 1m deep. Sharp flowered rush dominated.

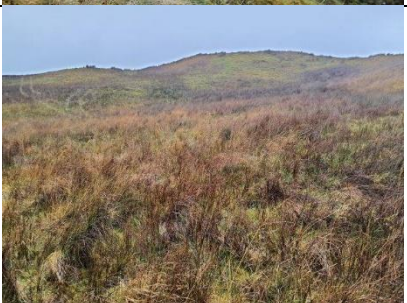
50	NM 97213 27551	Small disconnected, rush pasture (MG10) with some M25a marshy grassland. Drains not obvious at ground level, although can see water flow pathways from aerial imagery.

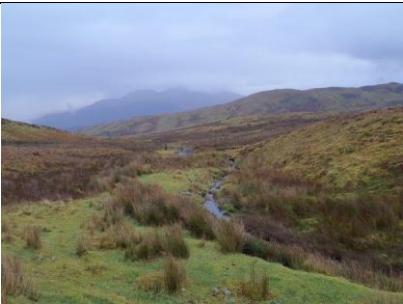
51	NM 97069 27318	View of rush pasture and watercourse suitable for riparian planting.

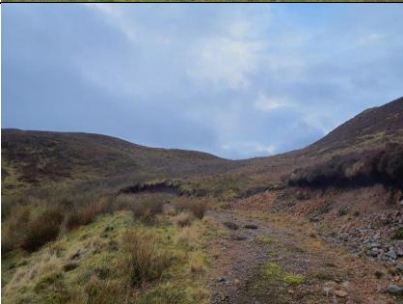
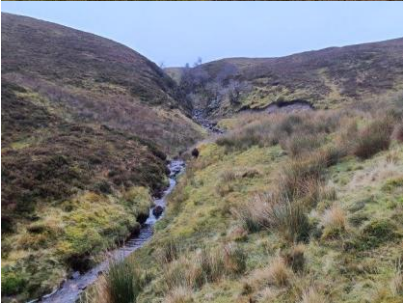
52	NM 97033 27243	Rush pasture considered unsuitable for peatland restoration. Watercourse would be suitable for riparian planting.

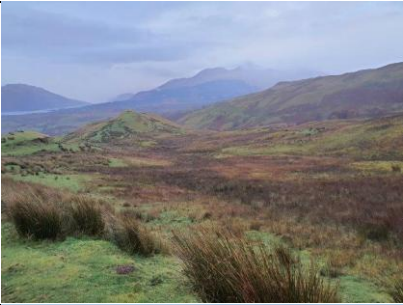
53	NM 97185 27792	Rush pasture unsuitable for peatland restoration.

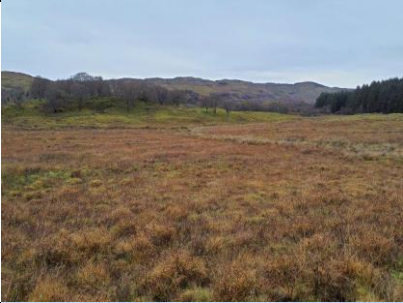
54	NM 97790 29188	Peatland habitat, M15b over deep peat – wet modified bog. Drainage ditches apparent and lined with rushes. Suitable for peatland restoration.

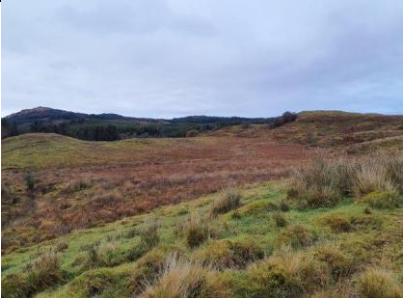
55	NM 97815 29659	Blanket bog habitat, set within hills of acid grassland and bracken. There were occasional birch present.

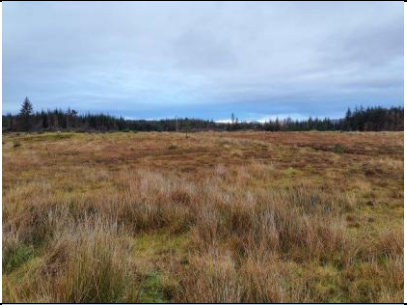
56	NM 97742 29983	Some peatland restoration potential between acid grassland hillocks.

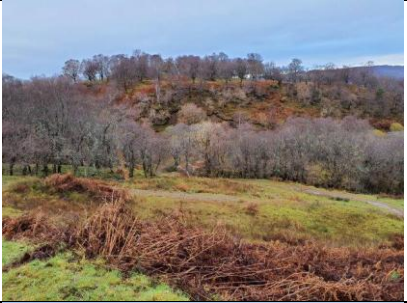
57	NM 99254 28486	High quality remnant oak woodland. Patches of bracken form part of the mosaic with open grassland. Likely to be good habitat for Lepidoptera.

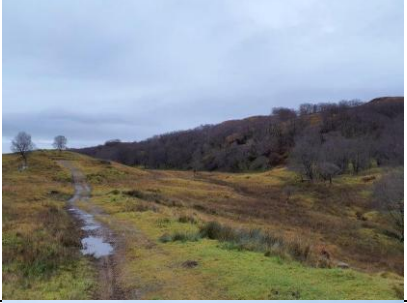
59	NM 99738 28133	Open woodland and grassland. The grassland is likely suitable for Lepidoptera.

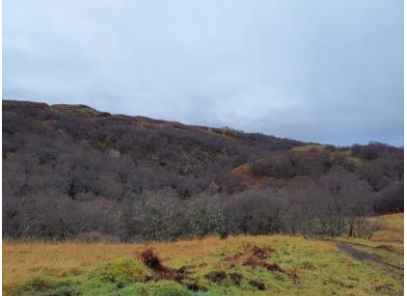
60	NM 00337 27627	High quality birch and oak woodland, with patches of bracken and grassland as part of the structure of the woodland.

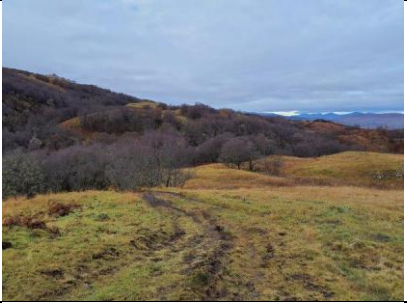
68	NM 00341 27626	Quiet area with open mature W11 oak and birch woodland. Potential source for local provenance seed.

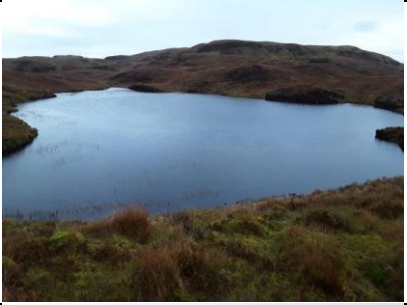
70	NM 99375 26119	Small loch. Potentially suitable for a diver raft?

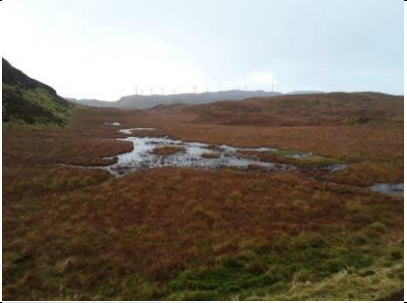
71	NM 99629 26450	Potential for native tree planting on slope above deep peat. Bog pool present within high quality blanket bog.

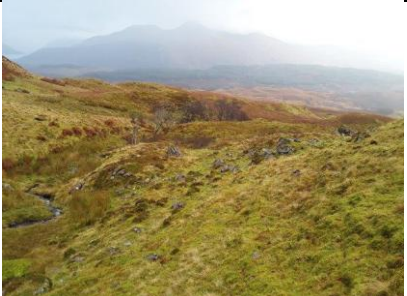
72	NM 99752 26666	Previous planning i.e. T3 link up with existing remnant riparian birch.

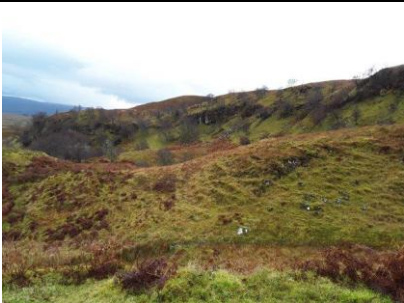
73	NM 99799 26678	Only short gap to link up with existing and extensive native riparian woodland. Planting would take place on shallow soils so avoiding deep peat.	
74	NM 99941 26715	Planting may not be necessary in some areas. Potential to fence cliff and remnant trees and allow natural regeneration to take place.

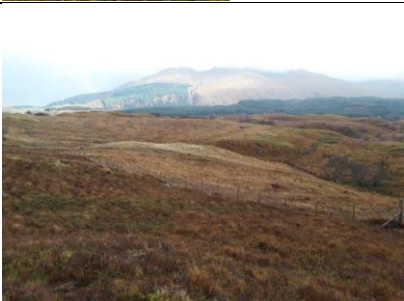
76	NM 00393 26789	Looking on to area of vegetated drains.

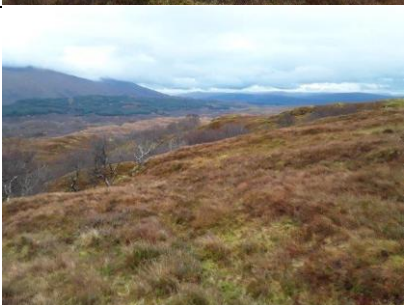
77	NM 99741 27197	Woodcock flushed. Making woodland wetter and extending trees likely to benefit this declining, red-listed species.

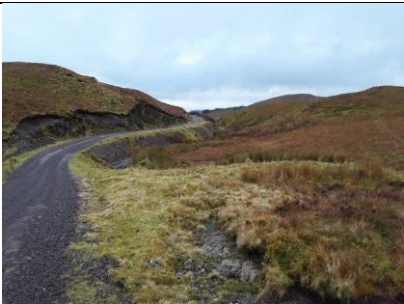
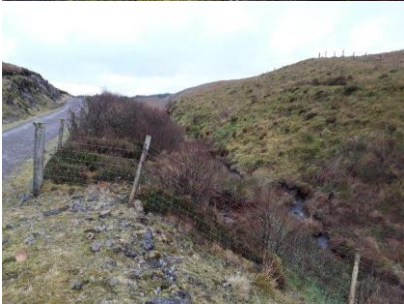
84	NM 98566 26478	Fenced riparian woodland fragment along access track side demonstrating suitable growing conditions in the absence of grazing pressure. As previously noted, where it is fenced there was a high proportion of heather and willow scrub inside.

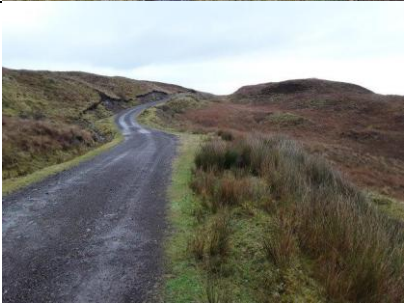
85	NM 98533 26515	Area for woodland planting on right side of access track looking north in photo.

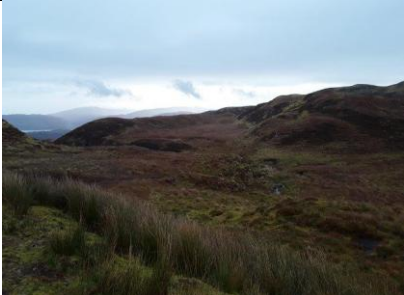
87	NM 98423 26940	Open burnside habitat suitable for riparian tree planting. Note in far left of the photo first broadleaved trees coming through from north.

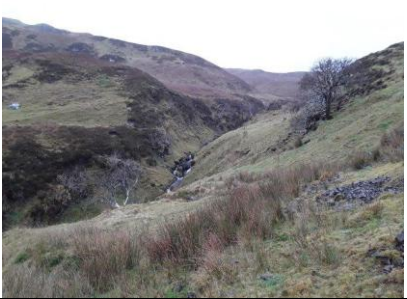
88	NM 98348 27160	Woodland remnants on cliff by watershed.

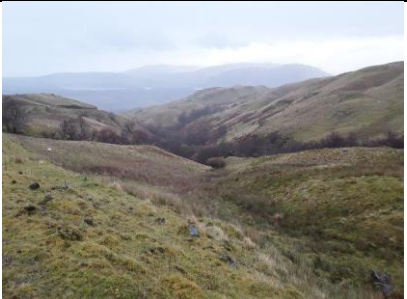
89	NM 98329 27287	Extensive existing broadleaved riparian woodland heading north from this location. Appears continuous from here northward.

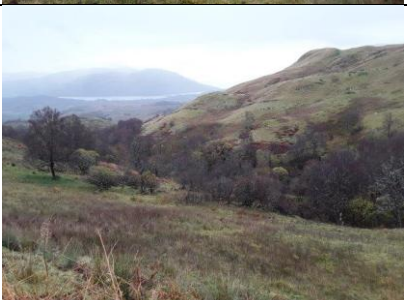
90	NM 98155 27850	Very good mixed mature broadleaved trees in valley bottom. Riparian corridor already very strong here and illustrative of what is potentially possible.

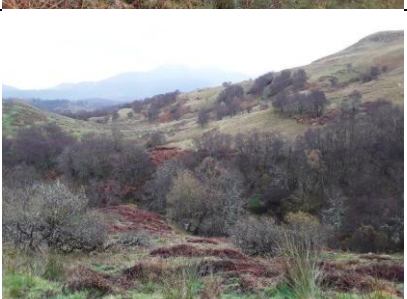
91	NM 98149 28134	Broadleaved trees have broken out from riparian corridor onto open hillside here.
